## **Customer Service Bulletin SD800006 Cable Issues in SE125 IP66 Transmitters**

**Application:** This bulletin applies to **SE125 IP66 Transmitters SLF33300/01 or SLF33400/01/02**. This applies to SE transmitters shipped prior to February 15, 2013.

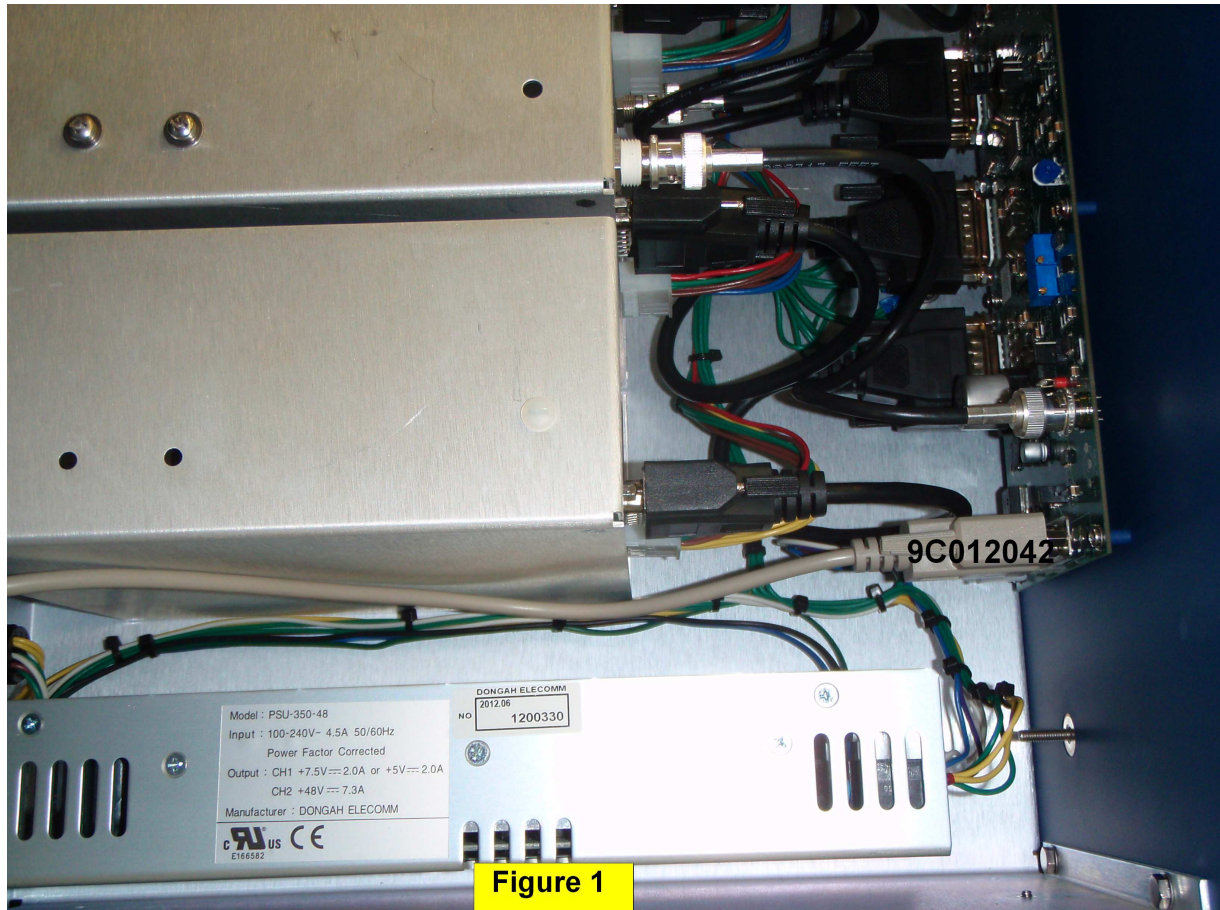
Example #1 - 9C012042 cable, SE125 IP66 Single and Dual Transmitters:

We have recently identified potential cable issues that could affect proper operation of the SE125 transmitters. Due to high failure rates, we have invested in more reliable cables for all SE series transmitters.

- Remove cable ties and disconnect the 9C012042 cable from the SLP45500 Transmitter Control PCB per Figure 1.
- Continue to Figure 2.
