Durability of GFRP Reinforced Concrete in Field Structures

by A. Mufti, M. Onofrei, B. Benmokrane, N. Banthia,
M. Boulfiza, J. Newhook, B. Bakht, G. Tadros,
and P. Brett

Synopsis: Recently, ISIS Canada studied the durability of GFRP in concrete in several field structures across Canada. The objective of the study was to provide the engineering community with the results of the performance of GFRP materials that have been exposed to the concrete environment in built structures. Cores of GFRP-reinforced concrete were removed from five field structures. Analytical methods, namely optical microscopy, scanning electron microscopy and energy dispersive x-ray, differential scanning calorimetry and infrared spectroscopy, were used to determine the composition of GFRP after being subjected to the alkaline environment of concrete for five to eight years. Three research teams from four Canadian universities performed microanalyses of the GFRP and surrounding concrete independently. Results indicate that no deterioration of GFRP took place in any of the field structures. No chemical degradation processes occurred within the GFRP due to the alkalinity of the concrete. The overall conclusion o

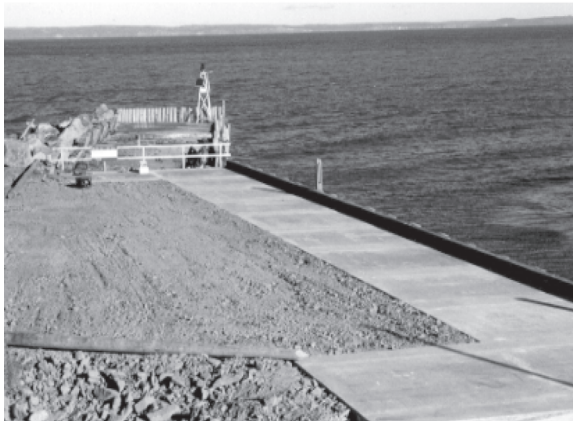
Figure 1 – Hall's Harbor Wharf.

The Hall's Harbor Wharf (Fig. 1) was the first marine structure in Canada to be built using ISIS Canada technology and design concepts¹³. The wharf, located on the Bay of Fundy shore in Nova Scotia, comprises steel-free precast concrete panels with GFRP bars and concrete pile cap beams reinforced with a hybrid GFRP-steel bar system. Concrete with a compressive strength of 45 MPa was used in the panels and beams. The structure is 5 years old and operates under the following environmental conditions: thermal range +35 to -35°C; wet and dry cycles, splash and tidal salt water; frequent freeze-thaw cycles.

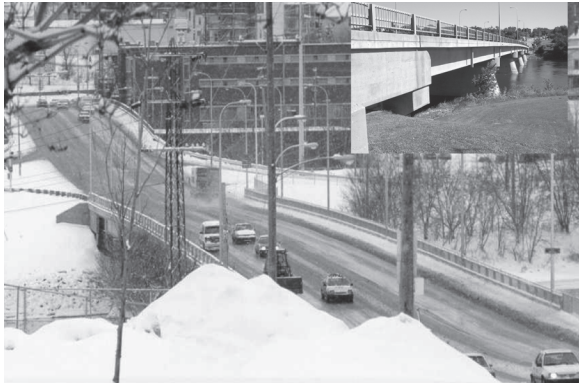
Figure 2 - Joffre Bridge.

The Joffre Bridge (Fig. 2), located in Sherbrooke, Québec, over the St-Francois River, contains GFRP bars as reinforcement in the 45 MPa concrete in the sidewalks and the traffic barriers¹⁴. In this structure, the GFRP material is a ribbed-deformed GFRP C-Bar. The structure is 7 years old and operates under the following environmental conditions: thermal range +35 to -35°C; wet and dry cycles; freeze-thaw cycles; de-icing salt.

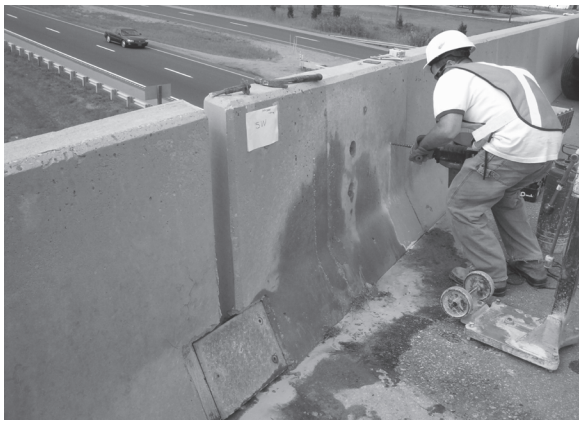
Figure 3 – Barrier wall of Chatham Bridge.

From each of the five structures, at least 10 cores of GFRP reinforced concrete were removed at various locations in the structure. Figure 3 shows a barrier wall of the Chatham Bridge, from which cores were removed. The cores had a diameter of 75 mm and a length varying between 140 and 180 mm. All cores removed from one structure can be seen in Fig. 4.

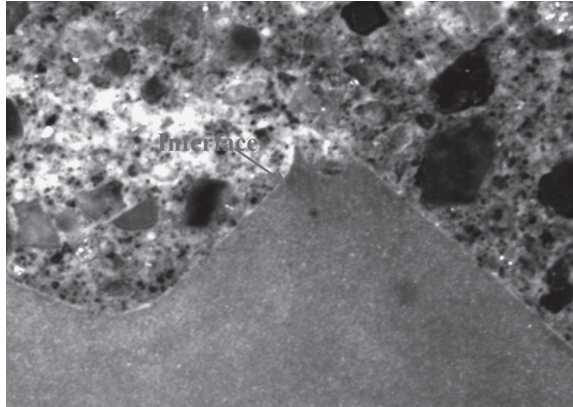
OM examinations of the interface between the GFRP and concrete of the cores from the five field structures exposed to natural environmental conditions show no loss of bond between the GFRP and concrete. Figures 5 and 6, showing OM results for cores from the Crowchild Trail and Chatham bridges, respectively, are typical of all OM observations. It can be seen in these figures that there are no gaps between the GFRP and concrete, thus confirming a good bond between the two materials.

Figure 5 – OM image of cross-section of GFRP from Crowchild Trail Bridge

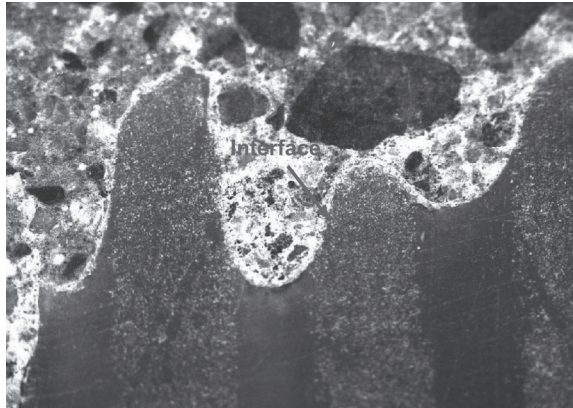
Figure 6 – OM image of cross-section of GFRP from Chatham Bridge.

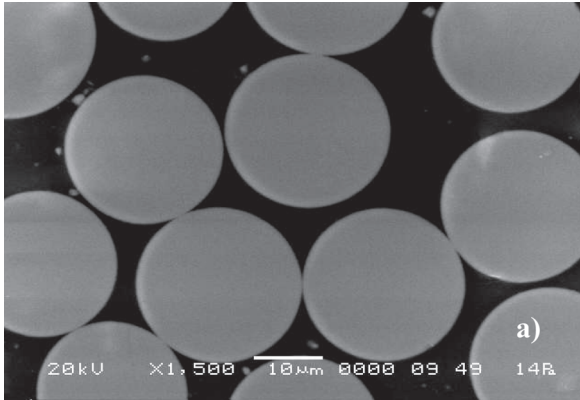
Results from SEM analyses presented in Figs. 7 and 8 are typical of all other SEM analyses, which have shown that the individual fibers are intact with no gaps between fibers and the matrix. There is no evidence of deterioration of the glass/matrix interface. A good contact between individual glass fibers and the matrix, between sand grains and the matrix as well as between concrete and the matrix was observed for all specimens. The SEM analyses confirmed that the GFRP in the five structures did not show any evidence of attack from the alkali in concrete.

Figure 7 – Micrograph of cross-section of GFRP from Crowchild Trail Bridge.

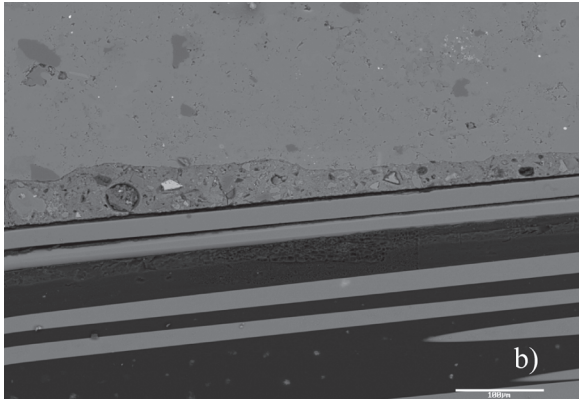
Figure 8 – Micrographs of longitudinal section of GFRP from Chatham Bridge.

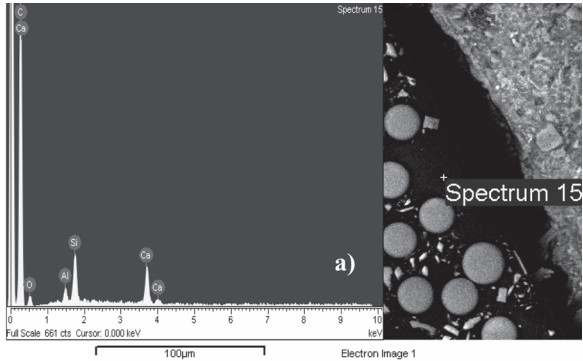
From two of the examined structures, samples of GFRP were saved and kept in storage for possible future investigation. These samples, referred to herein as the control specimens, provide an opportunity to compare the chemical composition of the GFRP extracted from in-service structures; the latter specimens are referred as the 'in-service' specimens. The EDX spectra of the in-service and control GFRP specimens from the Joffre Bridge are presented in Figs. 9 and 10, respectively. It can be seen that the matrix in both specimens contains mainly carbon, as it should. However, some additional elements such as Si, Al, and Ca have also been detected. Since the EDX spectrum of the

in-service specimen is almost identical with that of the control specimen, the presence of elements other than C in the matrix could be attributed to contamination introduced during the preparation of the specimens for the microscopic examination.

The concrete pore water solution consists mainly of Na^+ , K^+ with OH^- as counter ion. Other elements present in the solution are either very insoluble (Ca^{2+}) or have low solubility (Mg, Al, Si, Fe and SO_4^{2-}). Since the EDX cannot detect elements lighter than sodium, the OH^- ion cannot be detected. However, the OH^- ions and cations, Na^+ , K^+ , will diffuse together for charge neutrality to be satisfied. Therefore, a strong indication of alkali migration from a concrete pore solution toward the glass fibers would lead to the presence of Na or K in the matrix (Figs. 9 and 10). Observations on several specimens indicated that neither Na nor K is present in the matrix.

Figure 9 – EDX spectra of in-service specimen from Joffre Bridge.

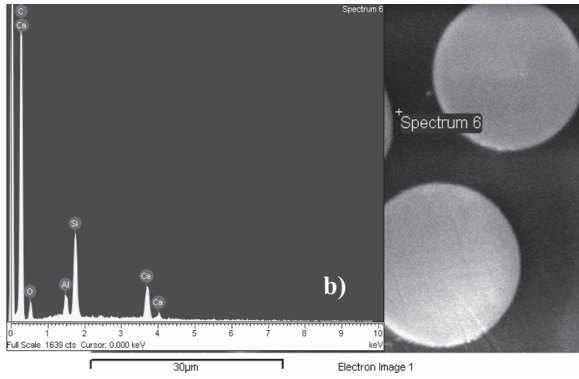
Figure 10 – EDX spectra of control specimen from Joffre Bridge.

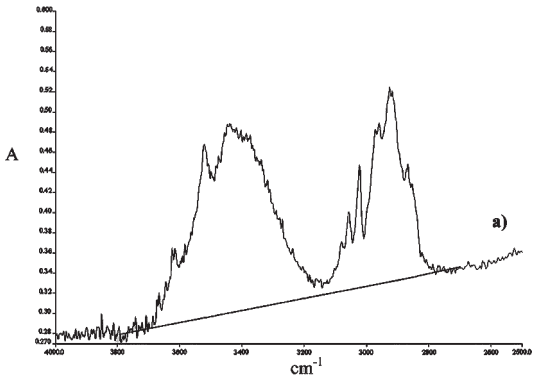
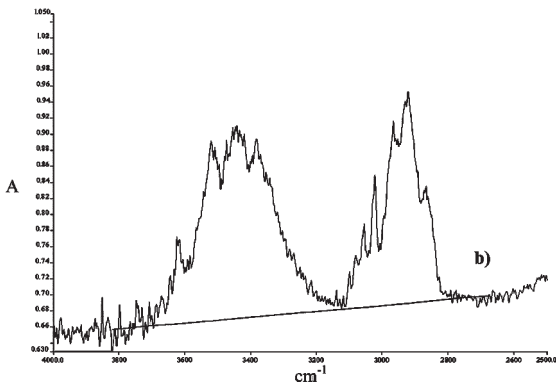
The durability of the matrix is governed to a large extent by the chemical nature of the structure of the polymeric chain. In their structure, all resins have ester bonds, which are the weakest link of the polymer. A possible degradation mechanism of the matrix is the alkali hydrolysis of the ester linkages. Due to the alkaline environment in concrete, alkali hydrolysis is expected to some extent. During the hydrolysis reaction, the OH^- induces ester linkage attack and the resin chain is broken. Consequently, the structure of the resin is disrupted and the material properties are changed. The resin material degrades and eventually will not be able to transfer stresses to the glass fibers and to protect the glass fibers against alkaline attack. Changes in the amount of hydroxyl groups present in the composite material provide insight into the hydrolysis reaction. The relative amount of hydroxyl groups in the specimens were measured by determining the ratio of the maximum of the band corresponding to the hydroxyl groups at 3430 cm^{-1} and the band corresponding to the carbon-hydrogen groups at 2900 cm^{-1} in the FTIR spectra. The C-H content is assumed to be constant. Since the vinyl ester resins naturally contain hydroxyl groups, all the spectra present a strong absorption band in this region. Typical results of the FTIR analysis of control and in-service GFRP samples from Hall's Harbor Wharf are presented in Figs. 11 (a) and (b), respectively. It can be seen that there is no significant change in the spectra of the two specimens. Table 1 lists the content ratio of OH/CH for the control and in-service specimens from the Joffre Bridge and the Hall's Harbor Wharf. The results show very little changes in hydroxyl content in the in-service specimens. In effect, the OH/CH ratio decreases in the in-service sample indicating that the hydrolysis reaction did not occur in the specimens during the exposure to natural environmental conditions.

Figure 11 – FTIR spectra of GFRP from Hall's Harbor Wharf: (a) control specimen, and (b) in-service specimen.

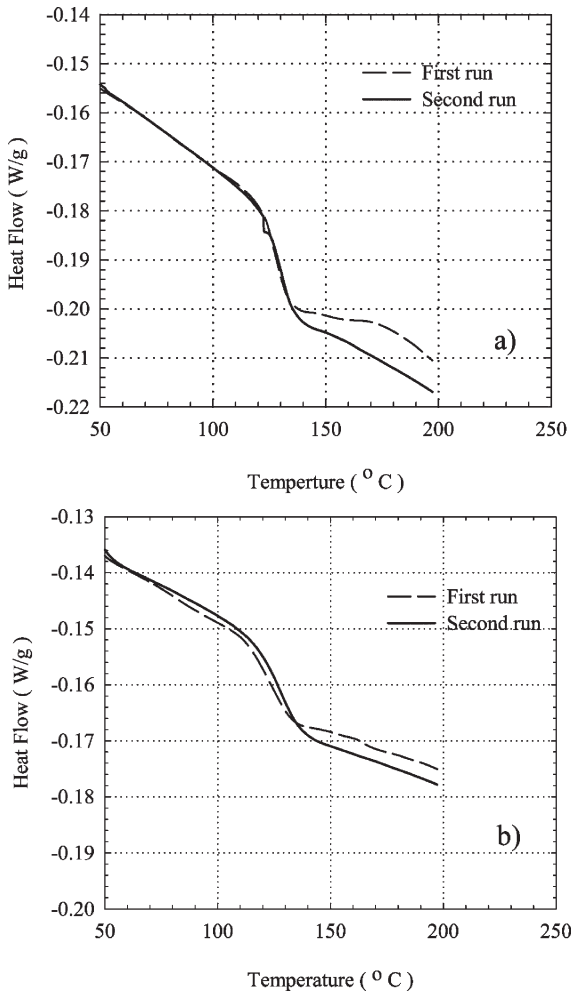
The results for the Hall's Harbor Wharf control specimen indicated a difference between the values of the T_g in the two heating runs indicating that the matrix in the GFRP ISOROD rod was not fully cured. In the 2nd heating run the resin was fully crosslinked and the T_g value increased from 105°C in the 1st run to 125°C. However, the T_g value for the exposed specimens did not show any significant change between the two heating runs, suggesting that the post-cure of the matrix occurred in the concrete structure. It is quite likely that the completion of the crosslinking process was due to structure exposure to high temperature during summers. The control samples on the other hand were stored at room temperature that did not initiate the post-curing process. Overall, the T_g results indicate that the structure of the matrix has been not disrupted by the exposure conditions at the Hall's Harbor Wharf. Similarly, no significant differences in the T_g values were observed for the control and in-service specimens for the Joffre Bridge. However, it should be noted that the T_g value for the 16 mm diameter GFRP C-Bar was 108°C which, even fully cured, was low compared with the T_g value for other GFRPs used in the Hall's Harbor Wharf and Crowchild Trail Bridge. The low value is attributed to manufacture formulation. High T_g values, ranging between 123 and 128°C, were measured for the 9 mm diameter GFRP C-bar. The T_g values for both types of GFRPs suggest no structural disruption of the matrix due to exposure to natural conditions at the Joffre Bridge. The thermographs for 9mm control and in-service specimens from the Joffre Bridge are presented in Figs. 15 (a) and (b). The results indicate that GFRP material was fully cured and the thermograph for the in-service specimen (Fig. 12a) was very similar to the thermograph for the control specimen (Fig. 12b).

Figure 12 — Thermographs for GFRP from Joffre Bridge: (a) in-service specimen, and (b) control specimen.
