LCD Failure Modes – It's All About Quality

Edward Wyrwas

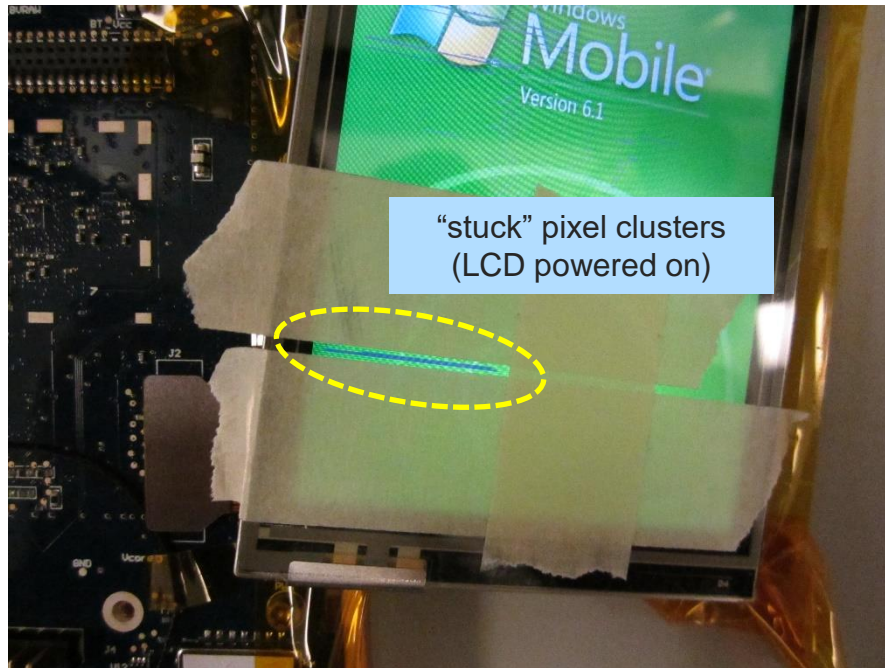
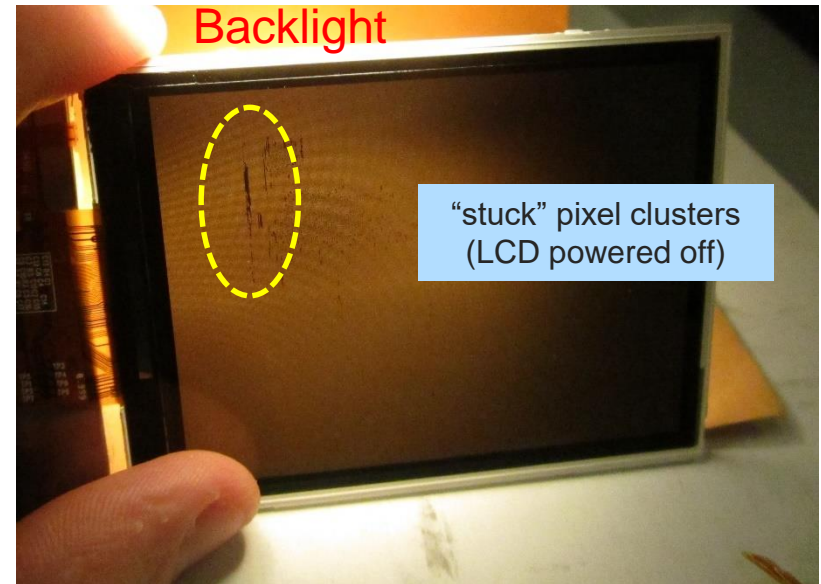
Stuck On vs Stuck Off Failure Behavior

- The failed and intermittently failed LCD modules had characteristics of “stuck” pixel clusters in the powered on or powered off states

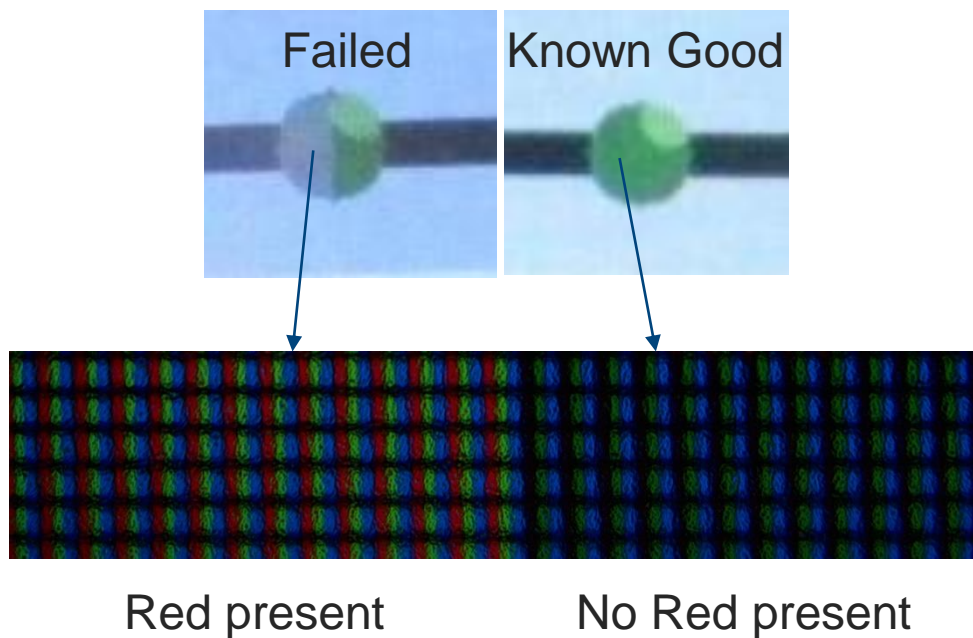
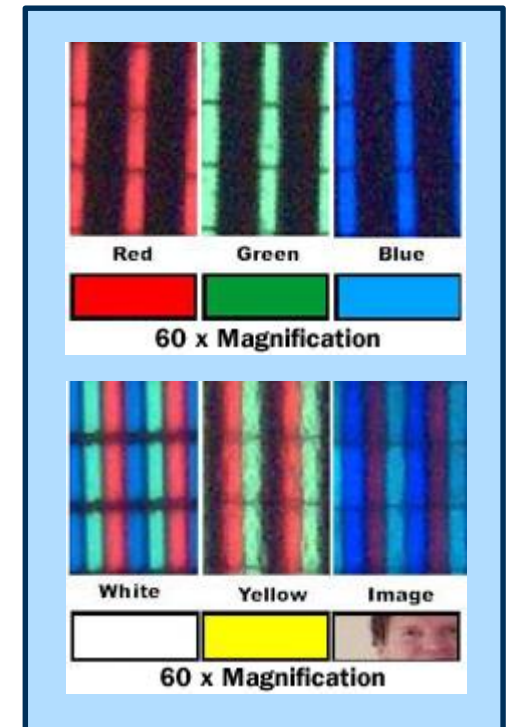
Grayscale Failure Behavior

- Example: The characteristic of failure is lack of green pixels on the left side of the display
- Upon investigation we find the red channel was constantly toggling on and off which is making the image gray scale

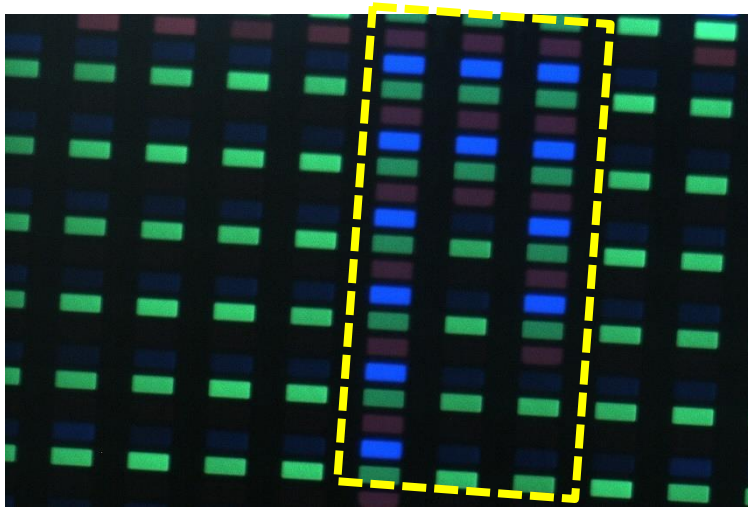
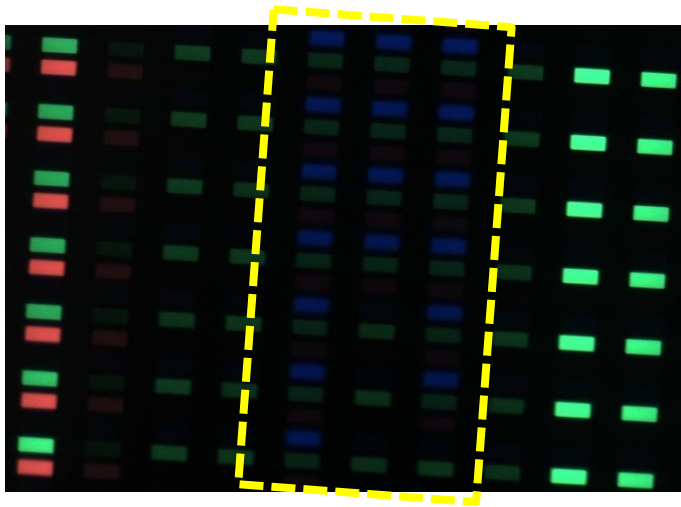
Behavior: Pixels Stuck On

- Blue and red pixels are illuminated when they shouldn't be
- Screening process:
 - Power up LCD on inverted microscope
 - Using a *dark-field* filter, focus on glass in front of color filter
 - Examine pixel array colors using solid color palette of red, blue, green, white and black
- Failure mechanism:
 - Electrical short in TFT matrix and/or electrical continuity issues with the chip-on-glass

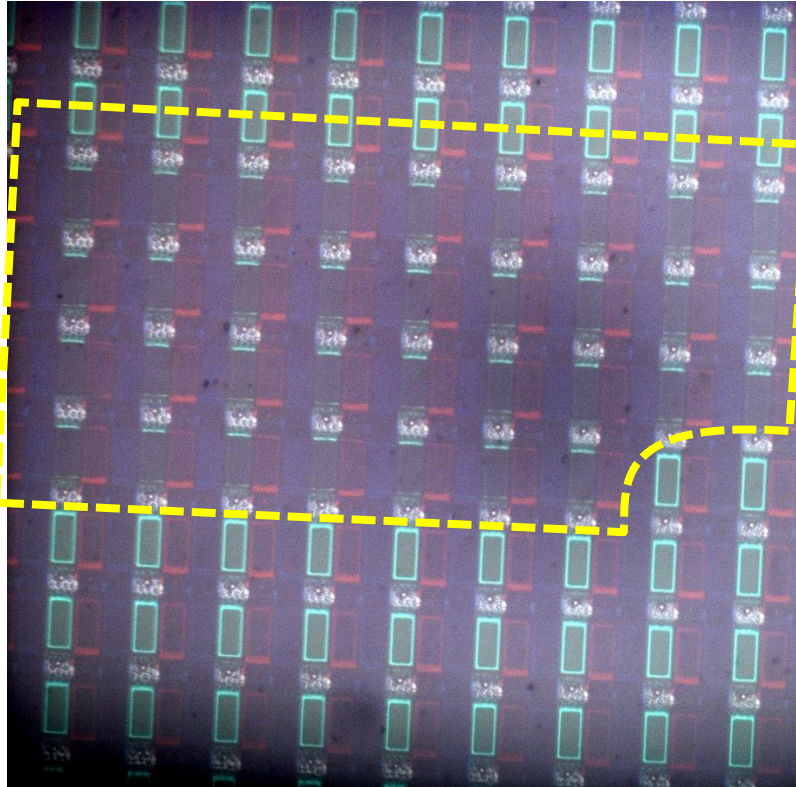
Behavior: Pixels Stuck Off

- Green and red pixels do not illuminate when they should be
- Screening process:
 - Power up LCD on inverted microscope
 - Using a *bright-field* filter, focus on pigment color filter within glass sandwich
 - Examine pixel array colors using solid color palette of red, blue, green, white and black
- Failure mechanism:
 - Electrical open in TFT matrix and/or electrical continuity issues with the chip-on-glass

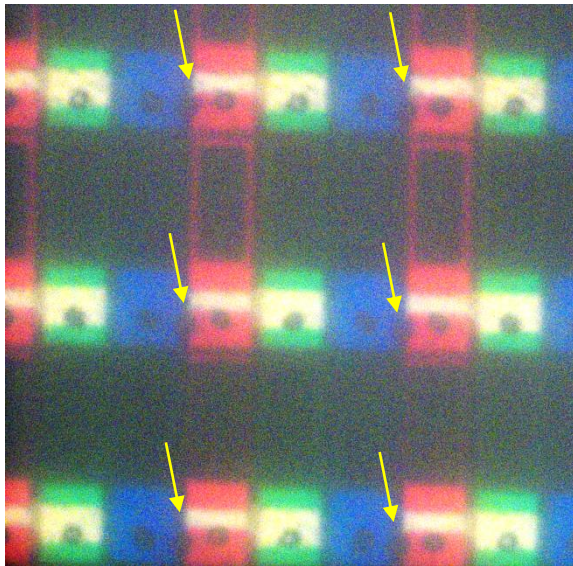
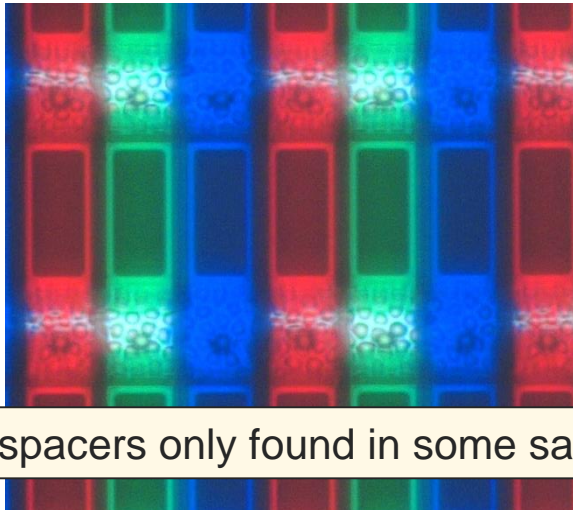
Non-Uniformity of Spacers/Extra Spacers

Extra spacers only found in some samples

- Pixels do not illuminate when they should be
- Screening process:
 - Power up LCD on inverted microscope
 - Using a *dark-field* filter, focus on pigment color filter within glass sandwich
 - Examine pixel array colors using solid color palette of red, blue, green, white and black
- Failure mechanism:
 - Non-uniformity in cell gap height causing active-unfilled area

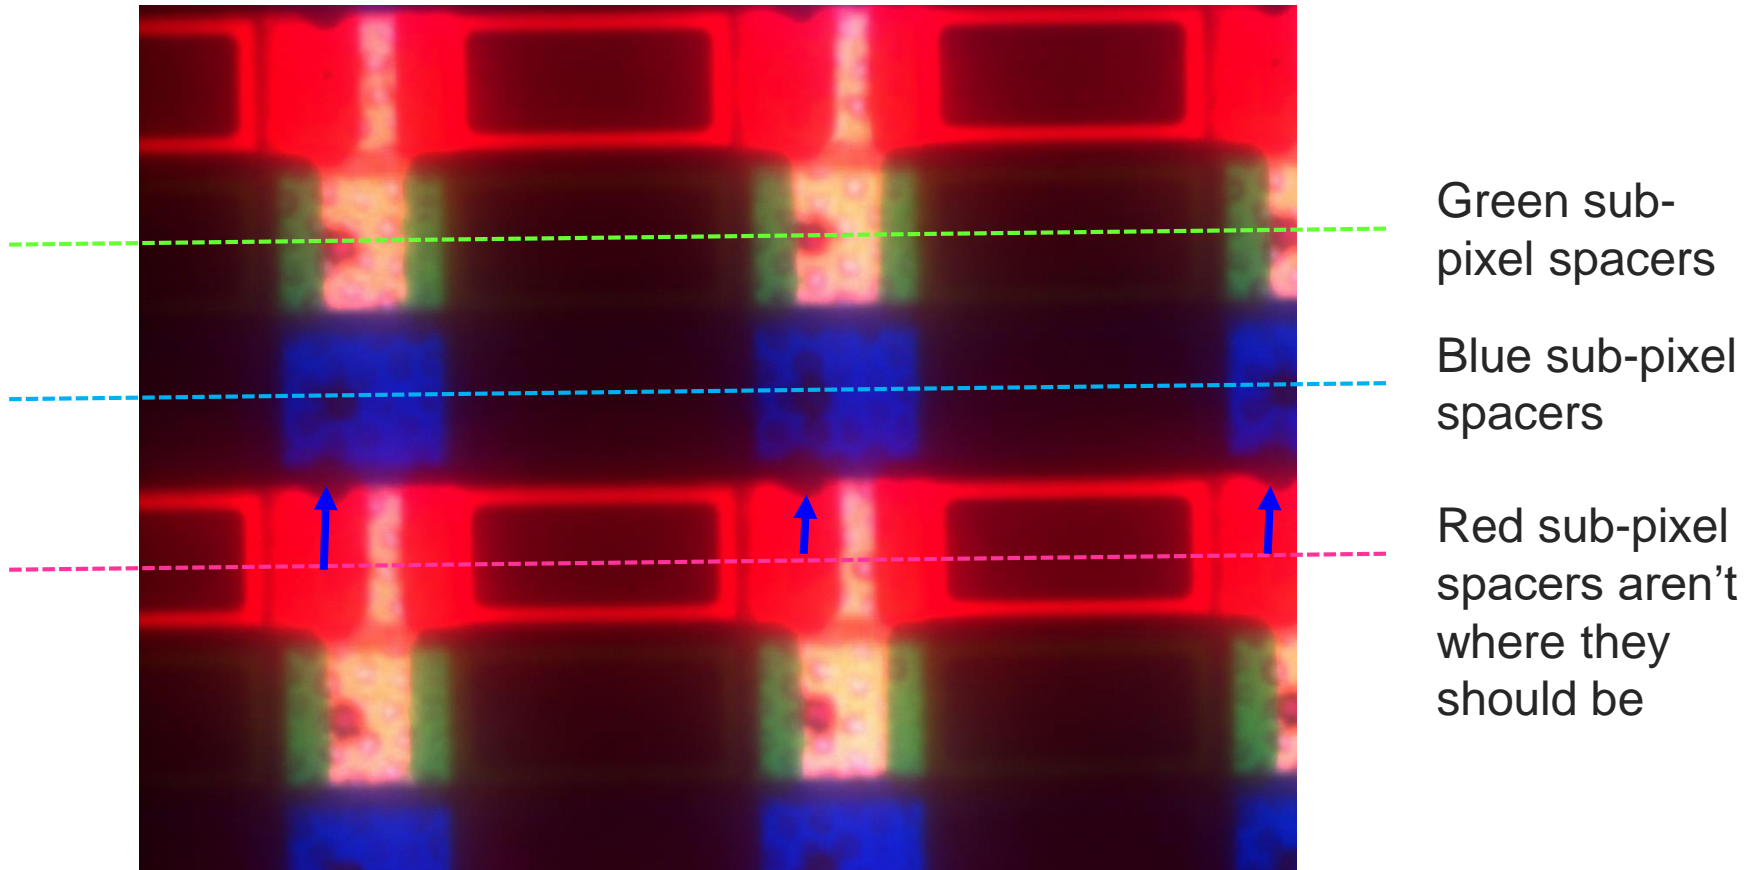
Non-Uniformity of Spacers/Extra Spacers or Debris (Cont'd)

The spacers are supposed to be patterned on the color filter glass at each sub-pixel

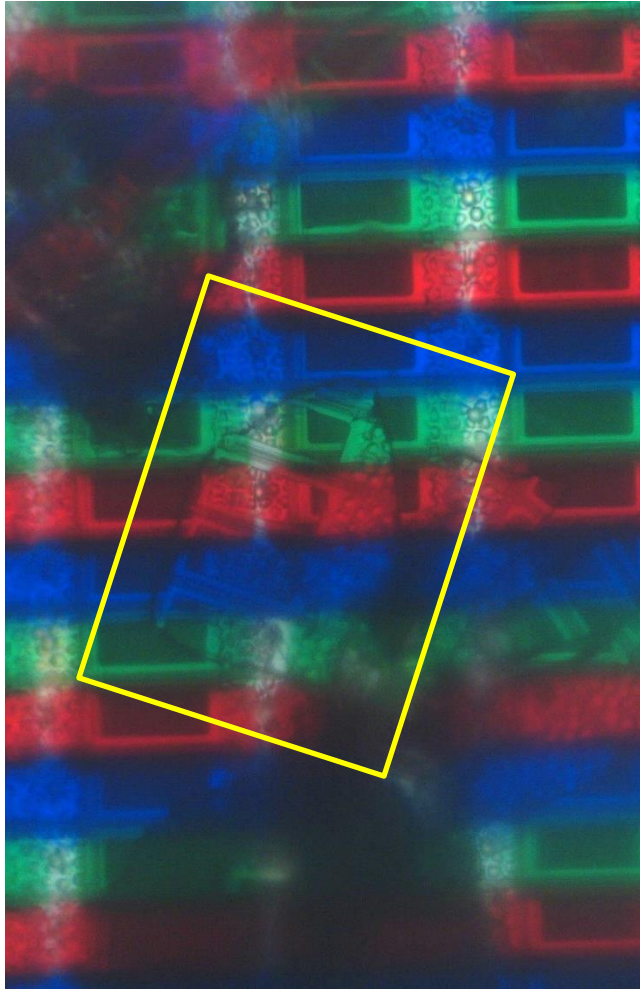
Delamination of TFT Metallization

- Pixels look grayscale due to blocked light output
- Screening process:
 - Power up LCD on inverted microscope
 - Using a *polarized light* filter, focus on the TFT array from the color side of the glass sandwich
 - Examine pixel array colors using solid color palette of red, blue, green, white and black
- Failure mechanism:
 - Mobile TFT metallization is bridging the active matrix
 - Noteworthy observation – orientation of debris does not affect color filter (colored rows are intact)

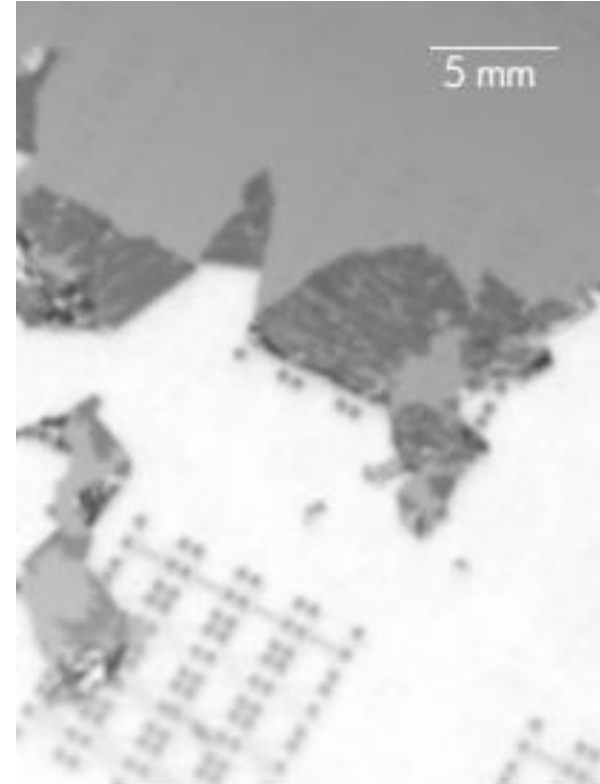
Discussion: TFT Delamination

- A reference image of gate delamination due to poor adhesion of the deposited metals is shown
- This failure mode takes place when there is a CTE mismatch between the substrate and the deposited materials. It also takes place when the substrate is not uniformly heated (or rapidly cooled) during the deposition process.

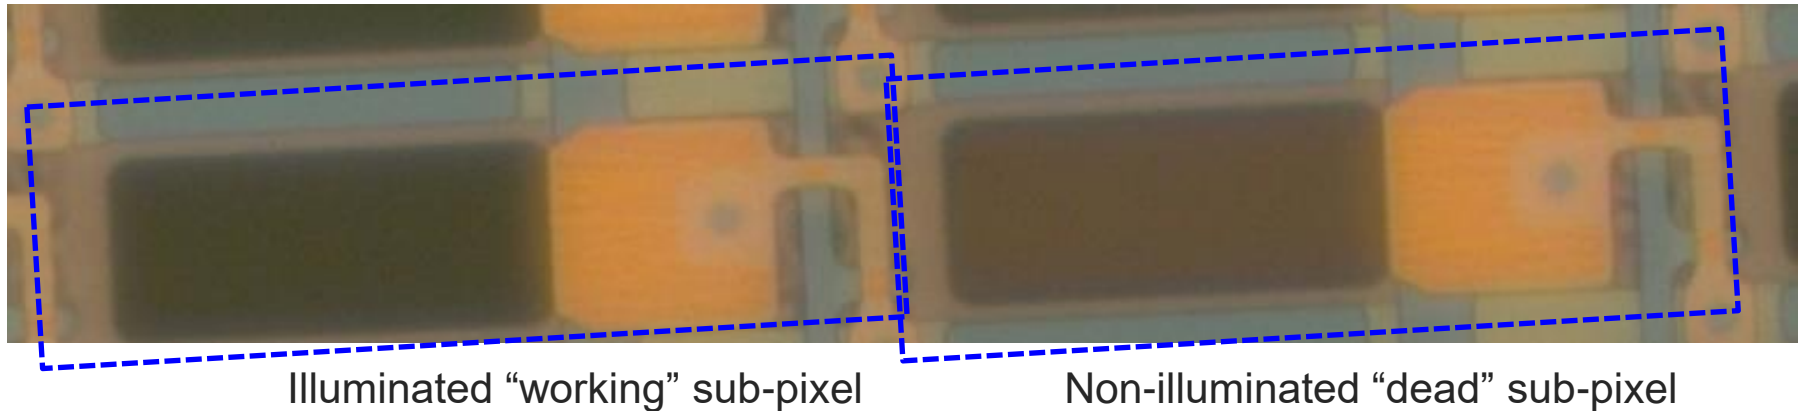
Thin-Film-Transistor (TFT) Array

- Sometimes it is possible to identify electrode patterning issues within the thin film transistor array
- The differences in opacity of the pixel itself is due to the surface tension of the liquid crystal on the opposing side of the glass
- Screening process:
 - Non-powered up LCD on inverted microscope
 - Using a *polarized light* filter, focus on the TFT array from the side opposite of the color side of the glass sandwich
 - Examine metallization, passivation and layering of the TFT constituents for anomalies

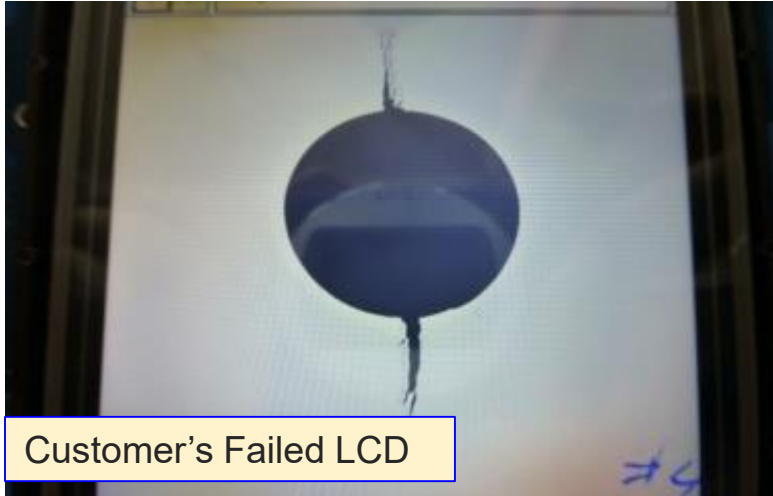
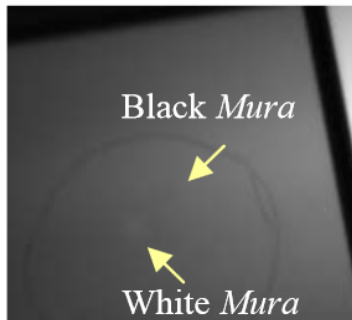
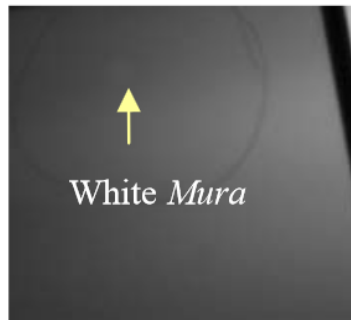
Touch Mura Appearance

- Mura images at different inspecting angle. (a) Both black and white mura can be inspected. (b) Only white mura can be inspected.

- During manufacturing, thermo-mechanical compression of the glass sandwich causes deformation of the spacers. Spacers towards the center of the display are plastically deformed, while those towards its periphery elastically deform. The uniformity throughout the display is less than optimal.
- Liquid crystal's function is based on the cell height at each pixel. If the spacers are non-uniform, then the light refraction through the liquid crystal is distorted. This effect can take place from external pressure on the screen or excessive internal cell pressure.
- The effect is a brownish/blackish blotch within the LCD viewable region.

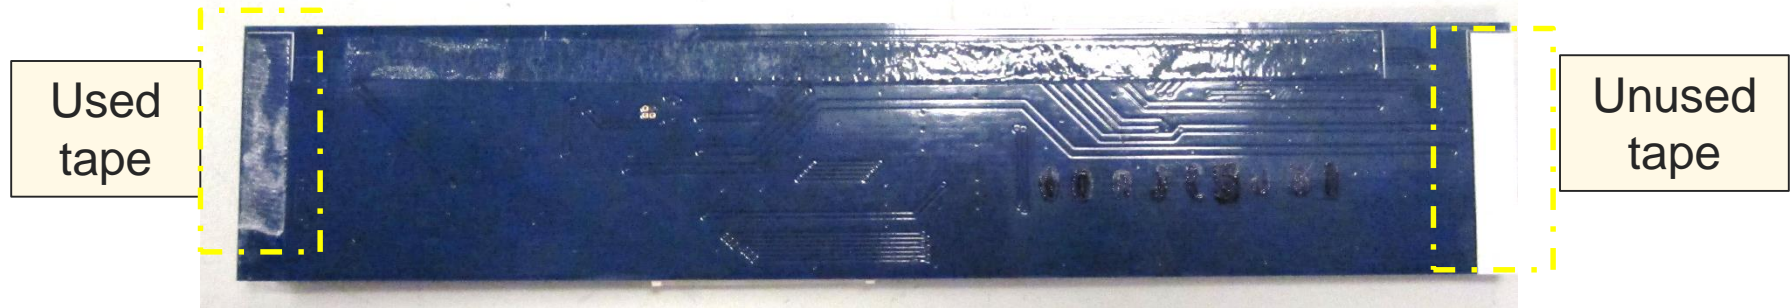
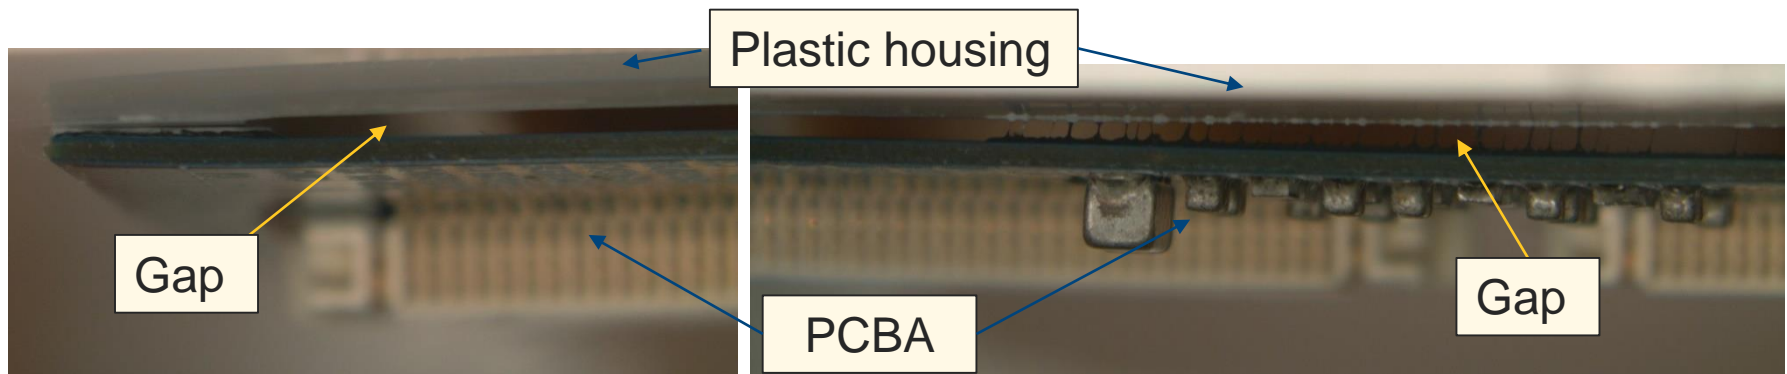
LCD Module – Mechanical Assembly

- Issues may occur in other stages of assembly. Here we see the PCBA adhesive was only attached on one side. The other side has non-bonded adhesive tape.
- The PCB was *not* flexed to take these images. It was merely held vertically.

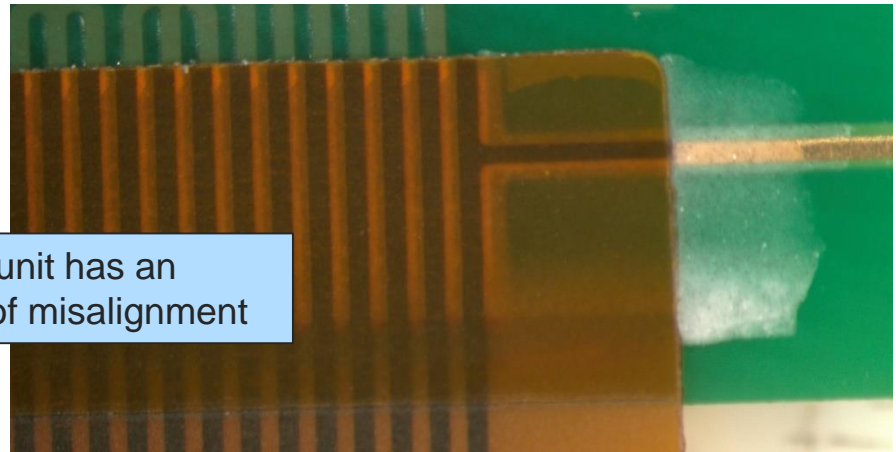
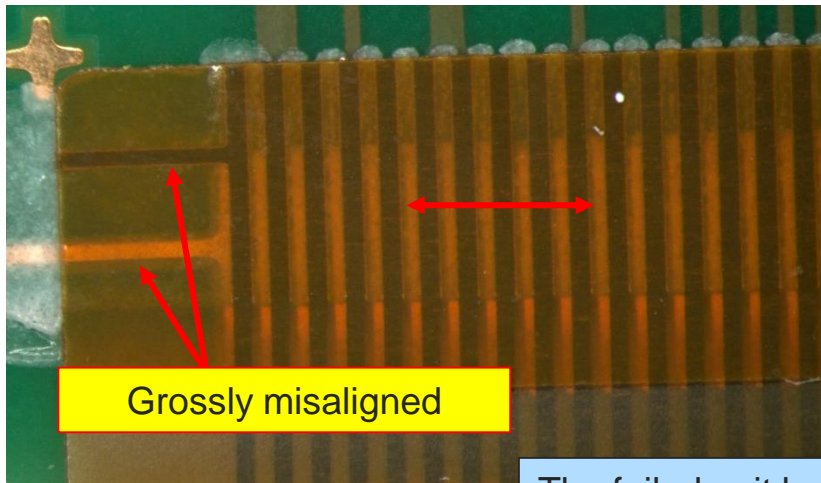
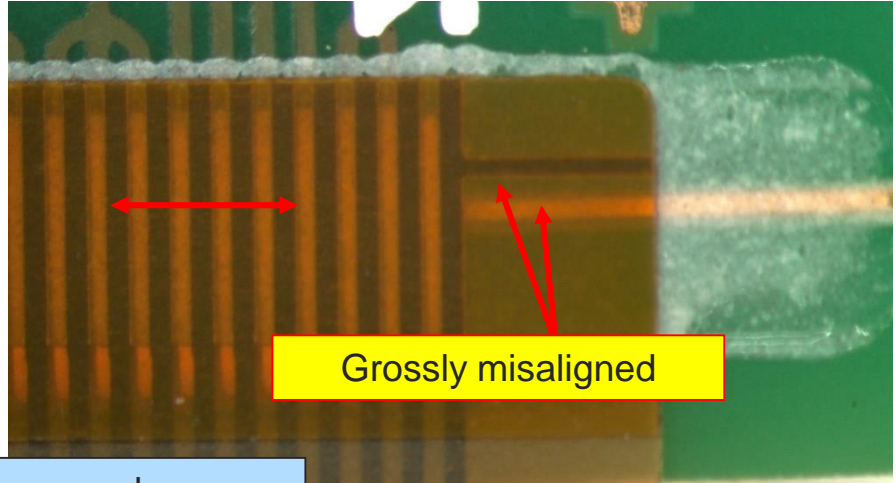
Grossly misaligned

The failed unit has a grossly misaligned flex-on-PCB connection

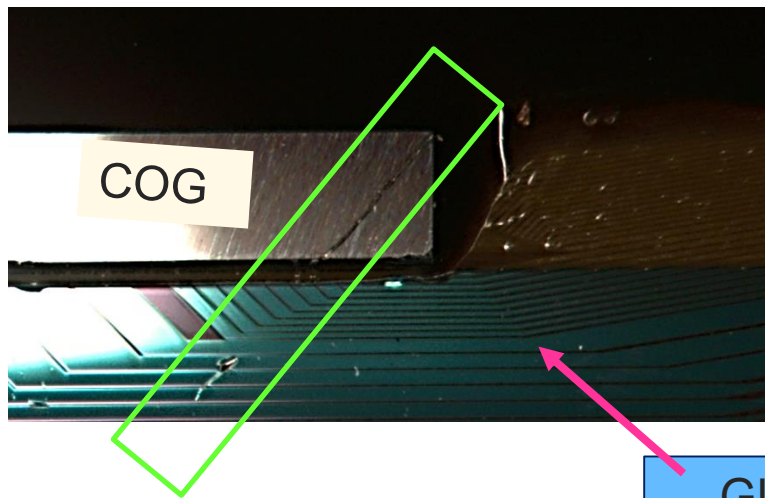
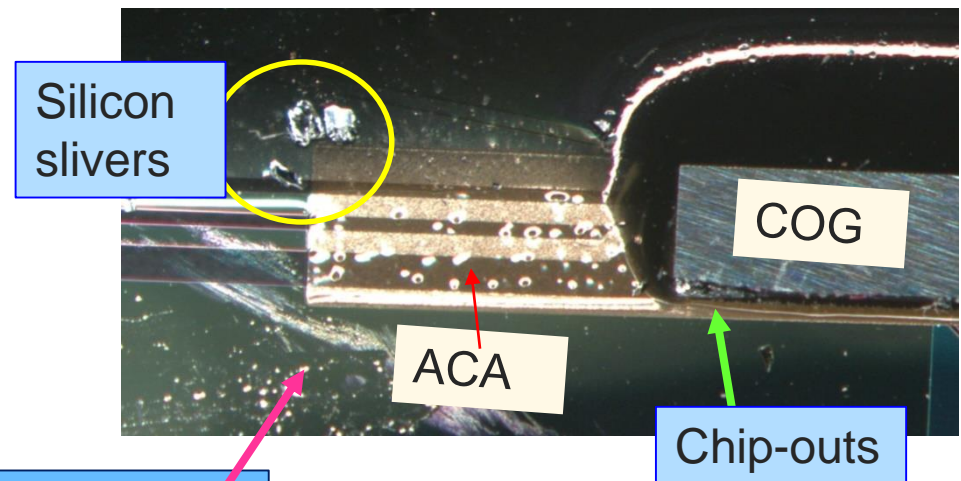
- Tooling damage was identified failed modules
 - A 'scrape' was found on the backside of one COG on the known good LCD assembly
 - Two chip-outs were found at the corners of the front face of the COG on the failed LCD assembly

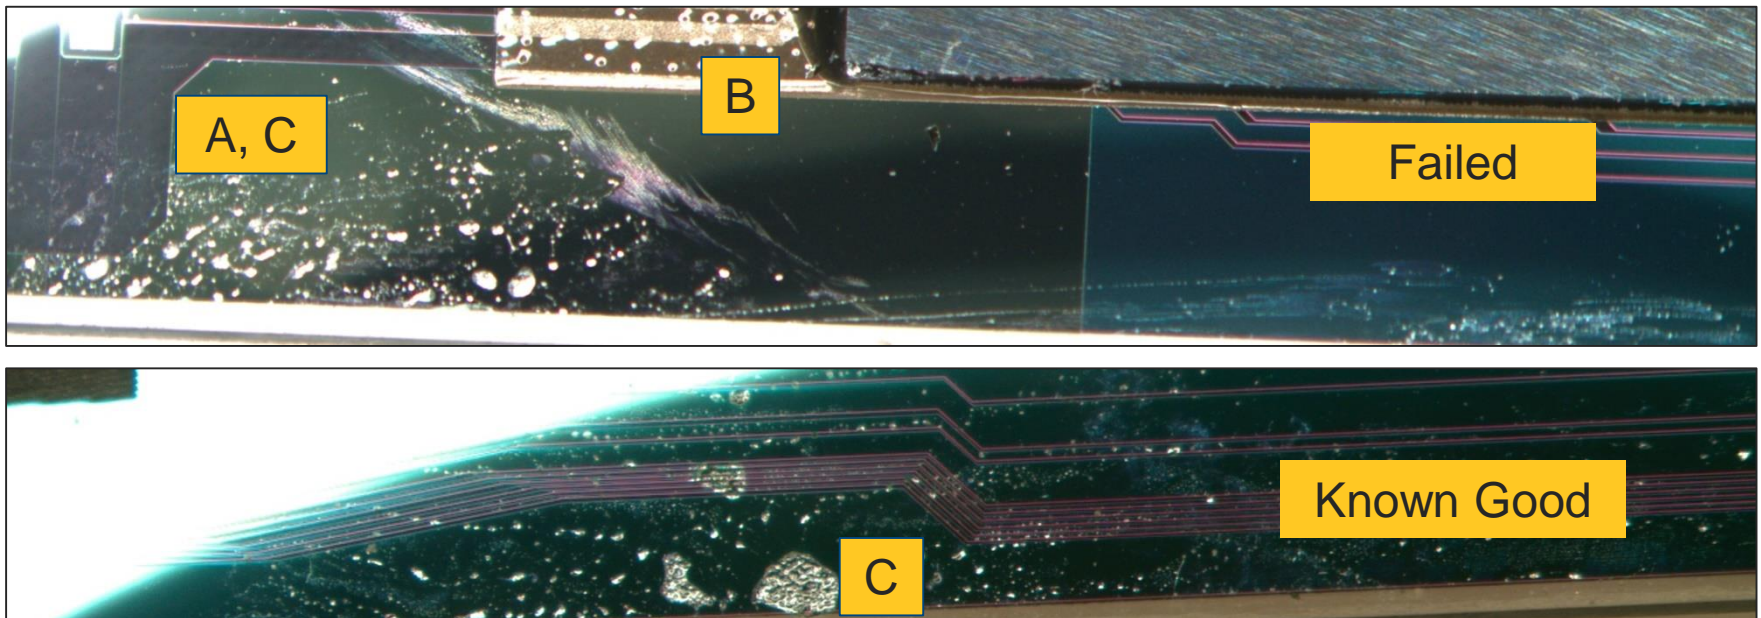
Other Findings (Cont'd)

- A general cleanliness observation of both units noted:
 - A. Particulate matter trapped in the ledge seal
 - B. Excess ACA film near the COGs
 - C. Residue on glass (likely a saponifier)

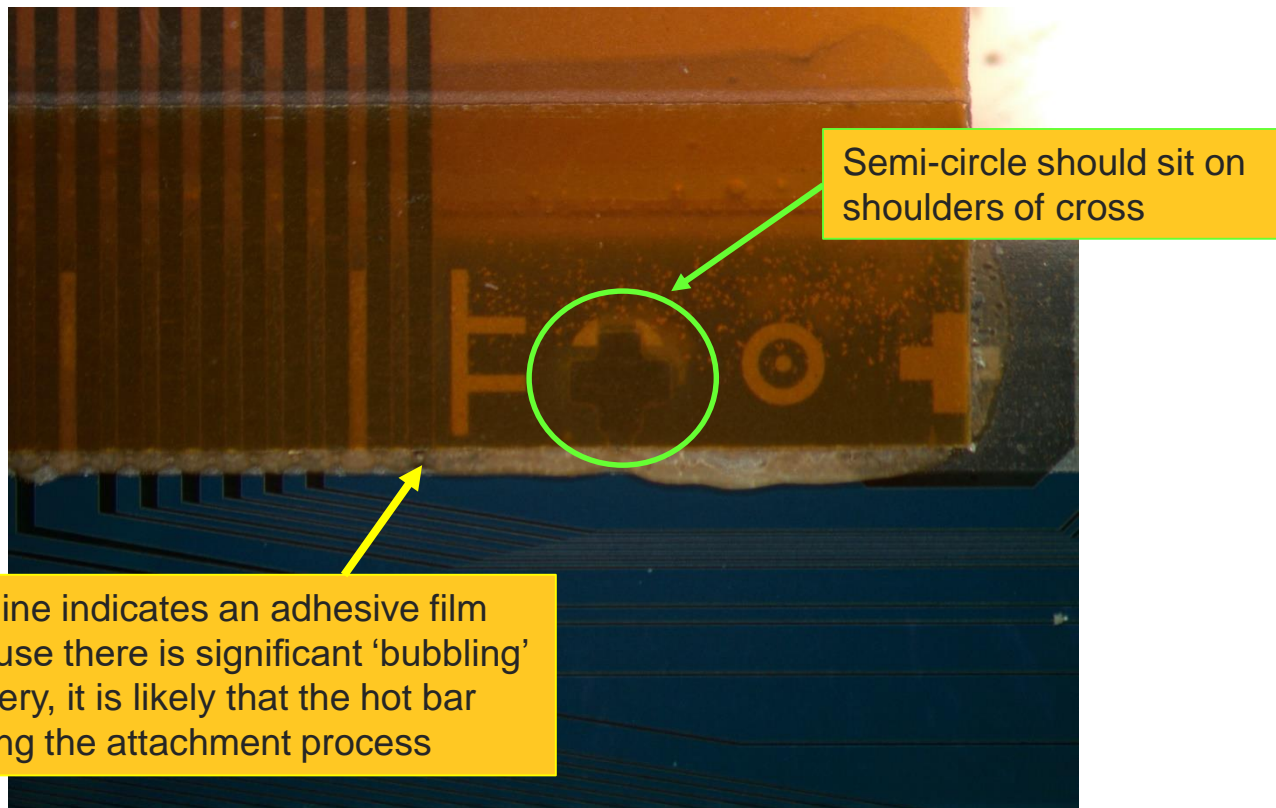
Inspection of Flex on Glass (Cont'd)

- Misalignment of Flex on Glass was noted
- The excess dried out adhesive around the flex cable would be a non-compliance (for both the known good and failed units)

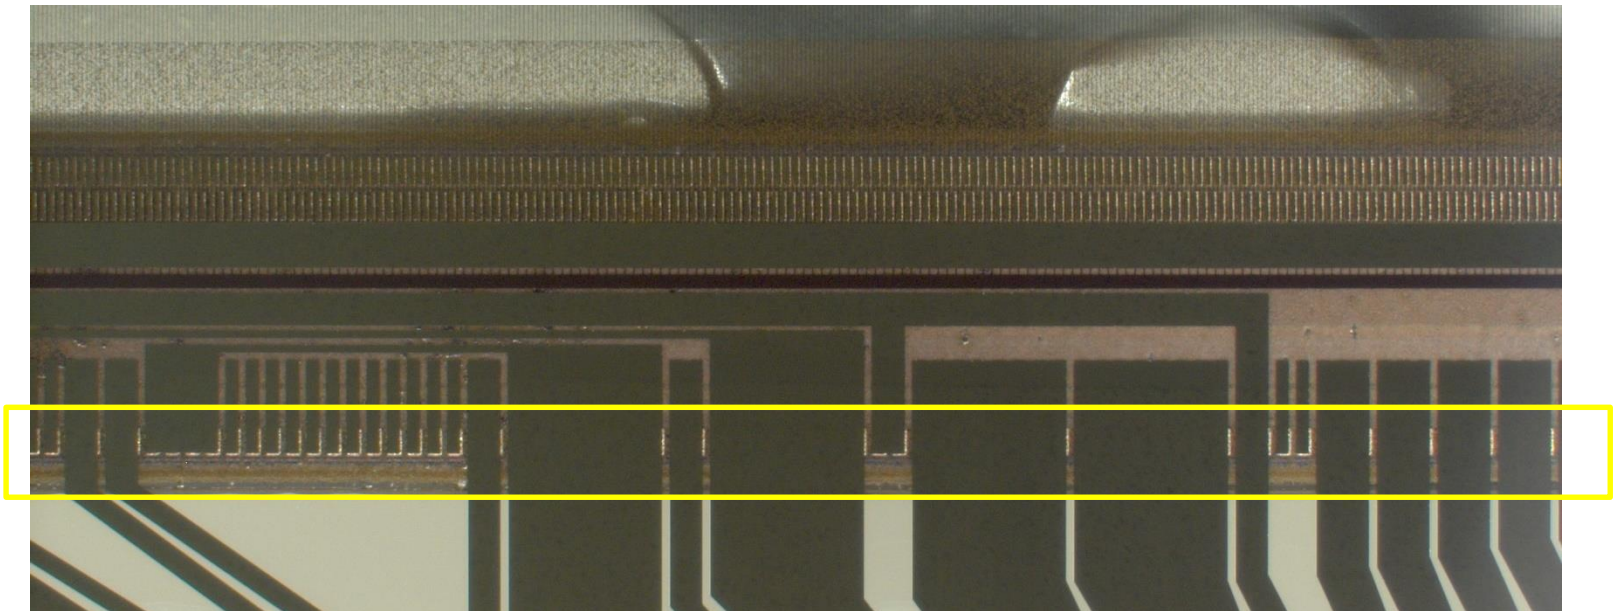
Alignment of Chip on Glass

- There is some misalignment with the COG to the glass substrate, this is seen as silvery outline in the lower right hand corner of each pad
- This characteristic effectively reduces the distance between conductors

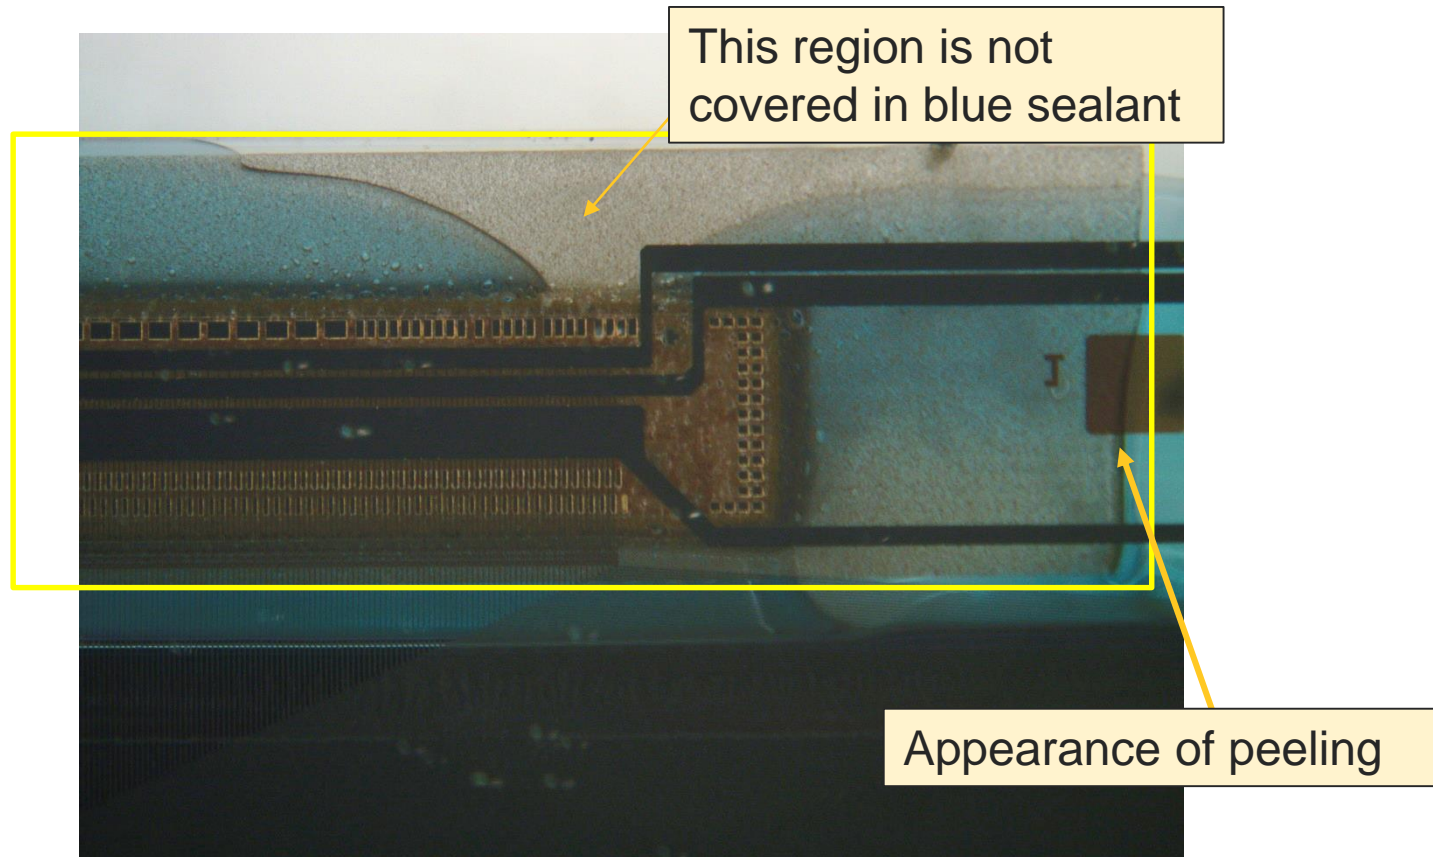
Optical Microscopy - Chip on Glass Adhesion

- Though limited, the side ledge chip on glass is not as sufficiently covered with sealant as the bottom ledge chips.
 - Allows for moisture ingress

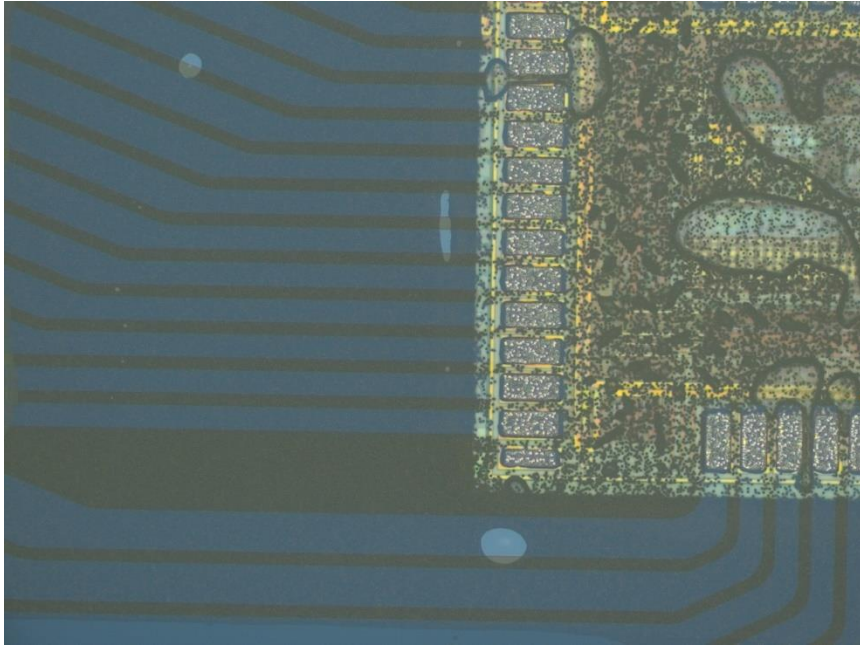
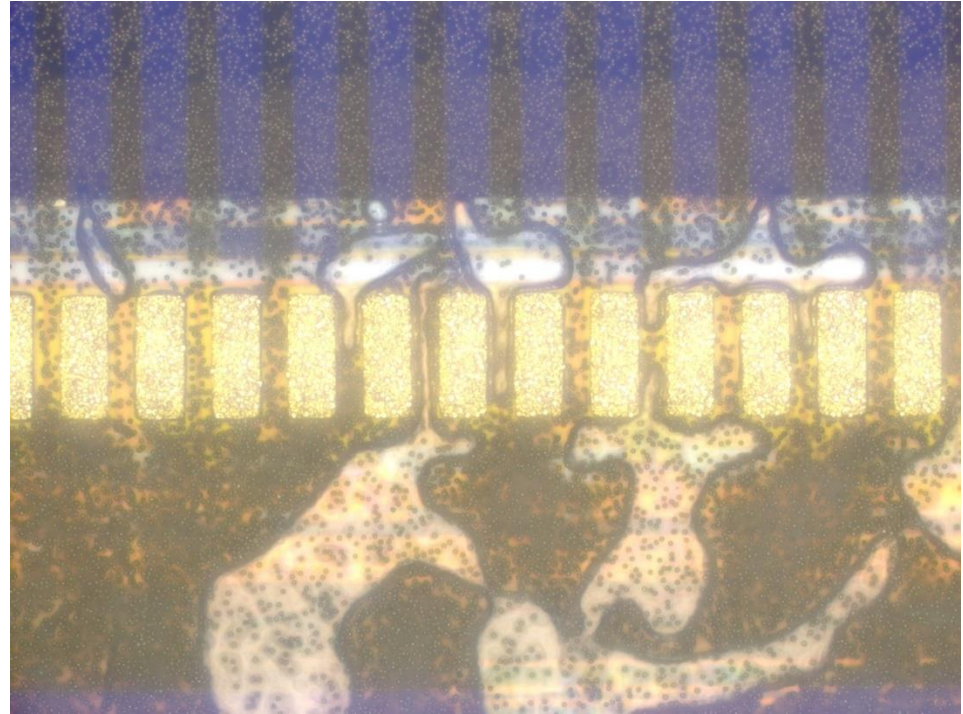
Poor ACA Fill

- Note the voids beneath the COG

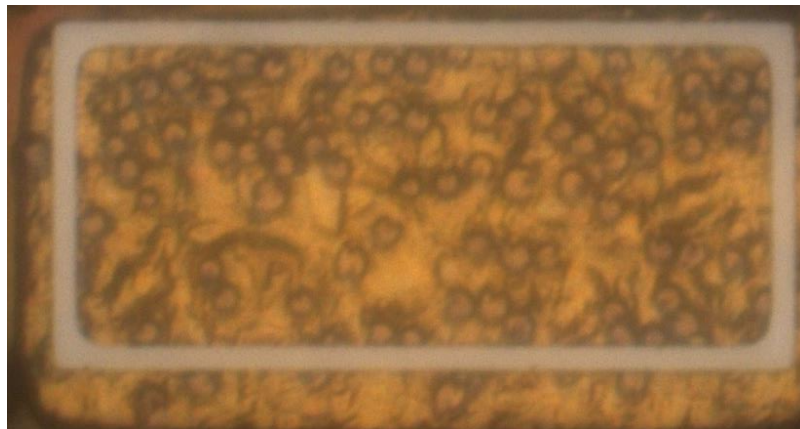
Inspection of ACA on COG

- Anisotropic conductive particles will deform under heat and pressure. The expected shape is a slightly crushed “pacman” with uniformly sized particles.
 - The appearance of particle sizes varies
 - The crush shape of the particles ranges from slightly deformed to completely flattened – indication of fast thermal ramp rates, non uniform heating and high bond force

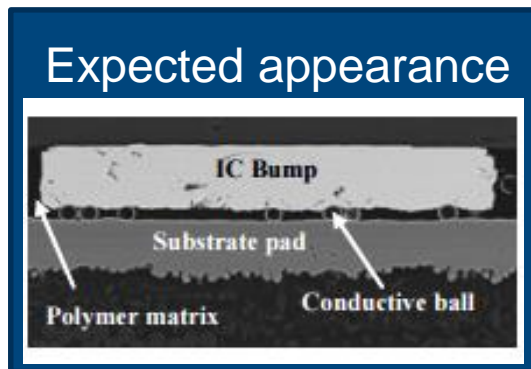
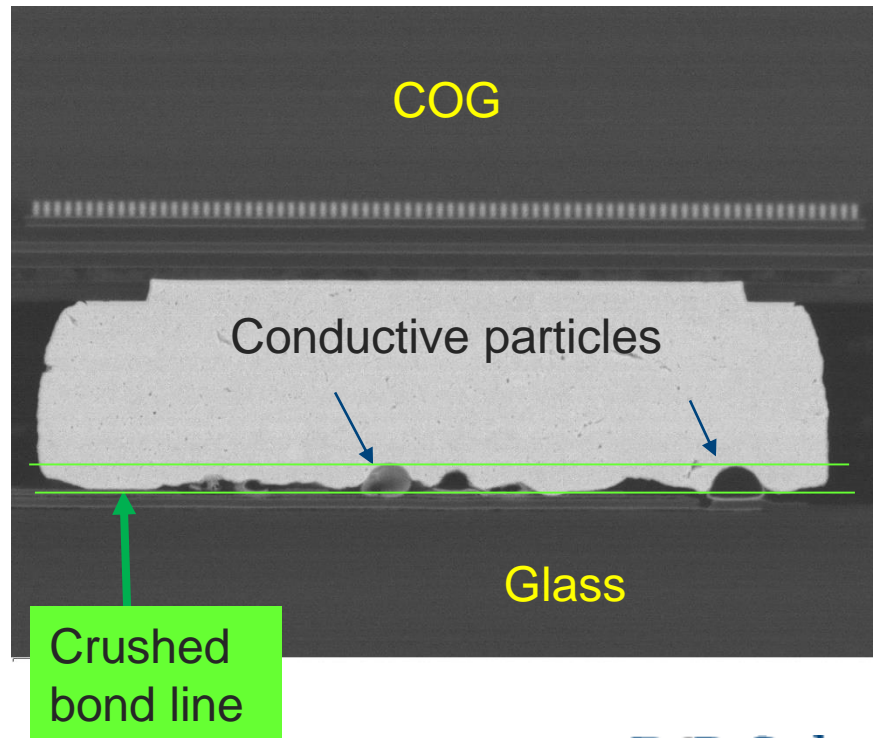
Inspection of ACA and COG

- Cross section of the COG shows deformation of the COG metallization
 - This is an indication of excessive bond force which displaces the conductive particles – references as a function of force are shown on the next slide

- The metallization bump on the COG is deformed at the interface

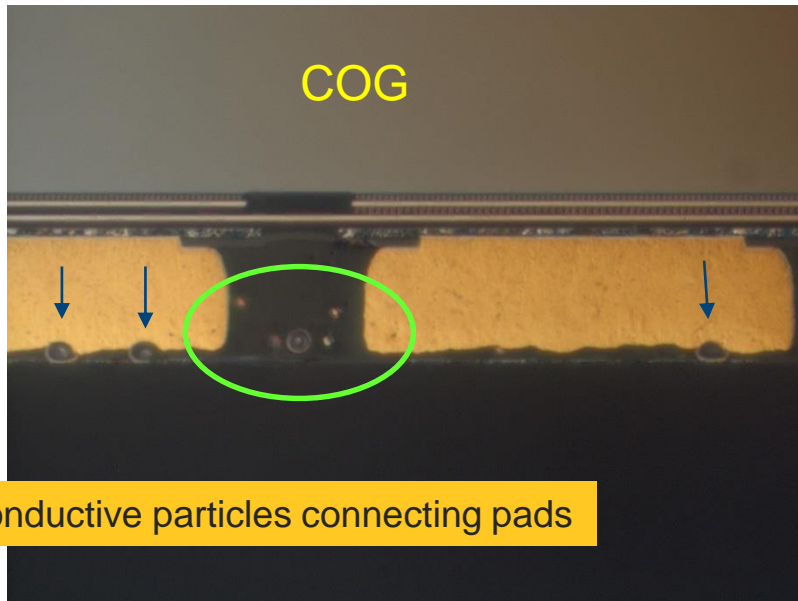
- Cross section of the COG shows aggregation of particles between conductors
- Particle grouping can cause cross talk of the LCD's switching matrix

Conductive particles connecting pads

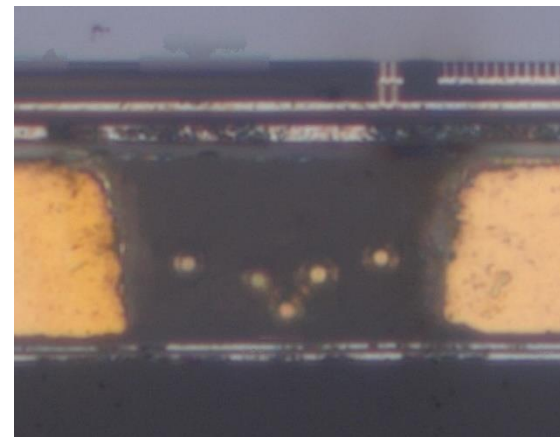
Closer look at particles bridging conductors

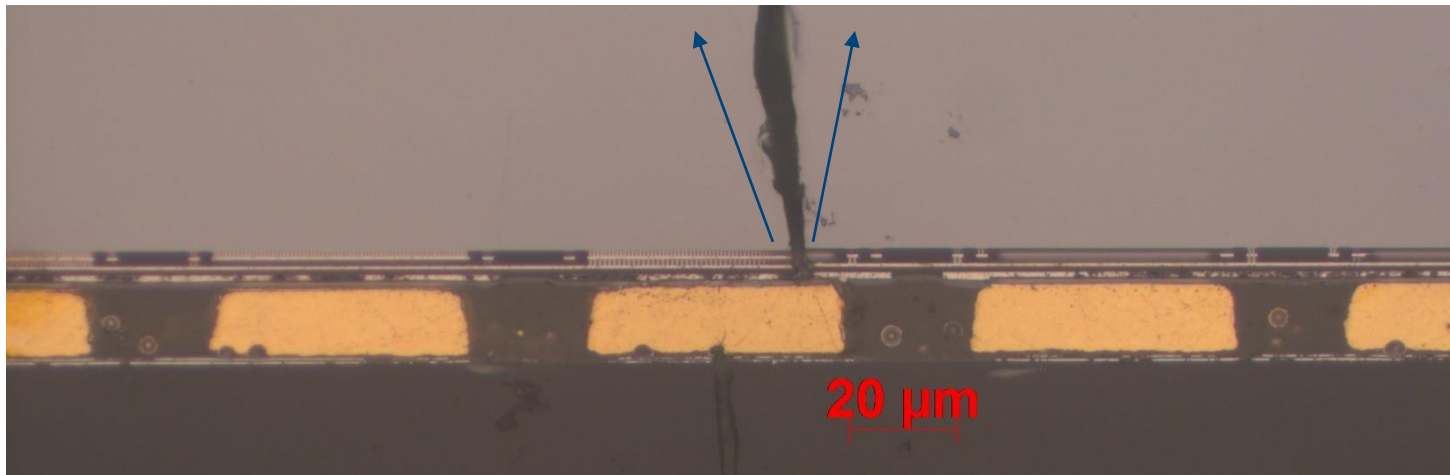
Glass Warpage & Stress Concentration

- The fracture direction is through the COG from the bonding interface

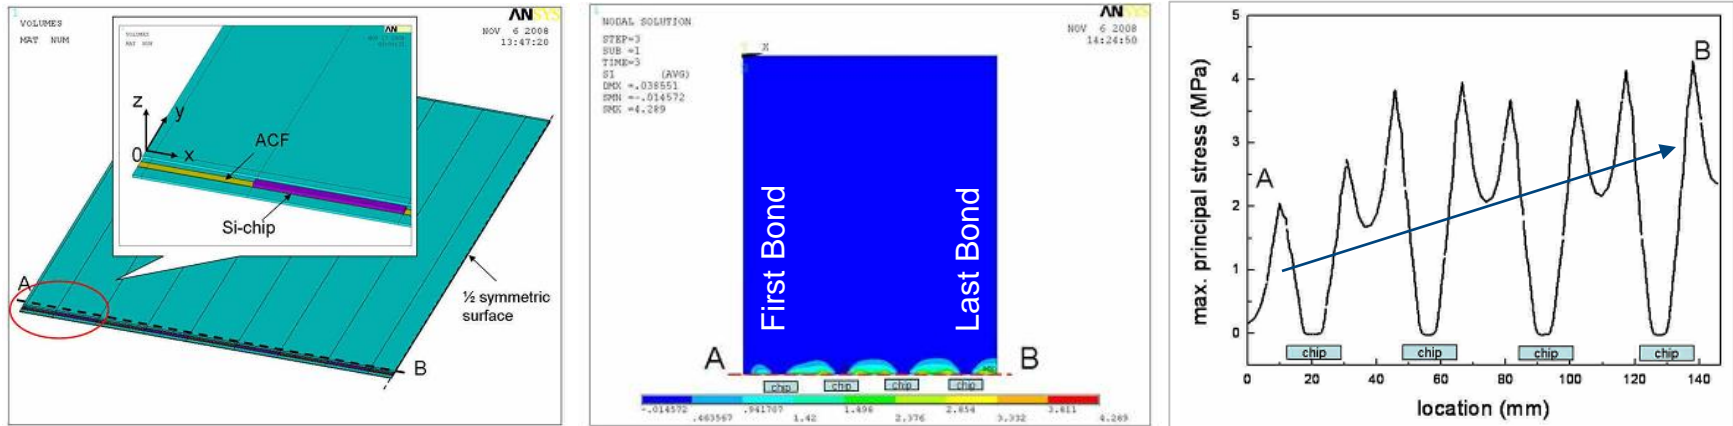
Warpage Simulation Reference

- Stress concentrations exist at the periphery of each COG due to the material system
 - Stress is magnified for each consecutive bond across the glass ledge
 - Stress can be mitigated by placing the LCD panel in a rigid fixture that heats the glass ledge uniformly throughout the bonding process
- The suspect LCDs are most likely assembled with the COG closest to the flex cable bonded first. If sufficient time lapses between hot bar operation, then the second COG will be bonded to a curved surface.
