#### **GENERAL CASUALTY REPORT**

1	Date of Survey:	1/13/14	Risk #:	2001234				
	Policy #:	CPP005555	Application #:	06079				
	Name of Insured:	Catering Systems	-					
	Address:	2301-2307 East 24 <sup>th</sup> Street, Seattle, WA 98111						
	Years in Business:	Owned this building for 10 years	At this location: Owned for 10 years					
	Est. Gross Annual Sales:	none Employee Count: non	e Es	t. Payroll: none				
	Insured is:	Owner x Tenant Lessee Corporation	on x Partnership	Sole Proprietor LLC				
	Updates:	Roof Not known HVAC	Plumbing	Electrical

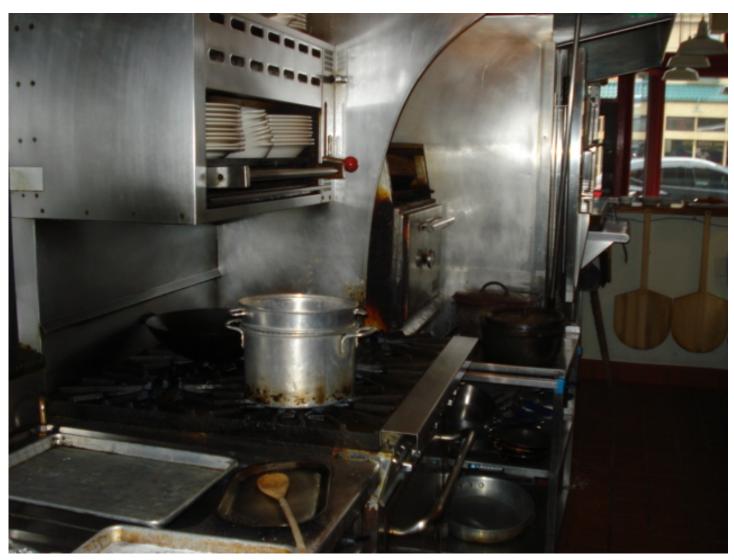
The cooking equipment in Café Lego is protected by a UL300 suppression system. It is maintained every 6 months, last maintained 8/13. The hood and vent is cleaned every 4 months and was last cleaned 12/13. There is a wood fired pizza oven, a gas range, and oven. The wood for the pizza oven is kept in nice organized piles. There is seating for 98 people in this space. The tenant that has not opened yet will reportedly also have a UL 300 suppression system and will be regularly maintained every 6 months. The hood and vent will be regularly cleaned every 6 months.

**Cooking in Café Lego**

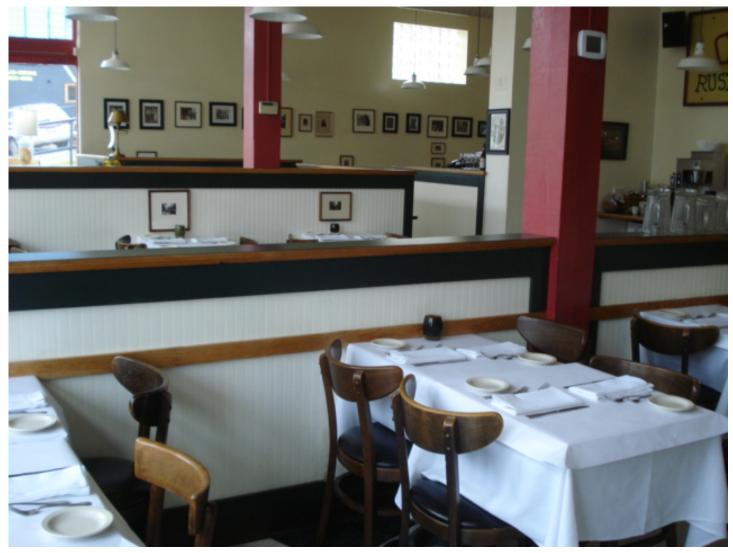
Interior of Café Lego

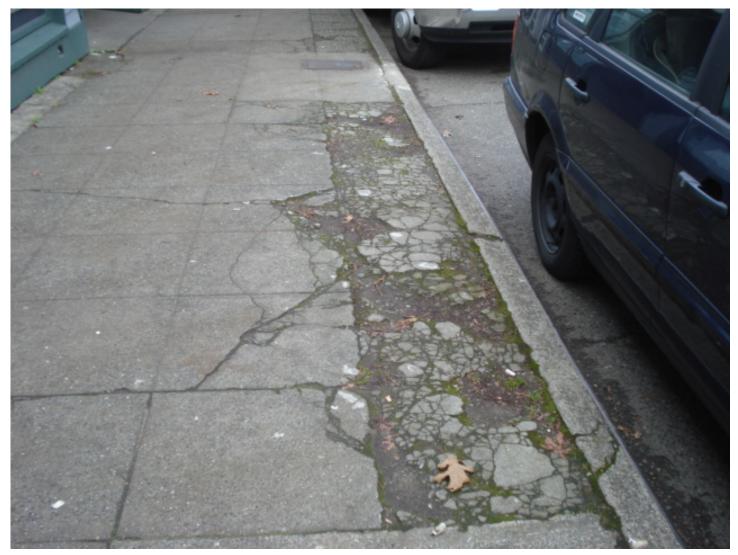
Q. The sidewalk is crumbling in areas.

Sidewalk crumbling
