Plastic Injection Molding Fluid Cleanliness

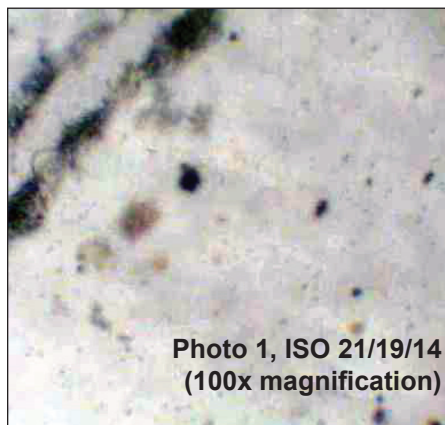
A PM-1 particle monitor was used to identify the most contaminated system. This system contained approximately 110 gallons of hydraulic fluid with an ISO cleanliness code of 21/19/14 (photo 1).

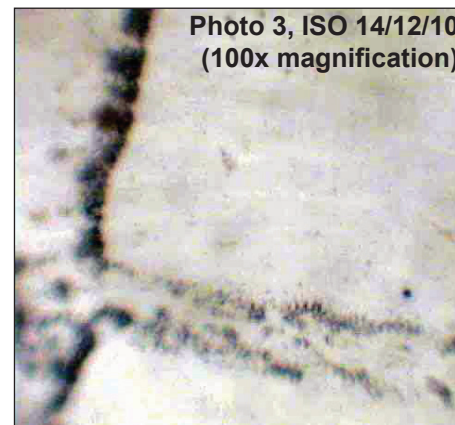
The cart with the competitors elements was allowed to run on the system for 1.5 hours. In this time the ISO cleanliness code of the system dropped from 21/19/14 to 20/18/13. Subsequently Hy-Pro HP709L20-1MB elements were installed in place of the rolled paper elements. Hy-Pro's full-flow design including pleated media and radial flow-path allow the diverter/bypass valves to be closed. Thus, 100% of the flow going through the filter cart was also passing through the filter elements. After 13 minutes of flushing with the Hy-Pro element the ISO code had dropped to 18/15/11 and after 30 minutes the ISO code reached 16/14/10 which is an acceptable cleanliness code for systems operating with servo valves. After one hour the ISO code was 14/12/10 (see photo 3). After 3 hours of flushing the ISO code plummeted to 10/9/1.

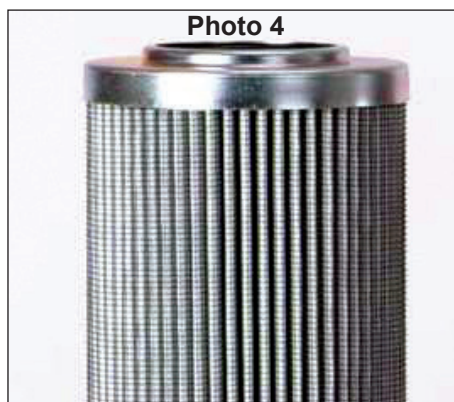
In rolled axial flow elements (see photo 5) the fluid enters the element through the end and must turn to pass through the media. The effective area through which the fluid must pass in a rolled media element is exponentially smaller than the flow area of a pleated, radial flow element (see photo 4).

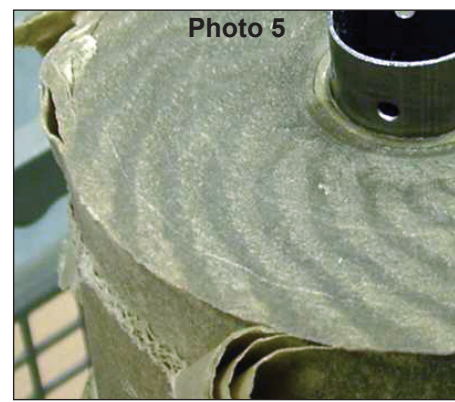
The rolled cellulose elements are not capable of handling the full flow of the filter cart. The cellulose media does not remove particles efficiently enough to clean the fluid to an acceptable fluid cleanliness level.
