Impact of substrate imperfections on the appearance of SilcoTek's coatings

Overview

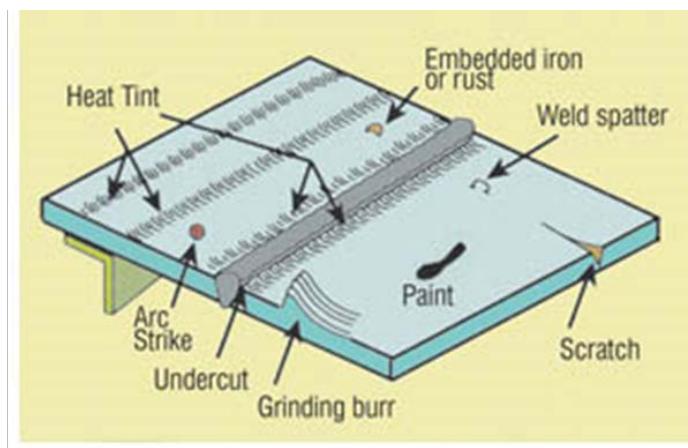
Most common stainless steel surface defects that are difficult to remove are produced during fabrication. These include embedded iron particles, sulfide inclusions, heat tint, arc strikes, weld spatter, grind marks, scratches and organic contamination. Figure 1 illustrates the common types of surface defects arising during steel fabrication.¹

Figure 1. Common types of surface defects arising during steel fabrication.¹

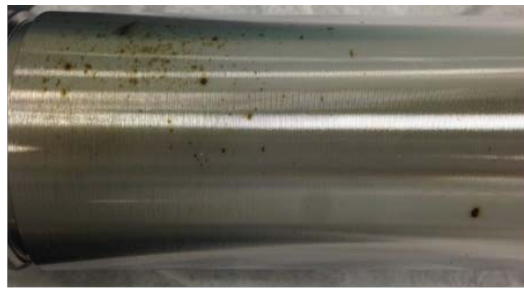
Iron particles embedded in the stainless steel surface will cause rust when they are exposed to a moist atmosphere, and if not addressed, can produce additional pitting corrosion. If a customer's parts have a high risk of iron embedment, SilcoTek recommends a simple water test or a more sensitive ferroxyl test as described in ASTM A380 to detect and remove embedded iron before sending to SilcoTek for coating. In cases where SilcoTek receives iron embedded parts and detect minor rust spots after our standard surface prep process (as shown in Figure 2 below), we typically employ a mild acid treatment to remove the rust spots before subjecting the parts to our CVD process. For details of SilcoTek's rust-removal process, please refer to our white paper "[Removing rust prior to coating](#)".

Figure 2. Rust spots developed on steel surface embedded with iron particles after SilcoTek's cleaning process.

For parts that show severe, large rust areas, where SilcoTek's acid treatment may be less effective, we recommend pickling treatments by the customer as SilcoTek is not equipped to handle such treatments. This requires elimination of the surface layers with embedded defects, including 25 – 40 μm of the substrate metal, and is usually done in a nitric-hydrofluoric acid ($\text{HNO}_3 - \text{HF}$) bath.³

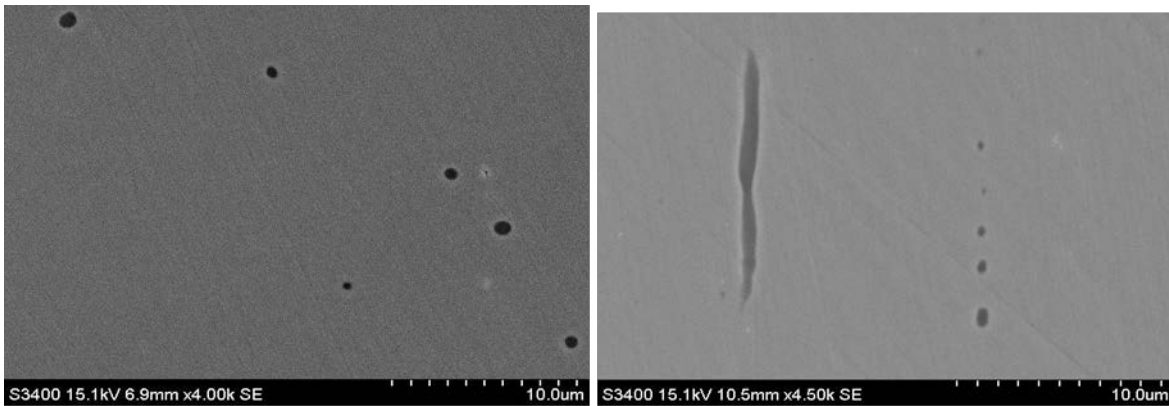
Sulfide inclusions, especially manganese sulfide (MnS) inclusions, are believed to be the predominant sites for the initiation of pit corrosion in stainless steel. Manganese is added in the fabrication of stainless steel to make the steel easier to machine, but it was recently discovered that during the cooling of the stainless steel, the MnS inclusions suck chromium atoms from the surrounding area, leaving behind a chromium-deficient region. This Cr-deficient region becomes a weak point for corrosion to initiate (pit), and deteriorates the steel surface.⁴

Such inclusions in stainless steel may be difficult to detect with the naked eye, but show up as dark spots or strings under SEM (scanning electron microscope), as shown in Figure 3 below.⁵ These inclusion sites can appear as local abnormalities post SilcoTek's coating deposition, as our thin CVD coating (sub-micron) often highlights substrate imperfections. If not addressed, these inclusion sites can compromise the protective properties offered by SilcoTek coating at these local areas, as these weak points serve as initiation sites for pit corrosion. For best coating appearance and performance, SilcoTek recommends the customer to remove any inclusions prior to sending their parts to us for coating. An acid treatment in nitric acid or a heat treatment of the steel to allow Cr atoms to diffuse from the inclusion back into the surrounding area is recommended to remove inclusion sites.⁵

Figure 3. SEM images of typical MnS inclusions in stainless steel surface.⁵

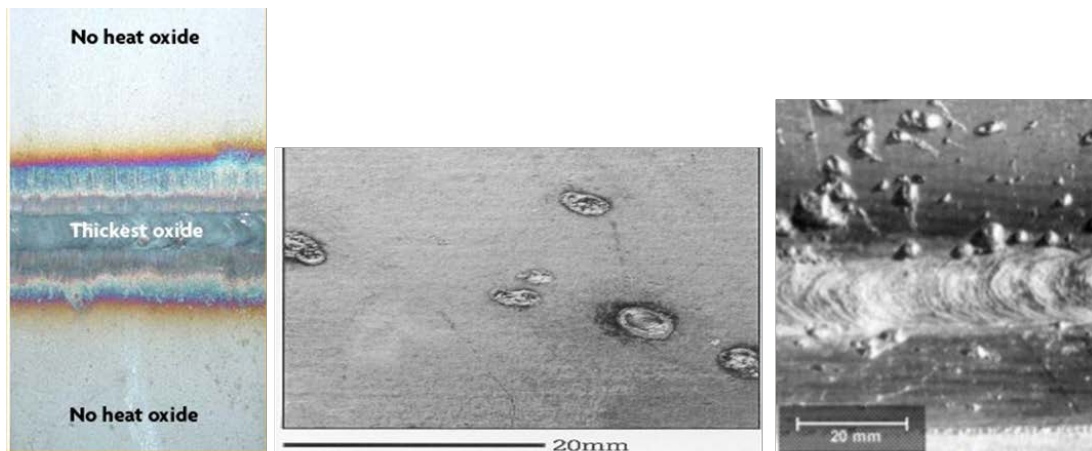
Figure 4. From left to right: heat tint, arc strike, and weld spatter – different surface defects produced during welding.^{6,7}

Heat tint (also known as weld discoloration) is a thicker-than-normal chromium oxide film on the surface of the stainless steel. Heat tint films range in color from light brown to black. Figure 4 above shows the typical heat tint on the welded side if stainless steel is welded without inert gas protection.⁶ As more chromium is consumed to form the heavier film; the surface beneath the heat tint is depleted in chromium and therefore reduced in its inherent corrosion resistance.

Arc strikes and weld spatter both produce small pinpoint surface defects that penetrate through the surface oxide layer and extend into the substrate steel. They form sites where corrosion can initiate.

These surface defects (heat tint, arc strikes and weld spatter) will show through SilcoTek coatings if they are not addressed, and will compromise the coating's local anti-corrosion properties at the defect sites. It is costly and difficult to completely remove these defects, and the best way to address them is by taking prevention measures, such as employing proper welding techniques, using inert gas shielding during welding, and using anti-spatter paint (and clean it off after welding is completed).⁸

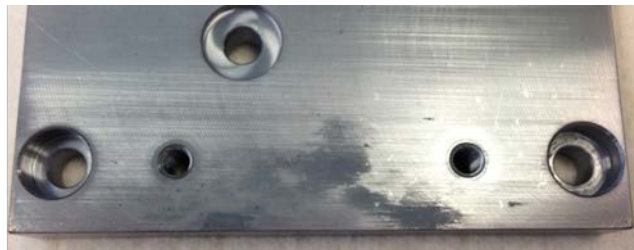
We have experienced difficulties in removing certain glycol-based or Krytox[®] fluorinated cutting fluids in the past, especially when the oil was left to dry on hot parts before rinsing. Go to our white [paper "How clean is clean"](#). Figure 5 shows a part contaminated with organic residues that cannot be completely removed by SilcoTek's pre-deposition procedures. In such cases, SilcoTek will contact the customer to learn more about the handling of the parts prior to our receipt of them, and discuss/recommend process changes as appropriate.

Figure 5. Organic contamination that cannot be removed by SilcoTek's cleaning process.

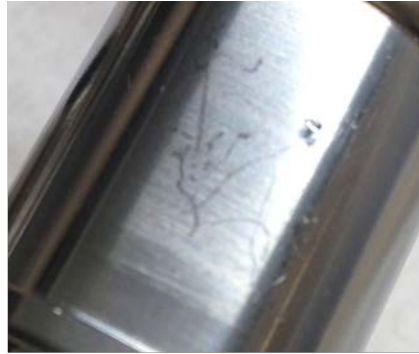
SilcoTek technicians conduct an inspection at the receipt of customer parts. If any scratches or physical damages are noticed on the parts at arrival, we will contact the customer to find out whether the scratched/damaged area is a critical area to their specific applications, and will either continue with processing or return parts to the customer for replacement based on the customer's feedback. An example of scratched part identified by SilcoTek receiving technician is shown below in Figure 6.

Figure 6. Scratches on incoming parts identified at SilcoTek's receipt inspection.
