# Las Vegas ReVISION House™

## Introduction

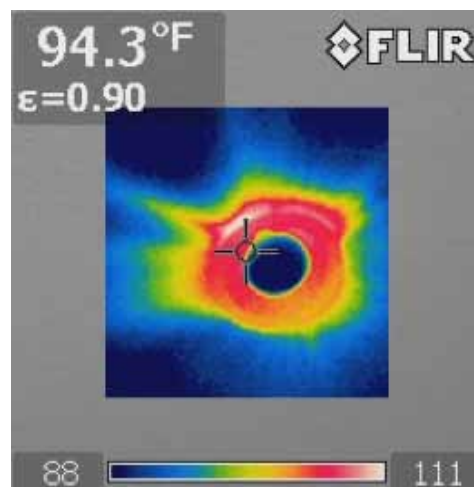
- The gas fireplace: this lacked glass doors and, because a gas inlet was present, the damper was fixed in the open position (as required by code). A significant amount of air was pulled down the chimney.
- Ceiling mounted recessed can lights: there were several can lights in the ceiling of this home. The ceiling is a vented, closed cathedral configuration insulated with fiberglass batts in the rafter bays. Significant air leakage could be felt and imaged coming from these recesses light fixtures.

Fig. 5: Infrared Picture Showing Air Leakage from a recessed can light

Prior to the foaming of the roof rafters, a strategy allowing the existing recessed can light housings was developed. Small sheet metal cylindrical spacers were fabricated and placed over the devices creating a 1/2” air space between the devices and the insulation. A minimum of 3” of closed cell foam covered the tops of the spacers. During this phase the lighting wiring circuits were traced and labeled, allowing the later installation of the **Lutron®** control system. Only minimal rewiring was required.

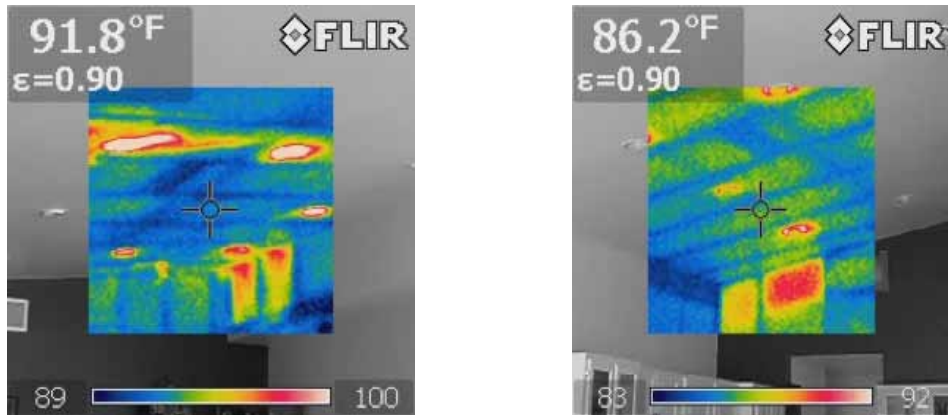
- The duct chases/dropped ceiling: There were a few dropped ceilings to accommodate the duct work coming down from the roof mounted air handlers. These areas communicated freely with the vented rafter spaces. The below images show the affects of this air movement through the insulation in the kneewalls and rafters.

Fig. 6: Infrared Images Showing Air Leakage in Dropped Soffits and Rafter Bays

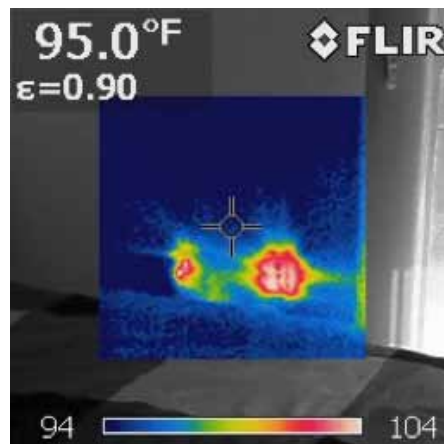
- Single pane, aluminum frame windows: Even when completely closed and locked, these windows leaked. Air was coming from the fixed windows as well as the operable ones.
- Outlets and switch plates: Air could be felt coming from these areas as well as seen with the IR camera. Interior wall penetrations leaked as much as exterior walls due to the connection with the vented roof.

Fig. 7: Infrared Image Showing Leakage from Electrical Outlets

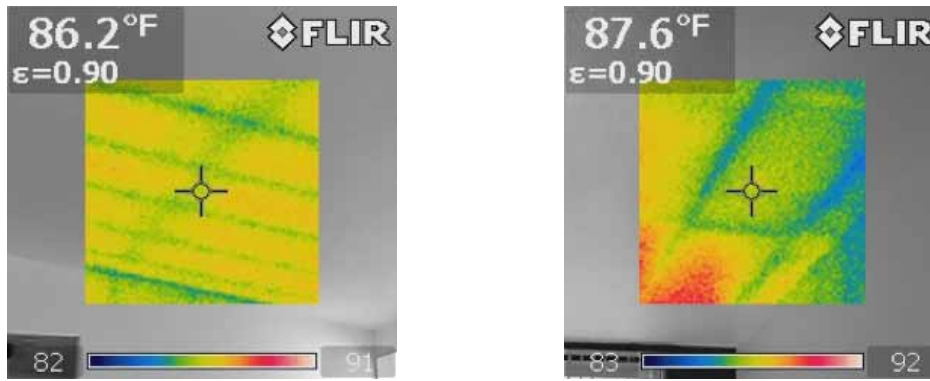
Fig. 8: Infrared Scan Showing Ineffectiveness of Insulation in Ceiling

Both of these IR images were taken prior to the blower door test. From these images it is clear that heat is getting around the insulation. In a well insulated cavity where it is much hotter outside than inside, the wood rafters should appear warmer than the cavity because they have a lower insulating value and the colors in the images would be reversed. The framing members should be yellow to red and the cavities green to blue in comparison. In the existing assembly the R-30 cavity insulation performed worse than the 2 x 10 rafters (approximately R-12).

Even though the insulation levels appear to be reasonable, the infrared camera indicated that the cavity insulation is performing worse than the framing materials in each location. This means that the ceiling was performing worse than an R-11.25 and walls worse than an R-3.75 effective value (based on the thermal gradient generated by the IR imagery). The kneewall insulation appeared to be completely ineffective.

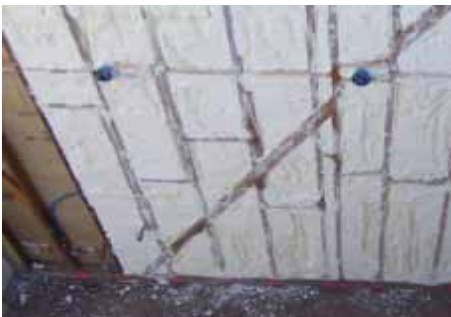
Exterior stucco and board-and-batten finishes were stripped exposing the original stud cavities. The ill-fitting fiberglass batts (nominally R-11) were also removed leaving the frame cavities void. The interior drywall (much of which had been previously replaced due to a fire in the 1990’s) was left in place, keeping the interior wall finishes largely intact. The carport, which had been previously changed to a garage, was gutted, bringing it back to the original carport function. Having exposed the wall framing cavities, minor electrical work could be accommodated from the exterior, and additional hose-bibs could be added. Once accomplished, the open-cell spray foam was added to the frame cavities, and raked flush.

Fig. 9: Exposed wall framing

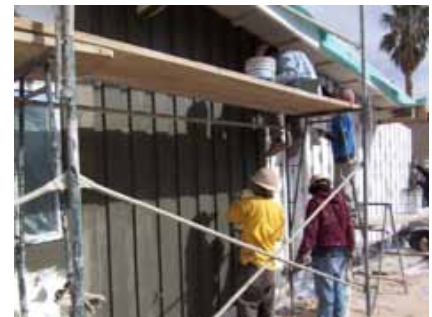
Fig. 11: Exterior EIFS

Following the sheathing application an EIFS (exterior-insulation-finish-system) was added over 2” of EPS foam insulation. Cumulative R-value of the upgraded wall is 21.25. The EIFS has multiple benefits for this project: it mimics the stucco removed from the existing walls; it is a complete system including the exterior foam, thus providing R-value and thermal breaks; and it comes with complete water management details for around windows, door, penetrations and base terminations. Most other thick foam applications require fussy and expensive alternate detailing.

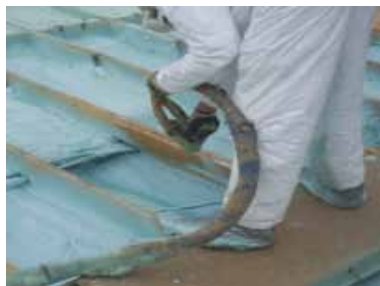
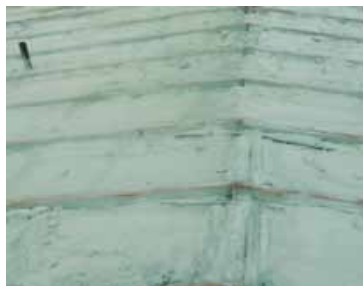
Fig. 12: Applying Closed-cell foam at rafters Fig. 13: 8.5” of foam in 2 x 10 rafters

Work on the roof proceeded using a similar strategy, with all roof covering and the roof decking removed leaving the rafter framing and the ceiling gypsum board attached to the bottom of the sloped rafters. Where a sloped ceiling did not exist (but a small attic space did) ledgers were attached along the bottom edge of the rafters and gypsum board was laid onto the ledgers. All 2 x 10 rafter spaces were then filled with 8.5” of closed-cell foam leaving a small 1” void at the top. The result is an R-55.25 assembly with outstanding air-sealing.

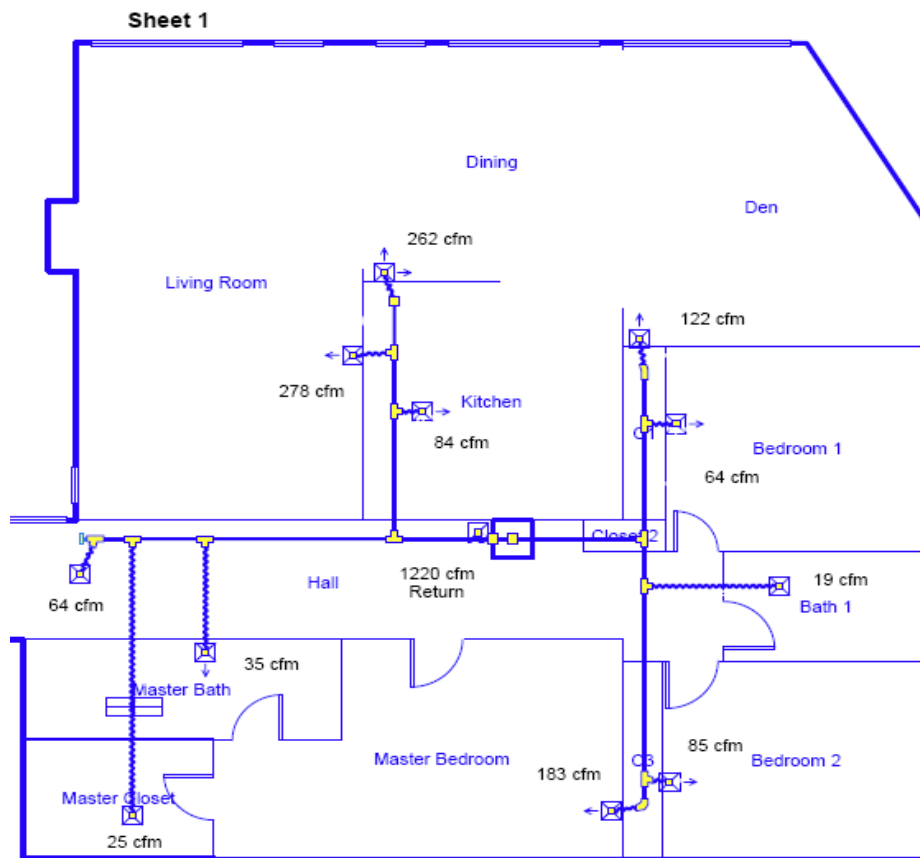
Fig. 15: Revised HVAC design

The first step in reaching the ultimate performance goal is getting the building envelope loads down as low as practical. The next step is to meet those loads with the most efficient mechanical systems practical. For the ReVISION House this included complete replacement of the HVAC systems using the specifications described above. Since the plan was altered slightly for the inclusion of the air-handler in conditioned space (in a small centrally located closet) and the redesigned ducts are accommodated in the now-in-conditioned-space attic loft, integrating the new SEER 18 heatpump, went smoothly. The zero-leak objective for the ducts was emphasized, as was the testing requirement, so the installer had additional motivation to see that the install was virtually leak-free. The installer did make minor adjustments to the register locations (although CARB felt them to be unnecessary). Operation or comfort was not affected by the changes.

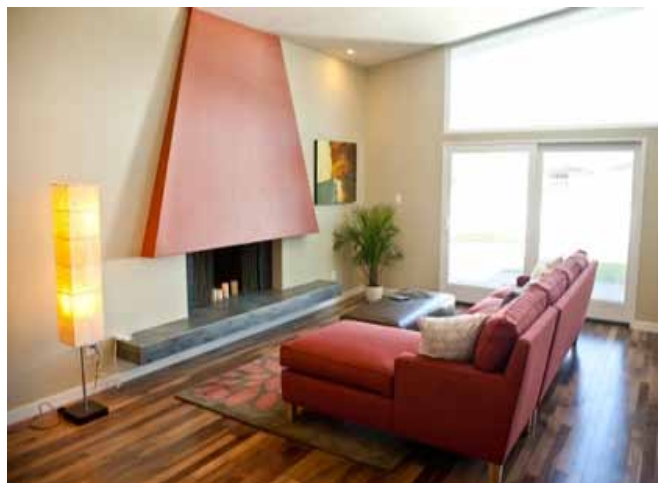
- The fireplace: Originally supplied with a natural gas option, the fireplace lacks glass doors and, by code, the flue damper was sealed in the open position. Sealed glass doors were recommended after initial testing, but designers chose to leave the fireplace as built, with the exception of removing the gas-line and altering the damper to be operational. Further sealing of the fireplace during

the blower door test showed that an additional 120 CFM@50 could be eliminated if the fireplace had been better sealed. This amounts to 15% of the air leakage detected during the final testing.

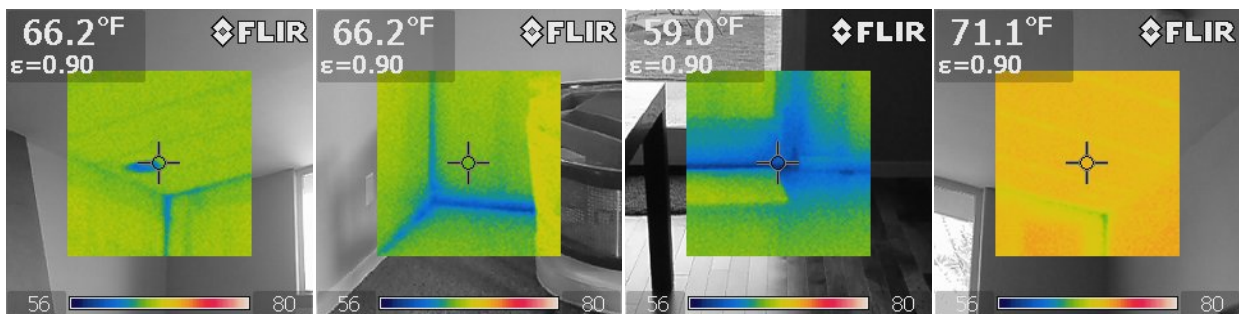
In addition to finding air leaks, the IR camera was used to detect thermal bypasses in the building shell. As noted above, the largest thermal bypass in this home was located along the edge where the wall meets the slab. Most other bypasses detected in the pre-retrofit audit were corrected when the walls and roof were sprayed with foam insulation. The following IR images show good alignment of the insulation, even coverage and few thermal bypasses.

Fig. 17: Post-construction IR Images
