Uses of Abaqus/Standard in Failure Analysis

Matthew T. Kenner, P.E., John A. Wilkinson, P.E.,

Engineering Systems Inc.

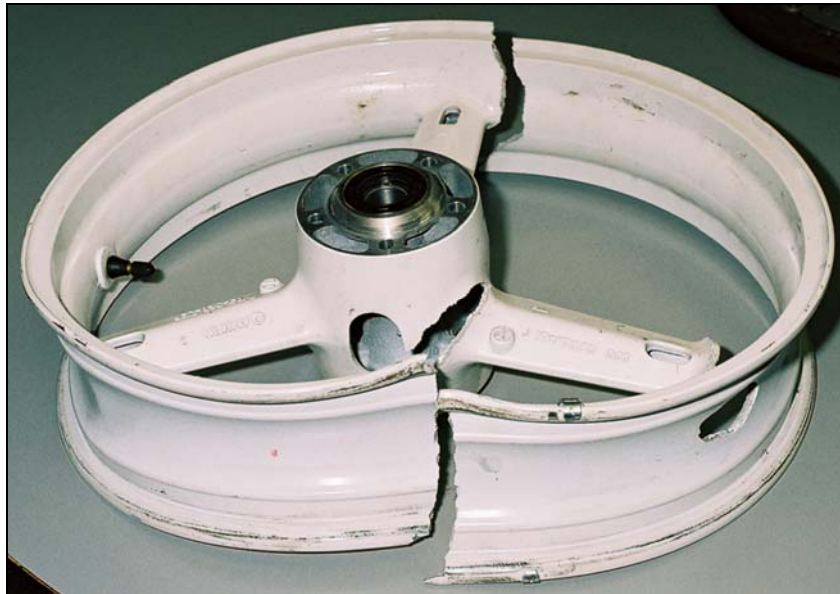
A rider was performing “wheelies” on a high-performance motorcycle when he lost control and crashed. The loss of control allegedly occurred near the conclusion of the “wheelie” when the front wheel was lowered to the ground. During the accident, the motorcycle tumbled and impacted a concrete block wall. Post-accident examination of the motorcycle’s front wheel showed it to be severely deformed and broken (see Figure 1). It was alleged that the front wheel failed as the motorcycle was lowered from the “wheelie” and this caused the loss of control, but the physical evidence suggested the front wheel directly and forcefully impacted the top corner of the wall as it tumbled.

Figure 1. Damaged motorcycle wheel.

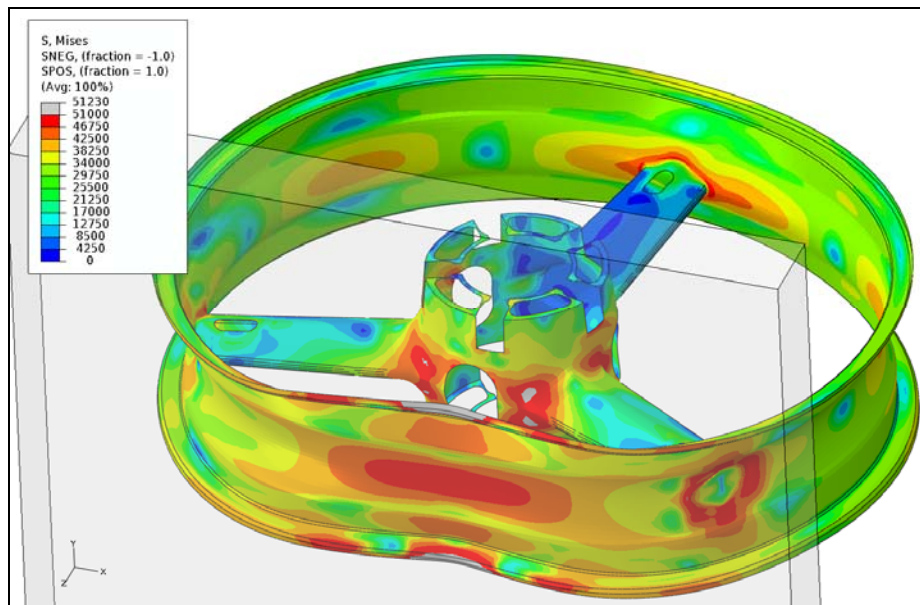
The load-deflection curves for the analyses are shown in Figure 4. The von Mises stress results under full load block displacement are shown in Figure 5 and Figure 6. The load-deflection curves show that the maximum displacement requires more than twice the load for the flat load block. Also, the load curve flattens much more quickly with the edge load block. In both cases, the load on the wheel is severe; with stresses at, or near, the ultimate true stress of 51,000 psi. This is to be expected, given the significant impingement by the load block and the fact that the subject wheel fractured in numerous locations (Figure 1). In both cases, the area of loading experiences some of the highest stresses. Additional areas of high stress are the intersections of the spokes with the hub and the rim. All these areas were fractured in the subject wheel. Note, though, that the results from the flat load block show high stresses in areas that did not fracture on the subject wheel, indicating that contact with a flat surface may not have been the most probable scenario.

Figure 5. Flat load block von Mises stress results at full displacement (psi).

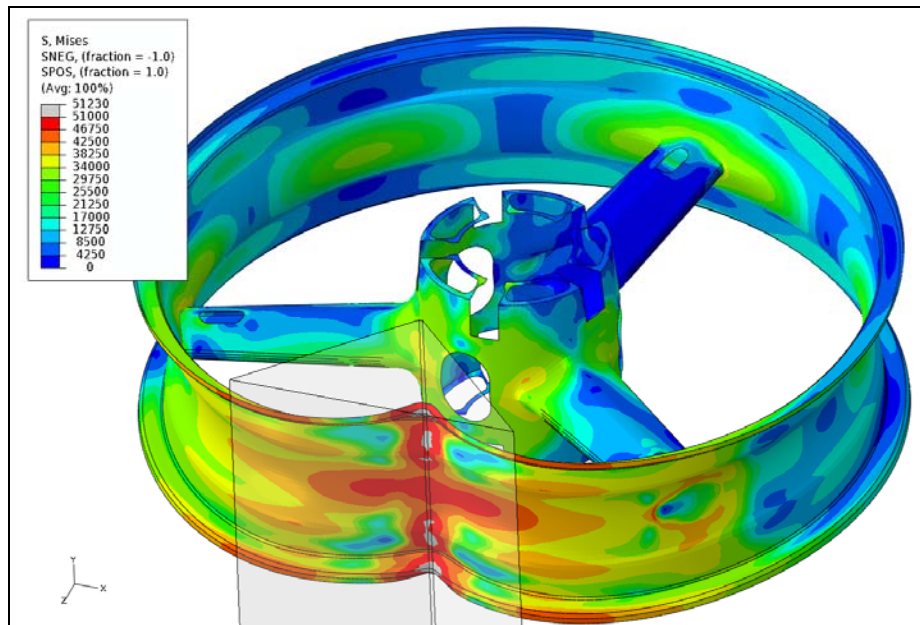
Figure 6. Edge load block von Mises stress results at full displacement (psi).

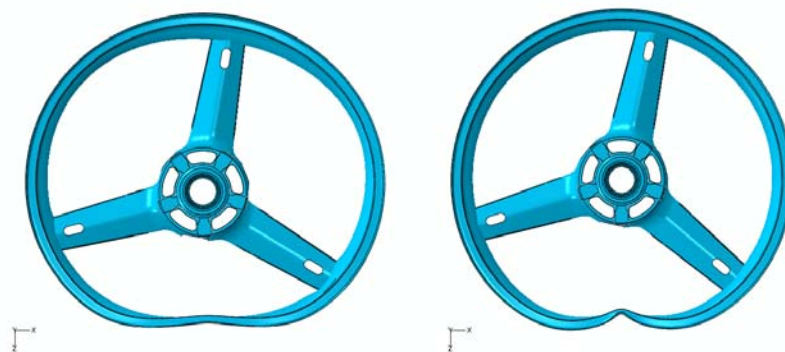
The deformed shapes of the wheel after unloading are shown in Figure 7. It can be seen that the residual shape in the area of the edge load block retains a severe bend after the block is removed. This is not the case with the flat load block. Comparing the analysis results to the subject wheel's rim fracture (Figure 8) clearly shows the similarity between the edge load block analysis and the subject wheel. Close examination of the wheel fracture in this region also shows that the edge of the rim was flattened in the vicinity of the fracture. This phenomenon was shown to occur under loading from the edge load block but not the flat load block.

Figure 7. Deformed shape after unloading of the flat load block (left) and the edge load block (right).

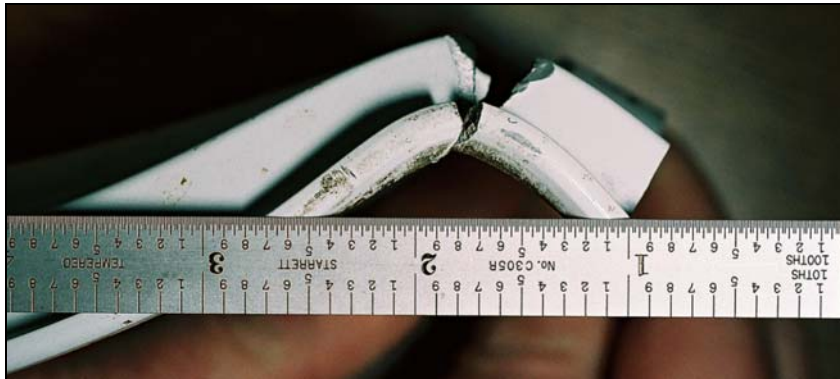
Figure 8. Details of the wheel fracture in the area of the load block.

It is clear from the analyses that the signatures on the failed wheel more closely match the edge load block analysis. Of course, the edge load block closely approximates the top of the concrete wall which suffered significant damage as a result of the accident. Additionally, the results show the edge load generates stresses near failure at roughly half the load required by a flat load block. This becomes significant when considering the load to fail the wheel is generated only by the inertia of a motorcycle and rider that weighs roughly 600 lbs and, in the wheelie scenario, a portion of that weight is reacted at the rear wheel. In the final analysis, considering the factors discussed above, as well as other aspects of the investigation that are not discussed here, it was determined that the front wheel of the motorcycle did not cause the loss of control.

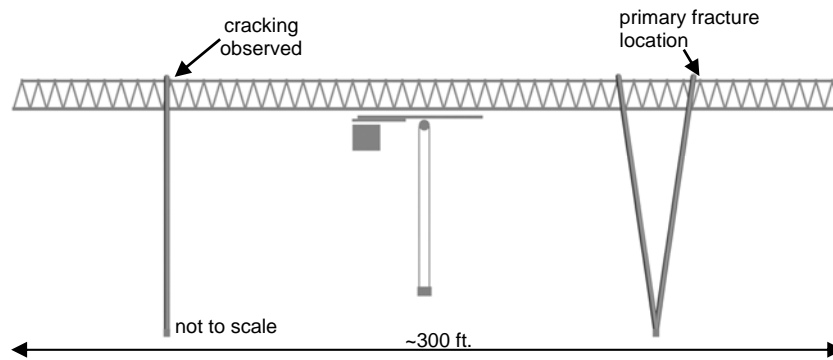
The accident occurred due to a sudden fracture of the top chord at a joint immediately outboard of the larger vertical supporting structure, as shown in Figure 11. The longitudinal chords of the truss were custom-fabricated (“built-up”) sections that became thinner toward the ends of the space frame (lower bending moments call for smaller moments of inertia). The design accomplished this by varying the web and flange thicknesses, but also by reinforcing the webs of the beams with thick plates. In the section where the primary failure occurred, one such transition in section size and properties occurred immediately inboard of one of the joints where the diagonal tube members were welded to the bottom flange of the top chord. In addition, this change in section was located immediately outboard of the larger vertical support structure.

Figure 11. Side elevation of the subject portal crane.

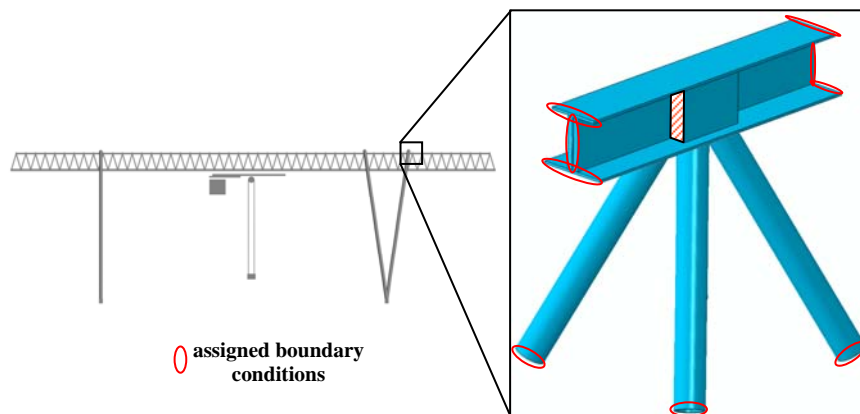
Further exacerbating the situation, all of the joints were stiffened by welding in four vertical L-shaped plates between the flanges of the beam, effectively forming a box-like structure between the two flanges, immediately above the location where the four tubes were welded to the bottom flange. This box structure prevented proper inspection of the various connections during service. A further complicating factor in this area was the addition of weld repairs during the crane's service, but prior to the final failure. The truss failed at the change in section in the subject joint, immediately inboard of the box-like structure, as shown by the hatched plane in Figure 13. One concern was whether the weld repairs may have contributed to this failure.

Figure 13. Top chord at the failure location - local model.

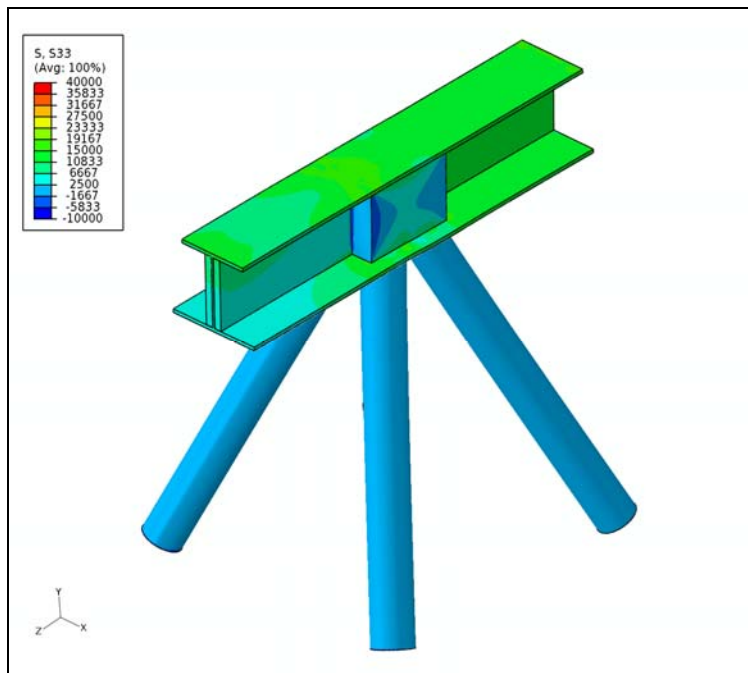
Figure 14 presents the overall longitudinal (S33) stress results for an un-cracked version of the detailed local model. Note the thick plates welded to the beam on either side of the web, inboard of the box structure. Figure 15 presents two S33 stress plots of the local model at, and outboard, of the fracture plane (components removed for clarity). Note the four “hot spots” located where the welds tying the thick web reinforcement plates to the box structure and the flanges join up. Three welds run into one discrete corner at each of these four locations. The maximum longitudinal stress at these hot spots was found to be 32 ksi for a nominal 1g vertical load. As a result, these high local stresses were determined to be sufficient to initiate the fatigue cracks that were observed at all four locations after the accident.

Figure 14. Local model – right tip load ($F_y = -32,000$ lbf) – S33 (psi).

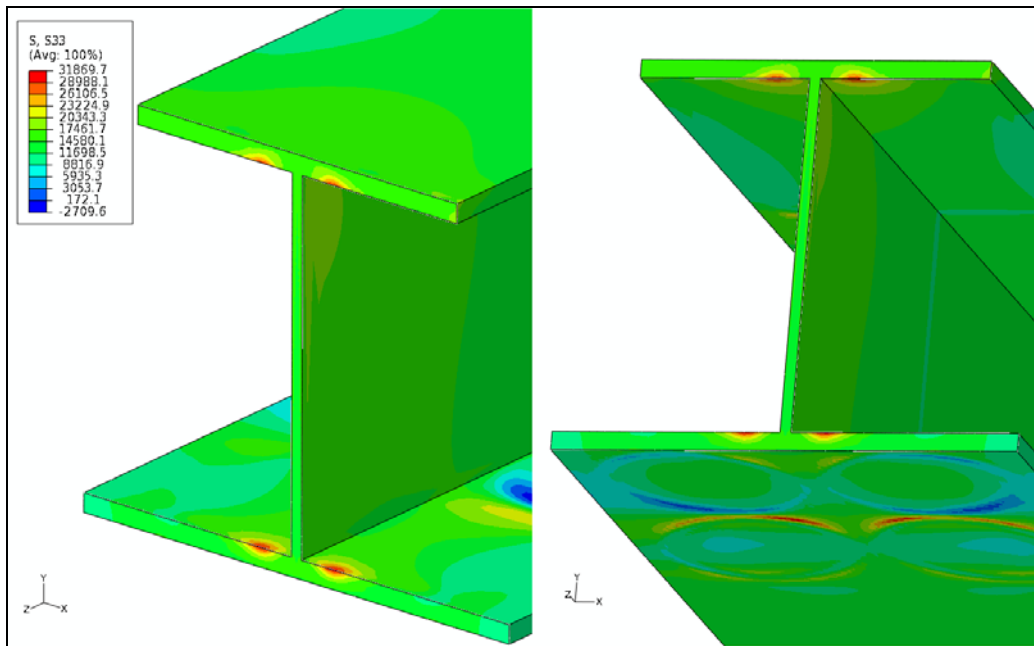
Figure 15. Local model – right tip load ($F_Y = -32,000$ lbf) – fracture plane – S33 (psi).

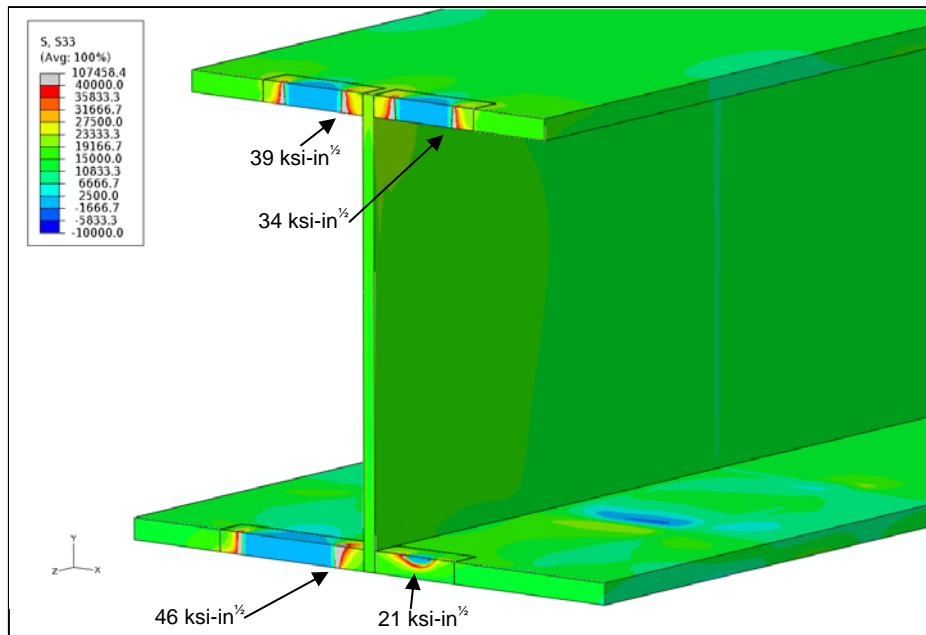
The results for two of the crack cases are presented below in Figure 16 and Figure 17. Figure 16 illustrates a case with three through-cracks and one surface crack, accounting for all four hot spots. Figure 17 presents a case in which the through-crack in the lower left of Figure 16 has been repaired, while the other cracks remain.

The fatigue cracks in these figures can be identified by the low stresses on the crack surfaces (blue contours). Also, note that the location and magnitude of the maximum stress intensity for each crack is identified in both figures.

Figure 16. Stress intensities – crack configuration A – S33 (psi).

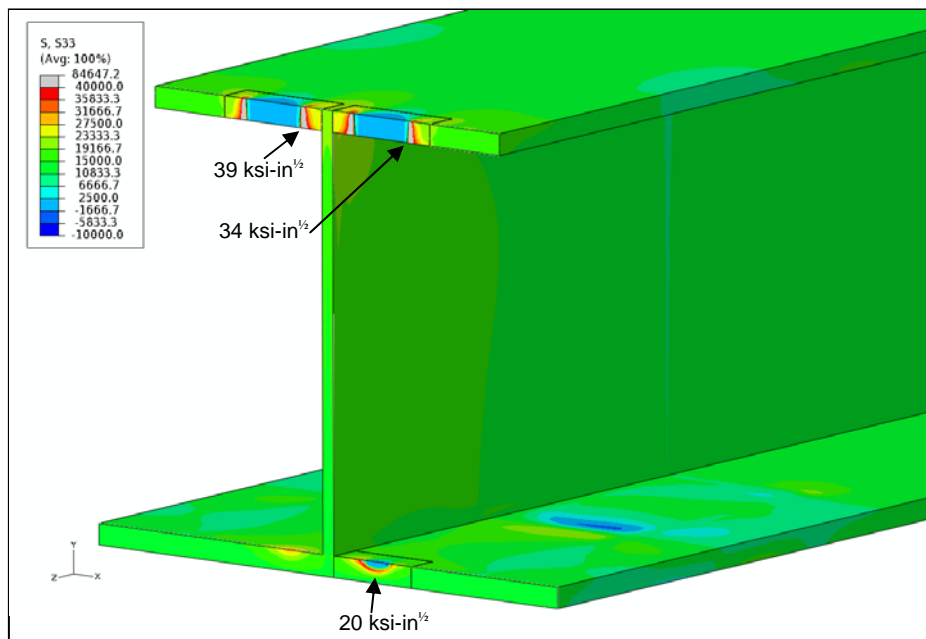
Figure 17. Stress intensities – crack configuration B – S33 (psi).

Examination of the stress intensities obtained for the four crack configurations for the 1G vertical load case, including the two shown above, clearly indicated that fatigue crack propagation could reasonably be expected on both the top and bottom flanges under both loading/crack configurations. In fact, there was little to no change in the crack tip stress intensities in the cases presented. Both scenarios exhibited crack tip stress intensities well above the threshold levels for structural steel. Evaluation of these scenarios allowed for the exclusion of the possibility that an inappropriate weld repair after fatigue crack growth had already initiated was largely responsible for the ultimate collapse.
