PD Monitoring – 3-5kV Medium Voltage Motors

This paper describes the effectiveness of PD testing for condition-based maintenance of stator windings in 3-5kV motors. Determination of usefulness is based on the results of almost 1000 results in the Iris Database [7] and various case studies [Section 5, [11], [12], [13]].

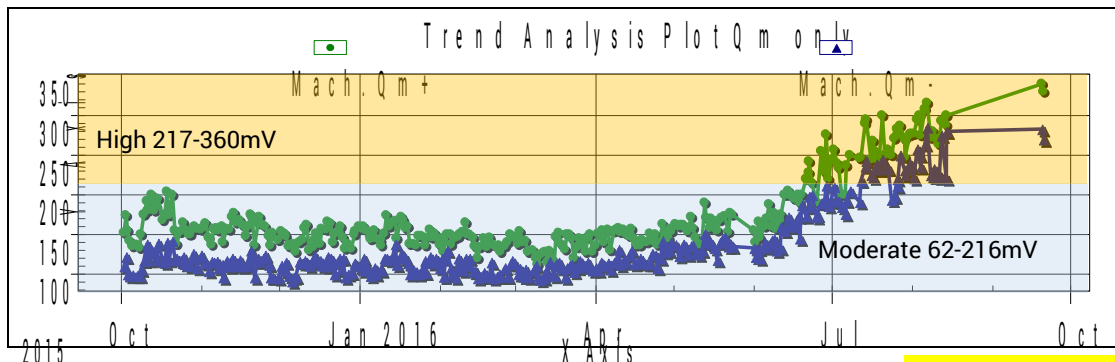
Figure 10. Continuous Trend in a 4.1 kV motor- notable upward trend in 2016 [Lemont 13GBM-1]

Because of the potential for variability with ambient and/or operating conditions, it is recommended that to avoid misdiagnosis for this voltage class the stator winding insulation, when practical, should be monitored with a continuous instrument [Figure 10]. This instrument can be connected to plant DCS and or periodically examined for changes in PD. When data is obtained it is important to evaluate both the maximum levels of PD over the timeframe and the overall trend. Any significant change in activity, up or down should be investigated [Figure 11] is a trend of Very High PD relative to the Iris database; however, it is relatively stable, exhibiting a recent slow upward trend.

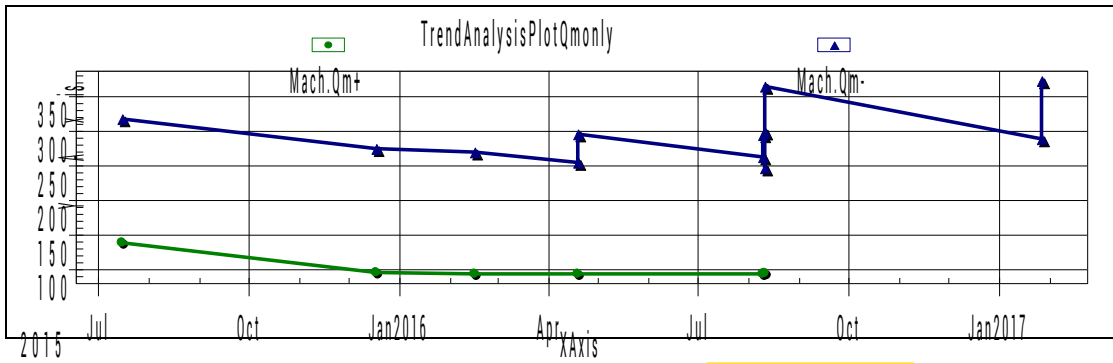
Figure 12. Periodic Test – High, but stable [Koch-UAN-M08]

Though continuous monitoring is recommended, in some cases periodic testing is more practical. In Figure 12, the PD is at Moderate to High levels but has been stable. It is too early to evaluate the overall trend to suspect a rapidly developing problem, though there is an indication of some activity. On the other hand, Figure 13 signifies data that is originally low, but because of the increasing, rapid trend should be closely monitored.

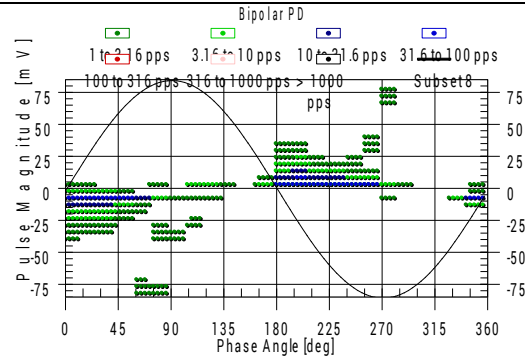
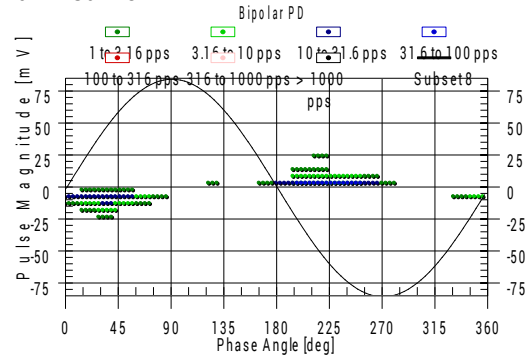
Plant: 4kV Induction Motor, 8000hp
 Original test date was: Jun 2012 (continuous)
 Max PD Values: Qm+ 85mV, Qm- 85mV
 Pulse phase analysis: primarily internal PD but high magnitude around the peaks
 Follow-up monitoring: continuous [Figure 10]
 Comparison of Jul 2012 to Feb 2013 showed higher activity in July with sporadic clusters often indicative of contamination which would be highly sensitive to variable ambient and/or operating conditions
 New PD Values: Qm+ 26mV, Qm- 20mV
 Current situation: continue to monitor, be alert to erratic behavior

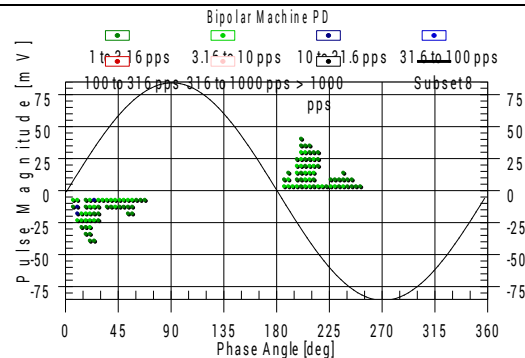
- Plant: 4kV Induction Motor, 1250hp
- Original test date was: May 2009 (periodic)
- PD Values: Qm+ 9mV, Qm- 7mV
- Pulse phase analysis: negligible PD
- Follow-up monitoring: increase in Oct 2013 [Figure 13]
- Emergence of a narrowband cluster, indicative of a source at or near the terminals
- Decision: continue to monitor
- New PD Values: Qm+ 23mV, Qm- 27mV
- Current situation: minor problem developing

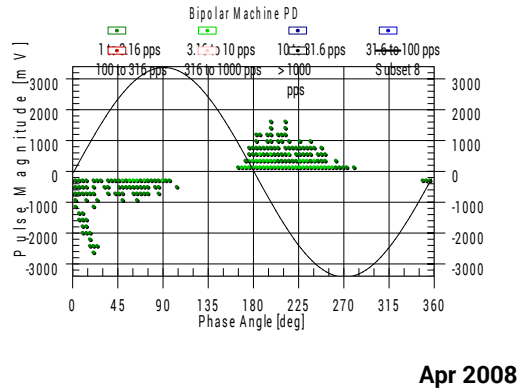
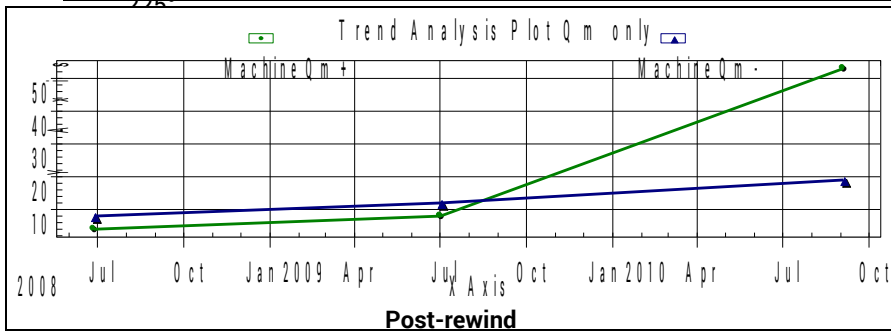
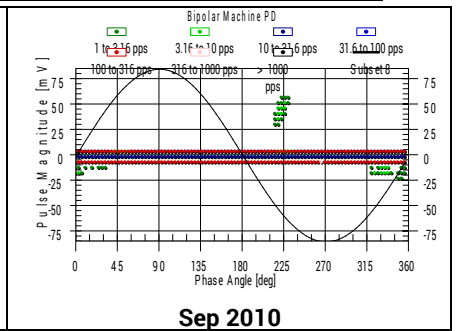
- Plant: 4kV Induction Motor, 1250hp
- Original test date was: Apr 2008 (portable instrument)
- PD Values: Qm+ 1368mV, Qm- 1466mV
- Pulse phase analysis: arcing at the motor terminals combined with both internal and surface voids
- Decision: rewind motor immediately in 2008
- PD Values: Qm+ 8mV, Qm- 4mV
- Follow-up monitoring: slight upward trend since Jul 2009, new PD values Qm+ 53mV, Qm- 19mV
- Current situation: isolated source of arcing at motor terminals indicated by a narrowband pulse near 225°

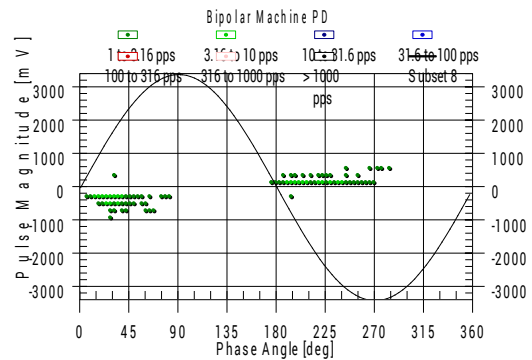
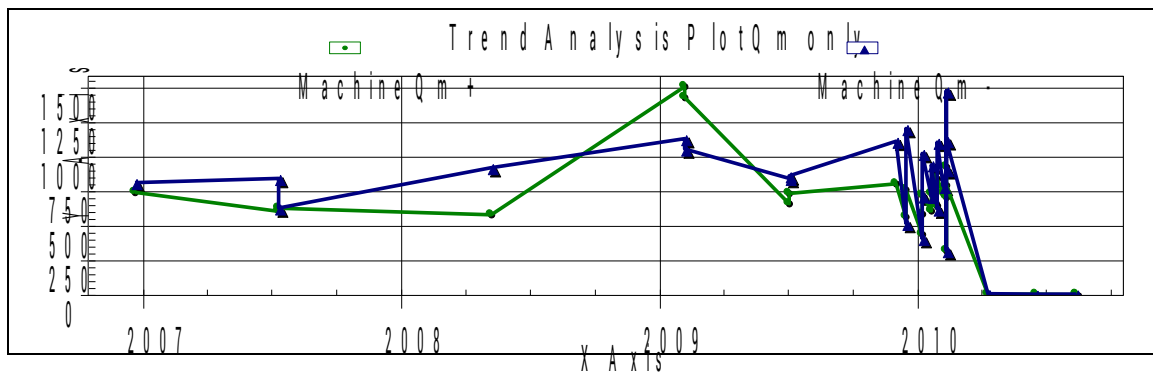
- Plant: 4kV Induction Motor, 3000hp
- Original test date was: Dec 2006 (periodic)
- PD Values: Qm+ 746mV, Qm- 817mV
- Pulse phase analysis: primarily internal PD
- Follow-up monitoring: mostly stable, but increase in negative PD Feb 2009, new PD values Qm+ 798mV, Qm- 1120mV. Negative predominance is a concern for multi-turn coil construction. (see below)
- Decision: rewind motor in 2010
- New PD Values: Qm+ 8mV, Qm- 9mV
- Current situation: no problems indicated

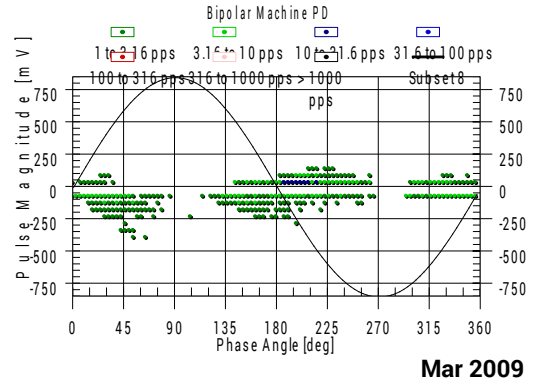
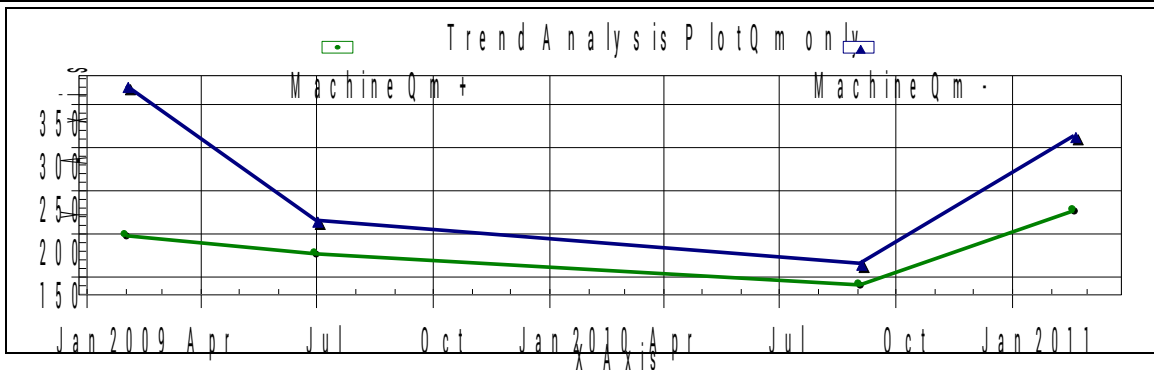
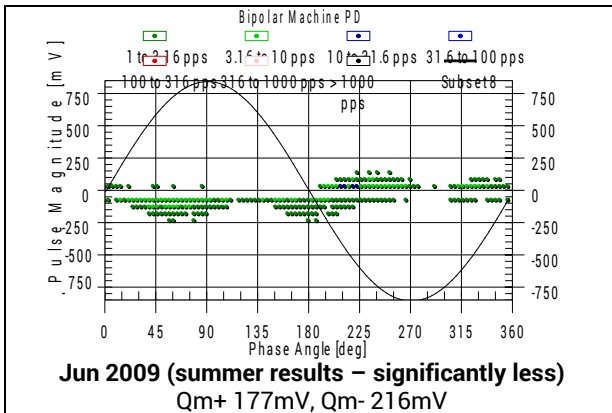
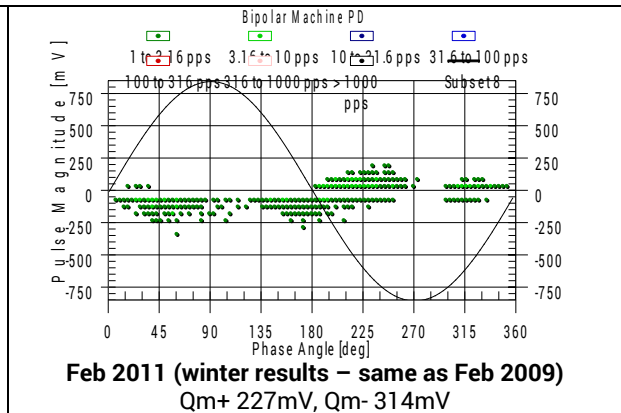
- Plant: 4kV Induction Motor, 1250hp
- Original test date was: Mar 2009 (periodic)
- PD Values: Qm+ 198mV, Qm- 372mV
- Pulse phase analysis: High primarily internal PD
- Follow-up monitoring: initial decrease followed by an apparent increase (see below)
- Comparison of Mar 2009 to Feb 2011 showed no change in magnitude or pattern, but the Jun 2009 levels were lower in magnitude (see below)
- Decision: continue to monitor
- New PD Values: Qm+ 227mV, Qm- 314mV
- Current situation: no problems indicated

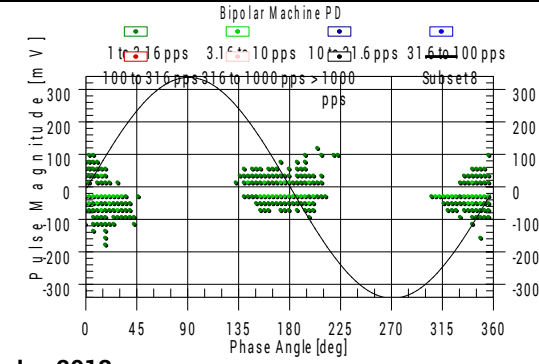
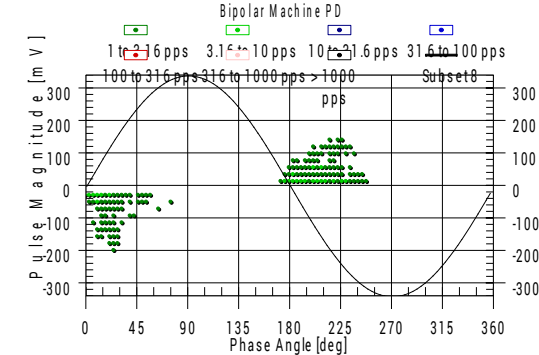
Plant: 4kV Induction Motor, 1250hp
 Original test date was: May 2009 (periodic)
 PD Values: Qm+ 95mV, Qm- 125mV
 Pulse phase analysis: primarily internal PD, but may be interphasal
 Follow-up monitoring: initial increase but since Jun 2011 primarily stable [Figure 12]
 Comparison of Jun 2011 to Oct 2013 showed similar magnitudes but a significant change in PD pattern
 New PD Values: Qm+ 132mV, Qm- 161mV
 Current situation: continue to monitor, but consider additional testing because of the change in PD pattern

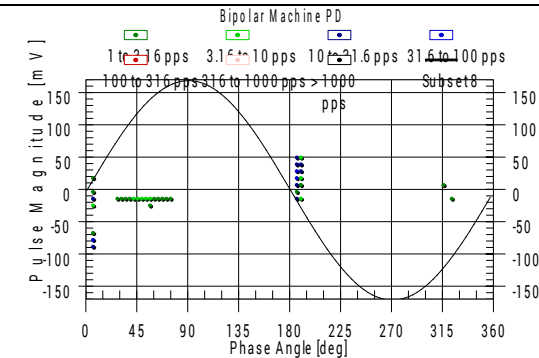
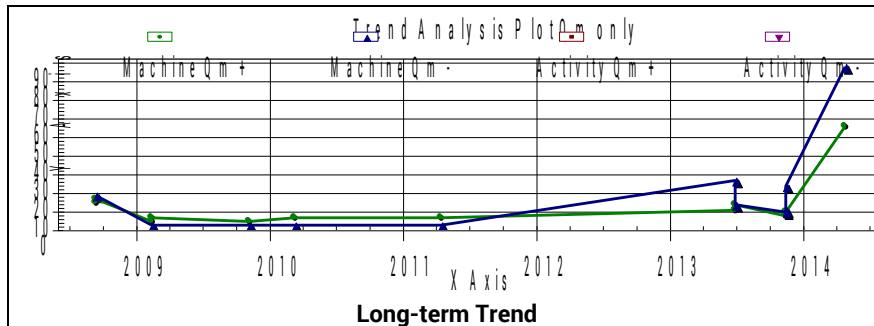
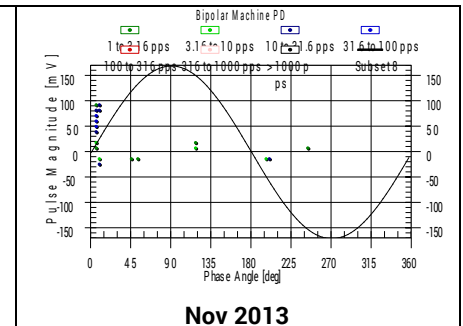
- Plant: 4kV Induction Motor, 1.865MW
- Original test date was: Sep 2007 (periodic)
- PD Values: Qm+ 16mV, Qm- 8mV
- Pulse phase analysis: negligible PD
- Follow-up monitoring: increase in Apr 2014 (see below)
- Comparison of Nov 2013 to Apr 2014 shows a single source at or near the zero crossings that has reversed polarity. This is not PD.
- Decision: continue to monitor
- New PD Values: Qm+ 56mV, Qm- 88mV
- Current situation: no problems indicated
