QUALITROL CASE STUDY:

SERVERON™

ACETYLENE: HOT METAL GASES

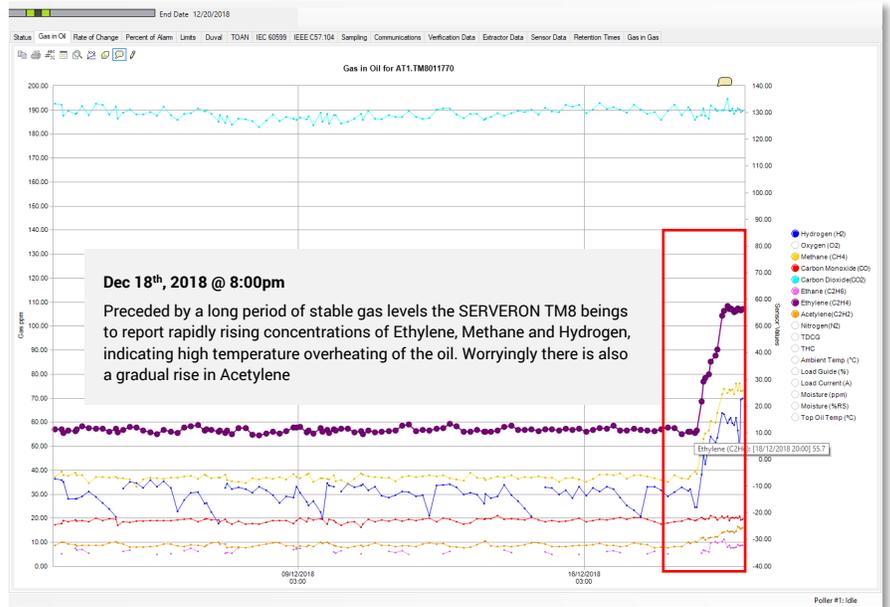
A Qualitrol Serveron TM8 monitor was installed on a transmission transformer at a US utility in 2016. Transformer operation was typical and stable for several years. At 9pm on December 19, 2018 the TM8 alarmed for increasing concentration of Acetylene. Upon reviewing the full DGA data it was observed that Acetylene and other hot metal gases were being generated at a significant rate. The online DGA data revealed gases had started rising just 24 hours earlier. Immediately upon alarm levels of gas being detected the monitor automatically switched into an accelerated sampling rate (from 6 times per day to 24 times per day), generating very detailed resolution on gas generation.

By reviewing the data around the time of the sudden increase in gas concentrations using SERVERON™ View one can observe that this combination of gases are typical of a high temperature fault:

Diagnostics Method	Indicated Condition
Duval Pentagon 1	T3 Thermal Fault >700°C
Duval Pentagon 2	T3 Thermal Fault in Oil >700°C
Duval Triangle 1	T3 Thermal Fault >700°C
Duval Triangle 4	N/A as only applies to low temp faults
Duval Triangle 5	T3 Hot Spot in oil
IEC 60599 Rodgers Ratios	T3 Fault
IEEE 57 104 2008	Condition 3 for Acetylene and Ethylene Condition 4 for total combustible gas

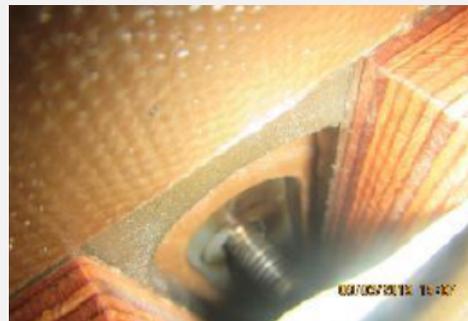
The transformer was inspected on site by the manufacturer and it was identified that a loose nut on the PA Core Leg Phase 1 resulted in an area of overheating (Figure 1).

Vibration in operation had caused the nut to loosen and disassemble.

Figure 1:
Loose nut on PA core leg phase 1

Repair was affected by replacement of the PA unit following careful inspection of threads for damage and the application of the correct torque to the nut.

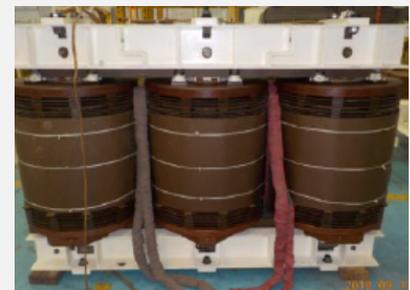
Figure 2.
PA after being removed from tank

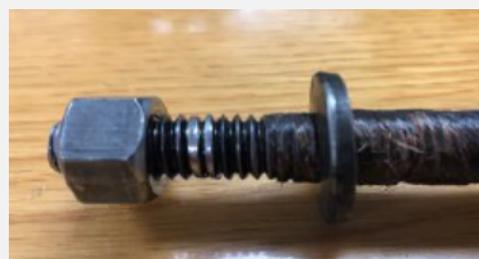
Upon returning the transformer to the factory for repair (Figure 2) it was further discovered that the nut had screw thread damage which resulted in the correct torque being applied during manufacture not actually tightening the nut sufficiently (Figure 3).

Figure 3:
Image of offending bolt/nut assembly showing thread damage
