ELIOS IN ACTION | PUBLIC SAFETY

SAFE FORENSIC INVESTIGATION IN LIVERPOOL PARKING LOT AFTERMATH

A SEVERE FIRE BROKE OUT AT THE LIVERPOOL ECHO ARENA MULTI STORY CAR PARK ON 31ST DECEMBER 2017. ONCE THE FIRE WAS UNDER CONTROL AND EXTINGUISHED, PUBLIC SAFETY WAS OF THE HIGHEST CONCERN. MANDATED BY LIVERPOOL CITY COUNCIL, PCF SURVEY DEPLOYED ELIOS TO SAFELY INVESTIGATE THE AFTERMATH.

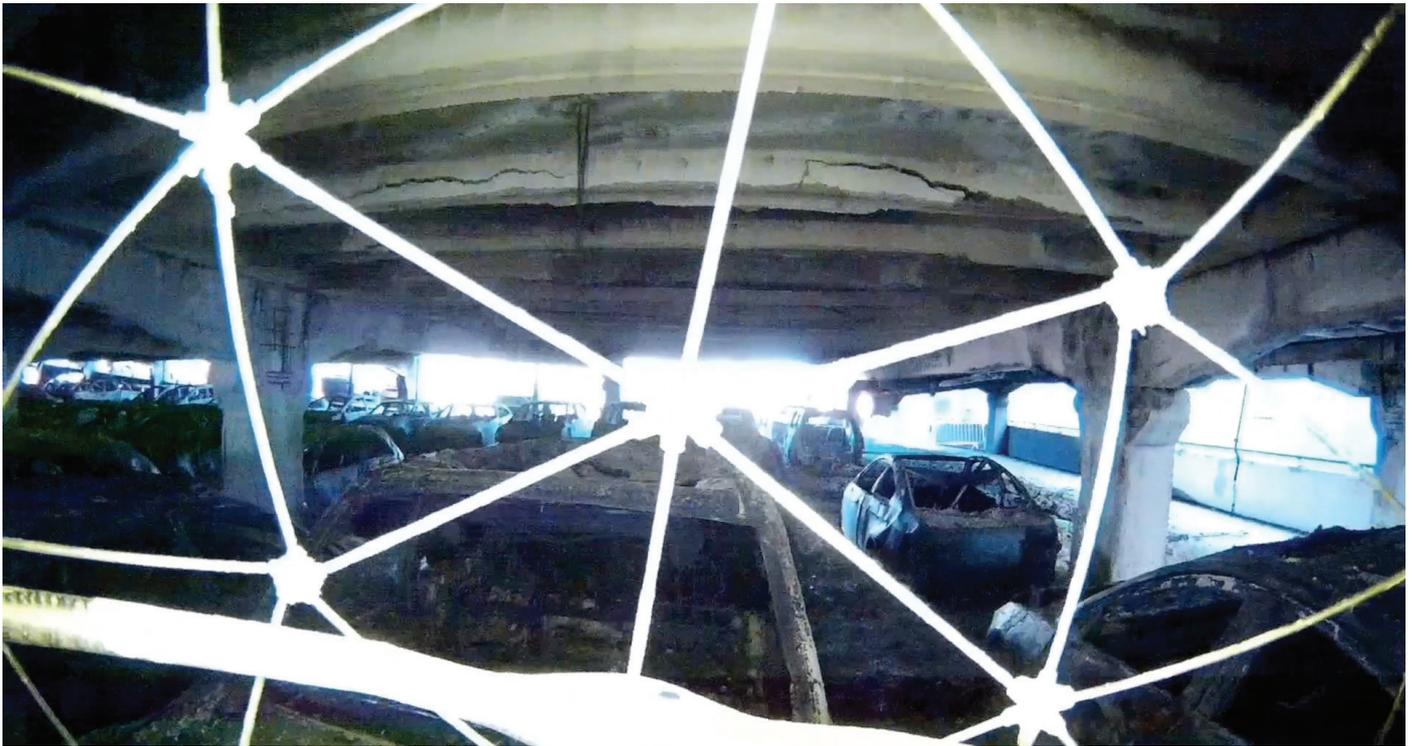
Unfortunately these surveys were limited due to the devastation caused by the fire. Although the reinforced frame appeared to be intact and maintained structural integrity, access to the floors was impossible. As seen in figure #1 the floors were simply too dangerous to enter, they had suffered significant damage and several collapses had taken place.

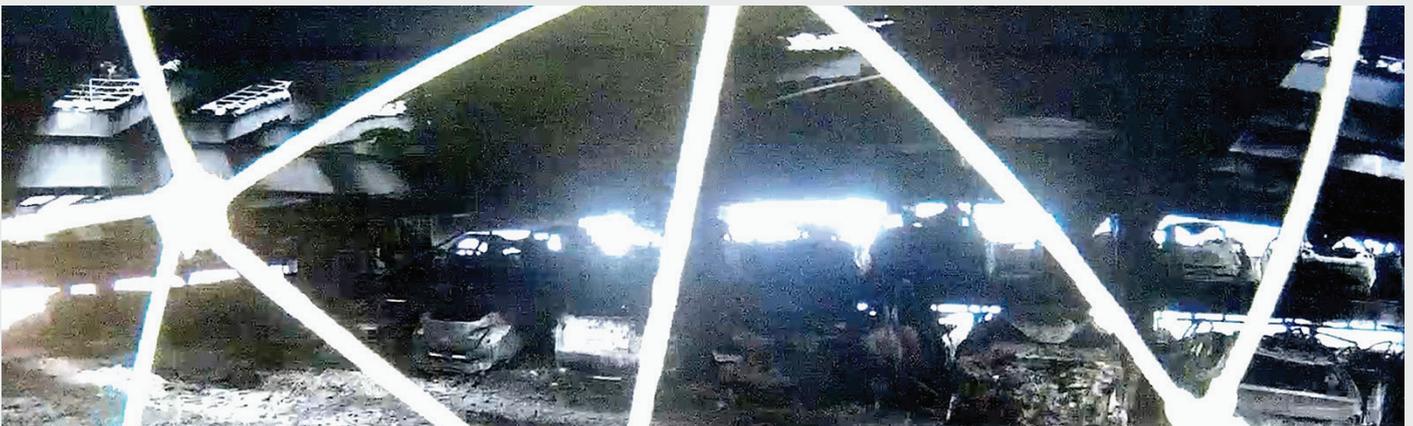
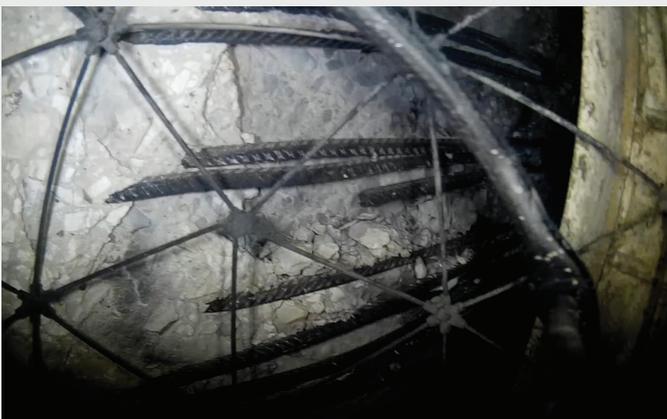
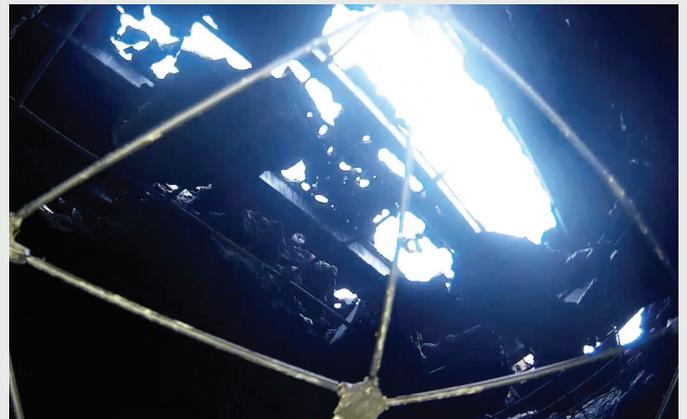
MISSION PICTURES TAKEN BY ELIOS

The last key target was the drainage channels. PCF Surveys interpreted the plans vs the physical structure. This skill is essential as the original plans do not always accurately relate to a structure once built. Late changes can slightly alter this. The channels were located and the Elios inspected these areas. Again accurate flight plans and reports were produced from these flights. Lastly, a general overview of some of the floors was conducted. Albeit this offers no valuable data, with regards to structural integrity, it offers an insight into the severe damage and devastation caused throughout all parts of the structure.
