## Case Study – Manufacturing & Packaging Evaluation of Pharmaceutical Vials for Glass Delamination

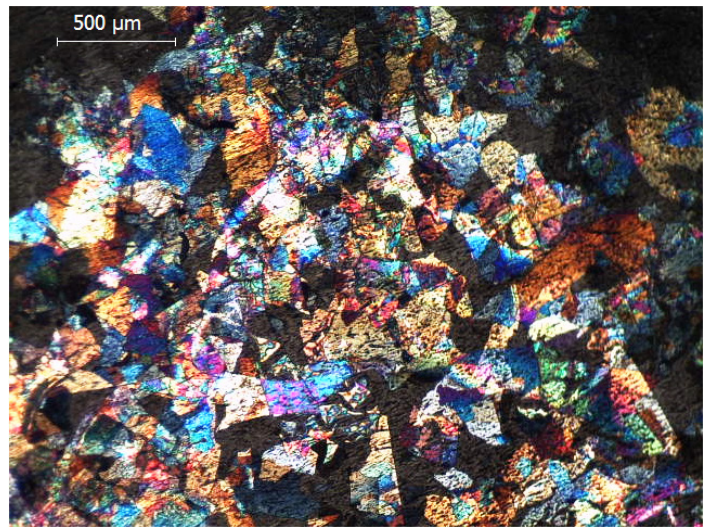
First the filter membranes were examined using a stereomicroscope. Gateway Analytical observed the presence of thin reflective flakes, but were unable to make definitive assessments of delamination. Representative flakes were then isolated from the membrane using meticulous micro-preparation techniques and prepared for further micro-analytical analysis.

*Stereomicroscope image of thin reflective flakes identified following vacuum filtration onto a filter membrane.*

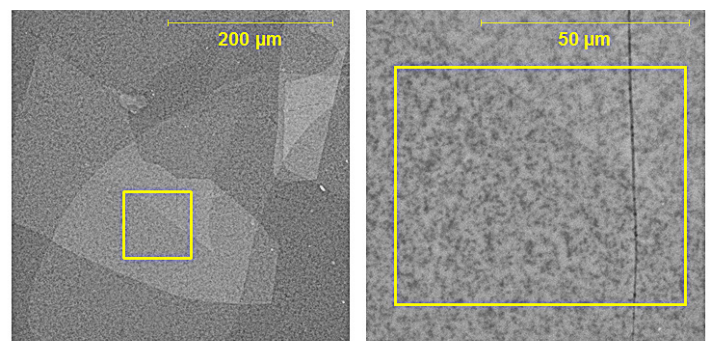
Gateway Analytical then performed SEM/EDS analysis and was able to determine the presence of silicon-rich flakes which were elementally and morphologically consistent with delamination. This also suggested that the flakes were in fact property of the glass vial and not a foreign contaminate.

*SEM-EDS image and associated spectra of Si-rich flakes.*

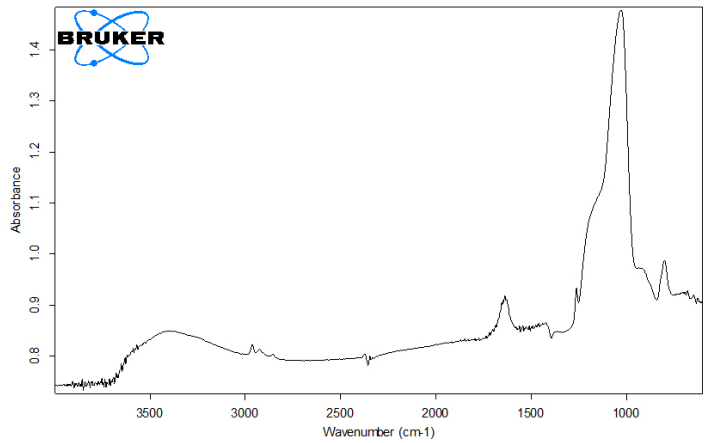
Flakes were then isolated for FTIR analysis which simultaneously collects data in a wide spectral range in order to provide the confirmation of the presence of silica.

*FTIR spectra indicating the presence of amorphous silica.*

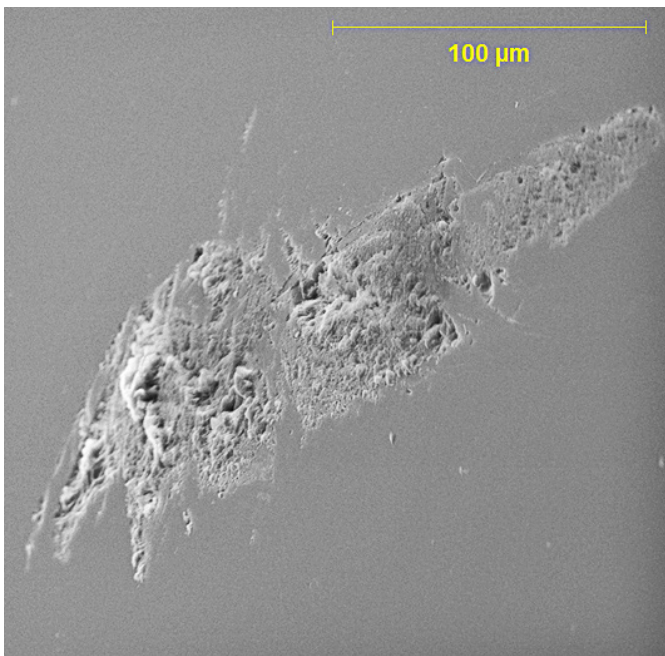
*High resolution SEM image of interior vial surface*

After the spectral analysis confirmed that the flakes were in fact silica; high resolution SEM imaging was taken of the interior surface of the vial. This provided information about the topography and composition of the vial in addition to a visual confirmation of the glass delamination.

Using a combination of specialized and micro sample preparation techniques, SEM/EDS, FTIR and high resolution SEM imaging, Gateway Analytical scientists were able to determine that what the manufacturer originally thought was a drug crystallization issue was in fact glass flakes that were caused by glass delamination. The manufacturer discontinued the development of additional lots until further analysis of the drug and its interaction with the vials could be reviewed after receiving the analytical report.
