# Casing leak – Fairview Field, Australia

Seal off the casing leak using ThermaSet® sealant.

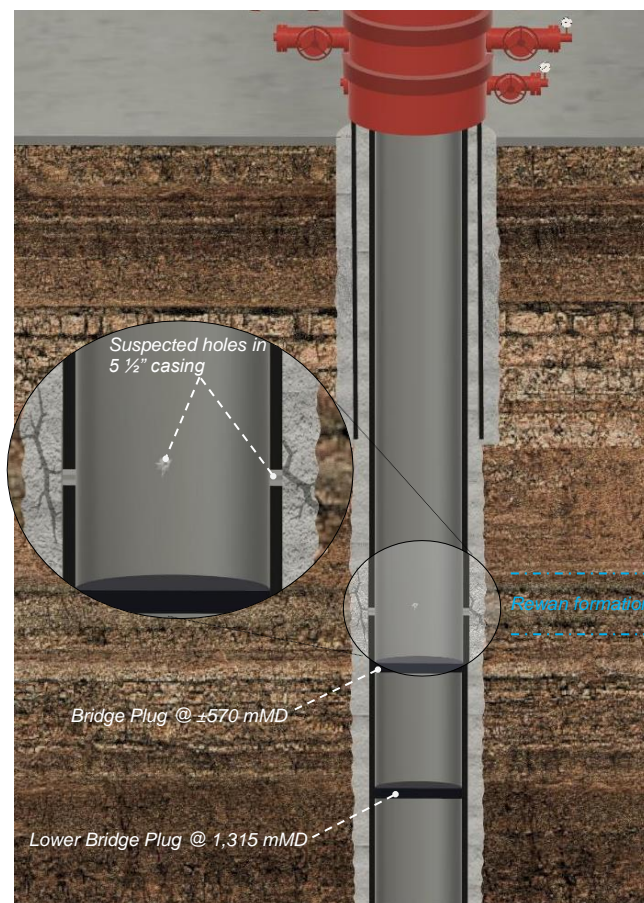
Figure 1 - Well status before ThermaSet® treatment

The candidate well identified for this operation was recently completed in March 2019. Shortly thereafter a leak was observed in the 5 ½" production casing across the Rewan formation located at 559.59 mMD. The leak was suspected to be sourced from a casing connection and traversed across the annular cement sheath thereby compromising the tubular integrity (Figure 1).

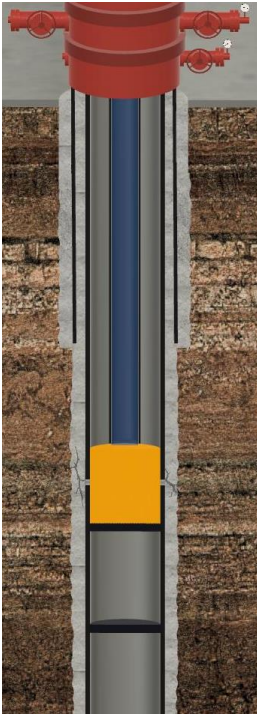
**Figure 2-a** Placed ThermaSet<sup>®</sup> pill (orange) on the bridge plug and displaced with water (blue).

The engineered solution prescribed a neat 1.03 SG ThermaSet® pill. Job execution is depicted in Figures 2-a and Figure 2-b and adhered to the sequence outlined below:

- Mix a 13.24 bbl. neat and solids-free ThermaSet® pill.
- Spot the pill downhole as a balanced plug and displace with fresh water.
- Proceeded to squeeze ThermaSet® into the leak in a Bradenhead fashion at an initial rate of 2.8 lpm at 2,500 psi.
- Squeeze pressure was maintained for the duration of the 06:15 hrs. gel time and a total of 1.44 bbls. resin was squeezed into the leak paths

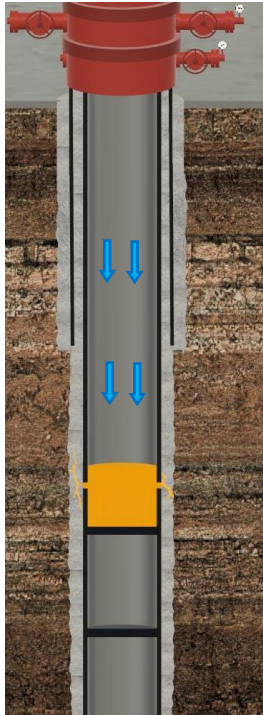
**Figure 2-b** Squeezed some ThermaSet<sup>®</sup> into the leak in a Bradenhead fashion.

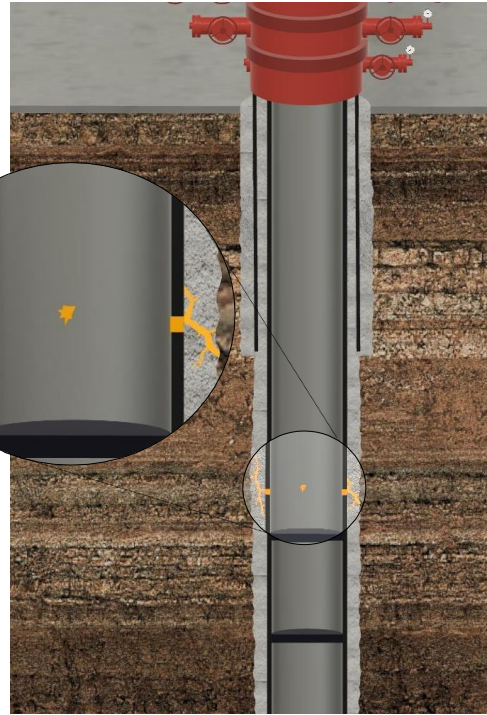
**Figure 2-c** Milled ThermaSet<sup>®</sup> plug.

Once the ThermaSet® was fully cured, the plug was tagged and the excess ThermaSet® was milled down to directly above the bridge plug (Figure 2-c). The 5-½" casing was then tested from surface to 1,350 psi with no recorded drop in pressure verifying a successful operation.

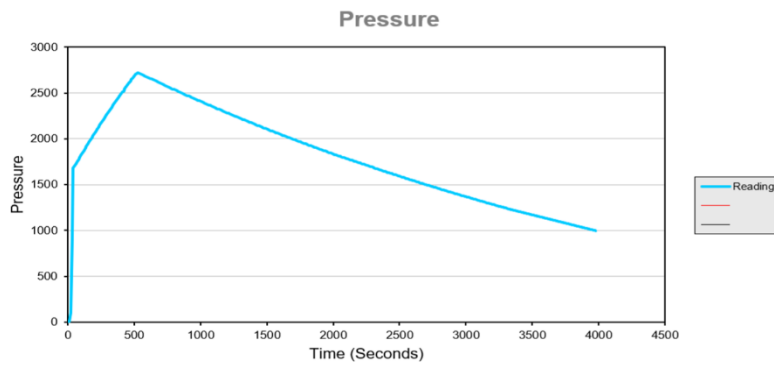
**Figure 3** Pre-operational pressure test

The pressure response of the well prior to the operation is illustrated in Figure 3. Figure 4 plots the post-operational pressure test where no decrease in pressure is observed validating the restoration of wellbore and annular integrity.
