# Packed Column - Damaged Packing

## Project Field Test

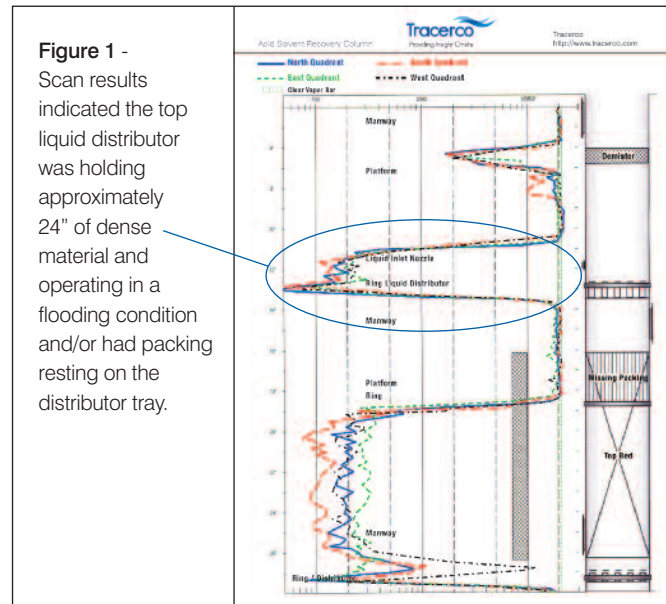
**Figure 1 -** Scan results indicated the top liquid distributor was holding approximately 24" of dense material and operating in a flooding condition and/or had packing resting on the distributor tray.

Based on the scan results (Figure 1) the top liquid distributor was shown to be holding approximately 24" of dense material and was operating in a flooded condition and/or had packing resting on the distributor tray.

The top portion of the upper bed appeared to be missing 30" of packing which could be due to lack of packing elements installed or displaced packing that was blown up onto the top liquid distributor. This bed was also operating with poor liquid distribution with liquid channeling through the south quadrant and liquid deficiency through the east quadrant.

The space between the bottom of the top bed and the liquid distributor above the lower bed should have shown a clear vapor space if all was well with the column. Instead this space was very dense with either liquid and/or packing material, especially in the eastern quadrant of the column. This could indicate a breach in the eastern portion of the top bed support that would have caused packing to collapse onto the distributor.

After reviewing the scan results the customer entered the column a few weeks after the scan to make repairs. They found that the top bed hold down plate was missing so packing from the top bed had been carried up onto the top liquid distributor. This caused the top distributor to appear flooded. The top hold down grid for the top bed was found buried in the lower portion of the packing. The bottom support grid for the top bed was still in place so no packing from the top bed had collapsed onto the bottom liquid distributor.

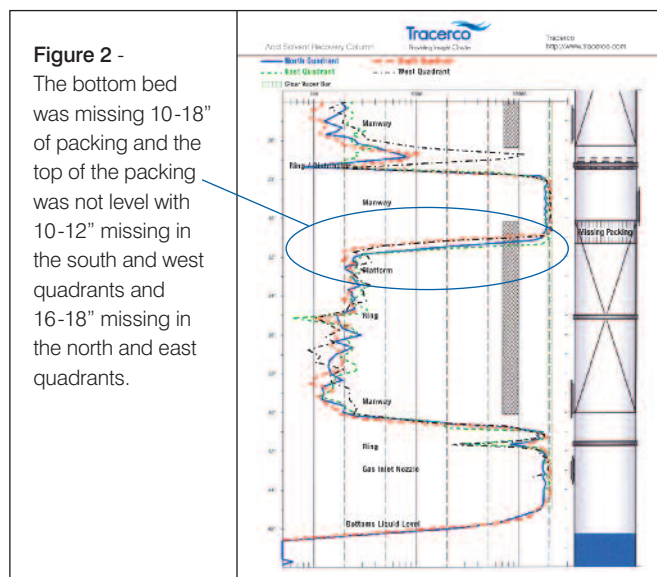
The top portion of the bottom bed appeared to have 10-18" of packing missing and the top of the packing was uneven with 10-12" missing in the south and west quadrants and 16-18" missing in the north and east quadrants (Figure 2). This missing material could indicate displaced packing that could have been blown up onto the bottom liquid distributor. The bed was also operating with a slight density gradient with denser material in the lower portion compared to the top indicating crushed or settled packing or fouling in the lower portion of the bed. The liquid distribution through this bed was fair-to-good in the top half but was worse in the bottom half of the bed.

**Figure 2 -**  
The bottom bed was missing 10-18" of packing and the top of the packing was not level with 10-12" missing in the south and west quadrants and 16-18" missing in the north and east quadrants.

Like the top bed, the hold down plate for the bottom bed was not in place so packing had carried up from the bottom bed onto the bottom liquid distributor. This accounted for the high density in the vapor space between the top bed and the bottom liquid distributor instead of a top bed collapse. The hold down grid for the bottom bed was buried in an almost vertical position in the lower portion of the packing.

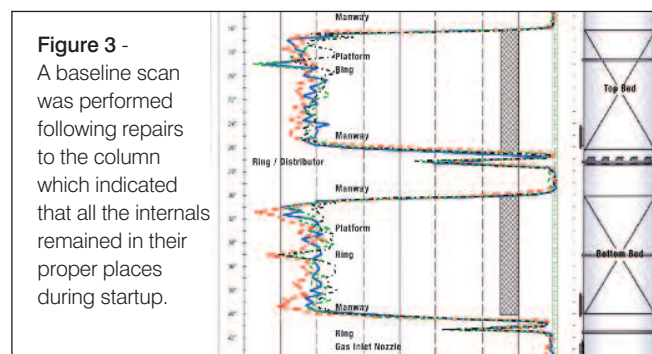
**Figure 3 -**  
A baseline scan was performed following repairs to the column which indicated that all the internals remained in their proper places during startup.

After all repairs were complete and the column restarted, the customer requested a baseline scan. The baseline scan results can be viewed in Figure 3. The baseline scan indicated that all internals remained in their proper places during startup and both beds were operating with fairly good liquid distribution. The baseline information will provide invaluable reference data for future troubleshooting scans.
