Doc. No.: HS-195ENG	<h1 style="margin: 0;">IRATA</h1> <h2 style="margin: 0;">Safety Bulletin No. 44</h2>

Date of Issue: 20/10/17		
Issue No.: 001		
Page 1 of 6

SAFETY BULLETIN NO. 44: ROPE ACCESS MAIN ROPE FAILURE

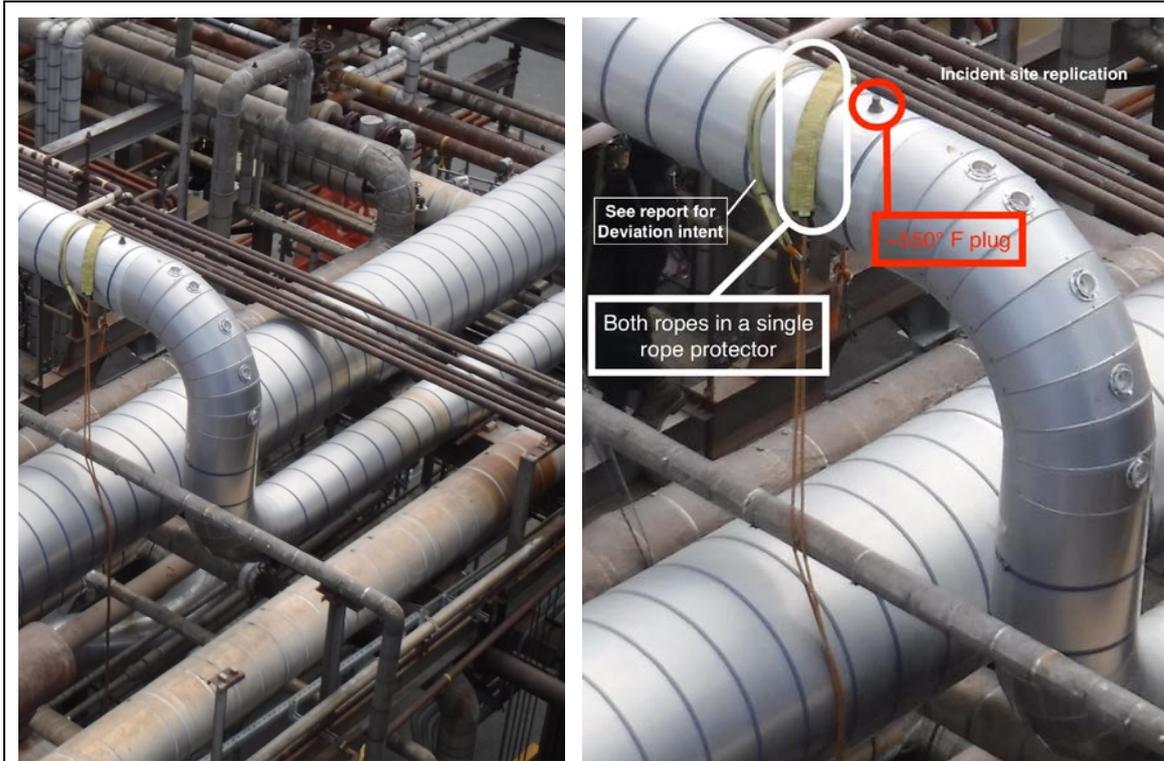
Figure 1: Recreation of the incident scene

3.2.1 A rope system was rigged by a Level 3 rope access technician over an insulated pipe, to establish a high-point deviation (sometimes known as an "up and over" directional). See **Figure 1**. Both the main rope and the safety rope were placed in a single, fabric rope protection sleeve to guard against rough and uneven surface hazards.

3.2.2 The technician ascended the ropes from ground-level. When the main rope was loaded, the system moved laterally such that it made contact with an exposed metal plug located on top of the insulated pipe.

NOTE: The surface temperature of the 1" diameter metal plug was found later to be approximately 550 degrees Fahrenheit (288 degrees Celsius).

3.2.3 Once the technician reached approximately 6 metres in elevation, the hot plug melted through both the rope protector (nylon/canvas) and the main rope to the point of failure. The technician fell approximately 1 metre until arrested by their back-up safety system. The technician immediately transferred body weight to the adjacent structure and, secured in position with an additional anchorage, waited until a new set of ropes were lowered into position.

- (a) Failure to identify the heated metal plug on top of the insulated pipe.
 - (i) Due to its location, the L3 technician did not observe the small and protruding hot metal plug.

- (b) The decision to place both ropes in a single rope protector exposed both the main rope and the safety rope to the same hazard simultaneously.
 - (i) Rigging/anchor angles were a contributory factor. The L3 technician decided that one rope protector was sufficient for potential sharp edges, based solely on the insulation bands encasing the hot pipe. When the technician, below, weighted the system the rope protector caused both the main rope and the safety rope to slide into the unrecognized hot plug hazard.

- (ii) The deviation (see **Figure 1**, right) was intended to guard against a different hazard (viz. rope travel over the large pipe's elbow) and, therefore, did not engage the rope system early enough to prevent contact with the hot metal plug.

- (a) Establish enhanced awareness of high temperature hazards, regardless of type, e.g. exposed hot plugs, flanges, valves, etc. Identify and review them as part of any risk assessment and job planning.
- (b) Modify the company rope access procedures to highlight enhanced awareness of rope path.
- (c) Inspect the full path of the rope system, including potential movement, once the ropes are weighted; or ensure that all hazards are identified and are suitably mitigated.
- (d) Separate the main rope and safety rope, including rope protection, whenever possible to reduce the risk of concurrent damage or failure; reducing the risk of total system failure.

6.2 IRATA notes that, where possible, deviations should be “engaged” with the working rope, rather than set up to ‘catch’ the ropes if they move.

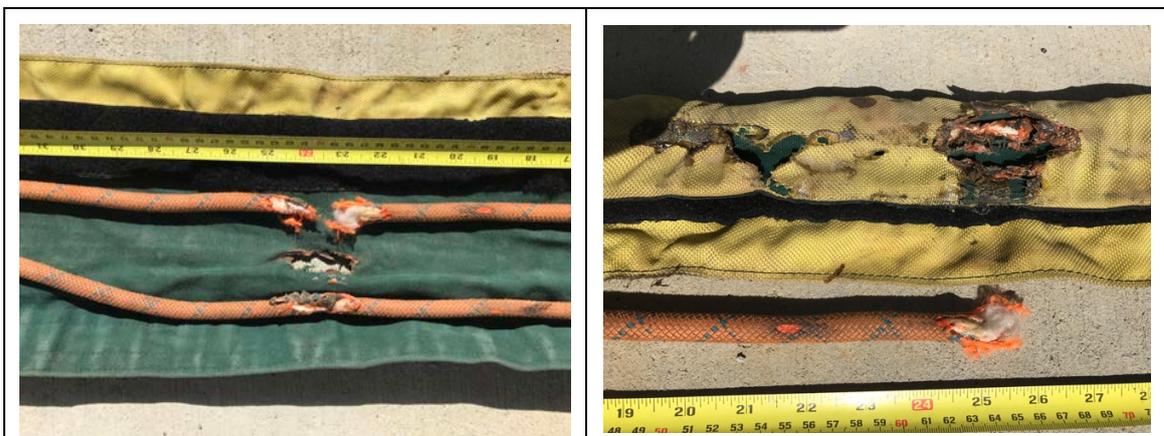
Figure 2: Damaged ropes and rope protector

3.2.5 An inspection of the damaged equipment involved showed that the main rope had melted through and the back-up safety rope had melted half through (approximately). See **Figure 2**.
