Doc. No.: HS-232ENG	<h1>IRATA</h1> <h2>Safety Bulletin No. 45</h2>

Date of Issue: 20/10/17		
Issue No.: 001		
Page 1 of 7

## **SAFETY BULLETIN NO. 45: FALL FROM HEIGHT: AID CLIMBING**

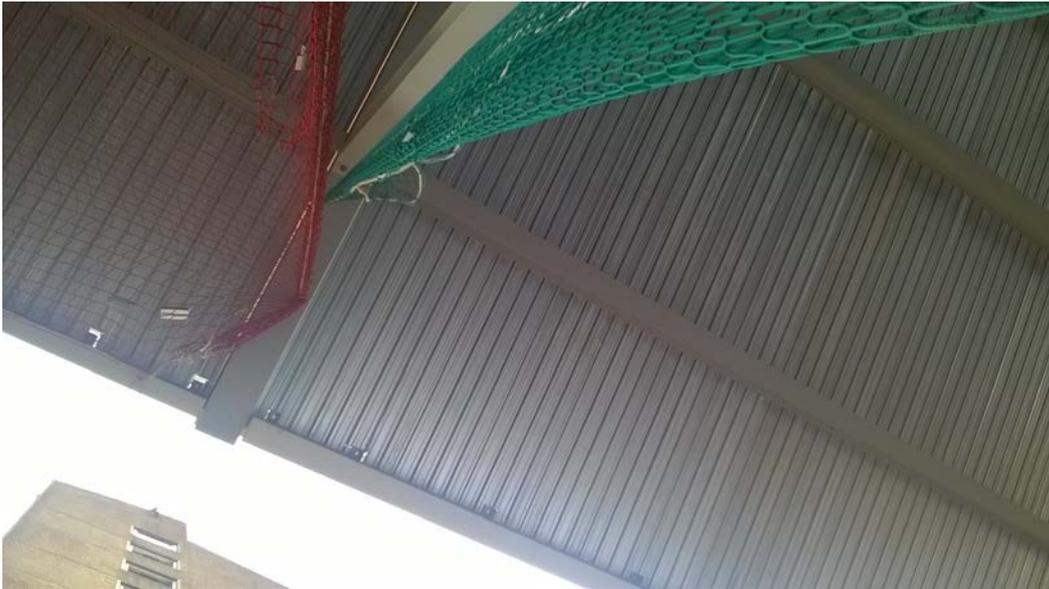
**Photo 1:**

First accident: Look upwards at the area to be de-rigged (left) and the area that had just been de-rigged.

The width of the bottom flange reduces from 200mm wide (right) to 150mm wide (left). The depths of the beams were also different.

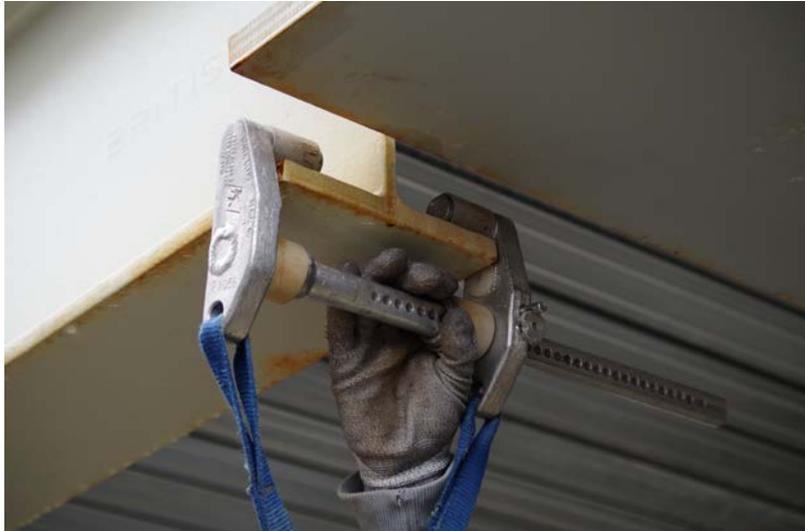
**Photo 2:**

- 3.2.6 There was a gap between the bottom flange of the beam and the flange of its connecting column. This dimension was such that it did not prevent the wheels on the beam glider passing through it. Thus, this resulted in the technician falling from height when losing both his primary support and back-up when the beam gliders were pulled off and/or fell off the open end of the bottom flange (see **Photo 2**).

First accident: Beam glider at open end of beam (37mm wide gap) [Reconstruction]

3.2.7 It appears that the equal and opposite horizontal reaction had not been recognised; and the direction of loading was no longer purely vertical.

- (a) designing the steelwork in such a way as to eliminate or substantially reduce open ends or cut outs; or if these are necessary;
- (b) introducing cleats or 'man locks', for example, that would prevent a beam glider leaving the steelwork (see 3.4);
- (c) considering the use of locking beam gliders which can be clamped to prevent unplanned movement;
- (d) ensuring a thorough pre-start check is carried out to identify any open-ended steelwork from the ground before gaining access at height.

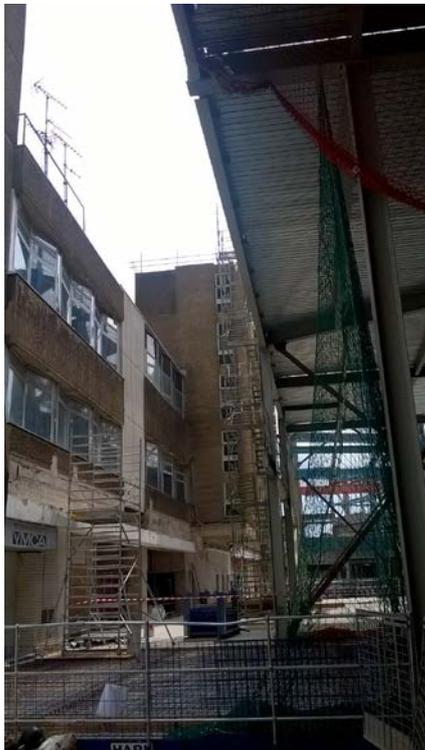
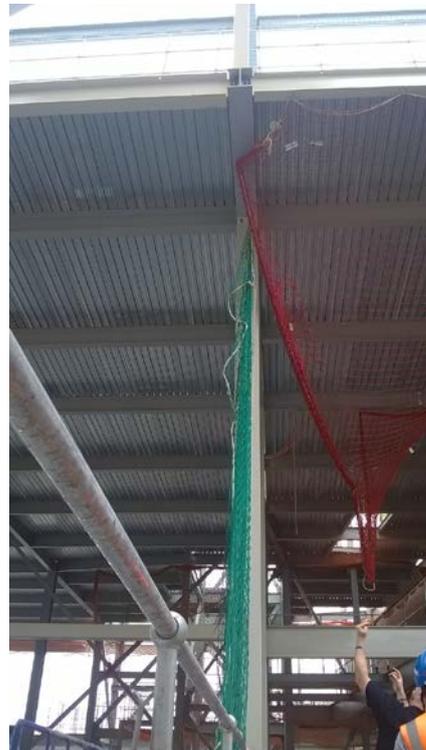
**Photo 3:**

3.2.8 **Second accident:** The technician, using three beam gliders, was travelling along the steel beam and did not identify an open-ended bottom flange, where two beams met. He pulled himself past this gap, which resulted in the primary and back-up support being lost and a fall occurring.

The location of the fall in one of the incidents
