SERVICE BULLETIN M20-299

**SUBJECT:** Mooney M20TN (Acclaim) Aircraft with KELLY AEROSPACE TURBOCHARGER(S)**MODELS/ SN** **M20TN (ACCLAIM):****AFFECTED:** 31-0039, 31-0042, 31-0044, 31-0046, 31-0047, 31-0049, 31-0050, 31-0052, 31-0053, 31-0056, 31-0057**TIME OF COMPLIANCE:** MANDATORY - BEFORE NEXT FLIGHT**INTRODUCTION:** This Service Bulletin is written in conjunction with Teledyne Continental Motors (TCM) Service Bulletin MSB07-4 and Kelly Aerospace Service Bulletins 023 & 027 (Attached). This Service Bulletin is to remove and replace the specified turbocharger(s) (TCM P/N 646677) from Mooney Aircraft M20TN (Acclaim) in accordance with attached TCM/Kelly Aerospace Service Bulletins.**INSTRUCTIONS:** **Read entire procedures before beginning work.**

**SUBJECT:** KELLY AEROSPACE POWER SYSTEM'S TURBOCHARGER REPLACEMENT

## TURBOCHARGER INSPECTION AND REPLACEMENT

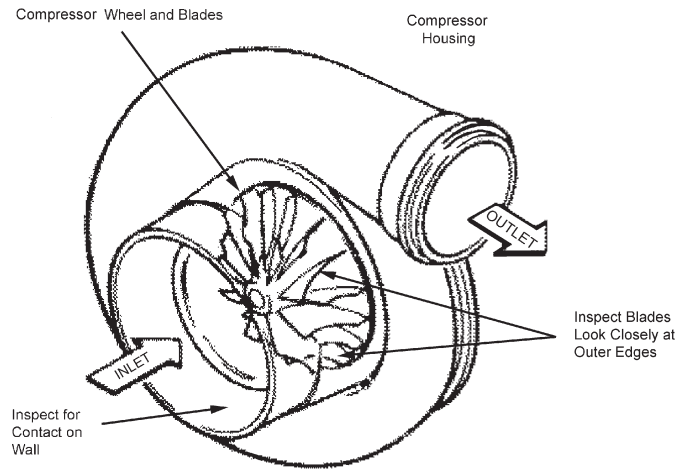
**Figure 2 - Turbocharger Inspection Points**

3. Visually inspect each turbocharger through the compressor inlet for any signs of contact. Look for witness marks from the impeller wheel, giving careful attention to the outer edges of the wheel blades and the inner wall of the compressor housing. Contact marks on the housing from the wheel will appear as a burnishing on the inner wall. Grooves or gouges of any sort are cause for turbocharger replacement. Utilize supplemental lighting if needed to facilitate visual inspection. Refer to Figure 2, page 3.

4. If any anomalies are noted during the visual inspection, replace the turbocharger. If nothing appears in the visual inspection, the turbocharger is suitable to submit for a ferry permit. This will allow the aircraft to be relocated to qualified facility for turbocharger replacement.
