SUBJECT: Improve Dimmer Function of Panel Lights

MODELS/ SN M20U Ovation Ultra - 32-0002

AFFECTED: M20V Acclaim Ultra - 33-0002, 33-0003, 33-0005

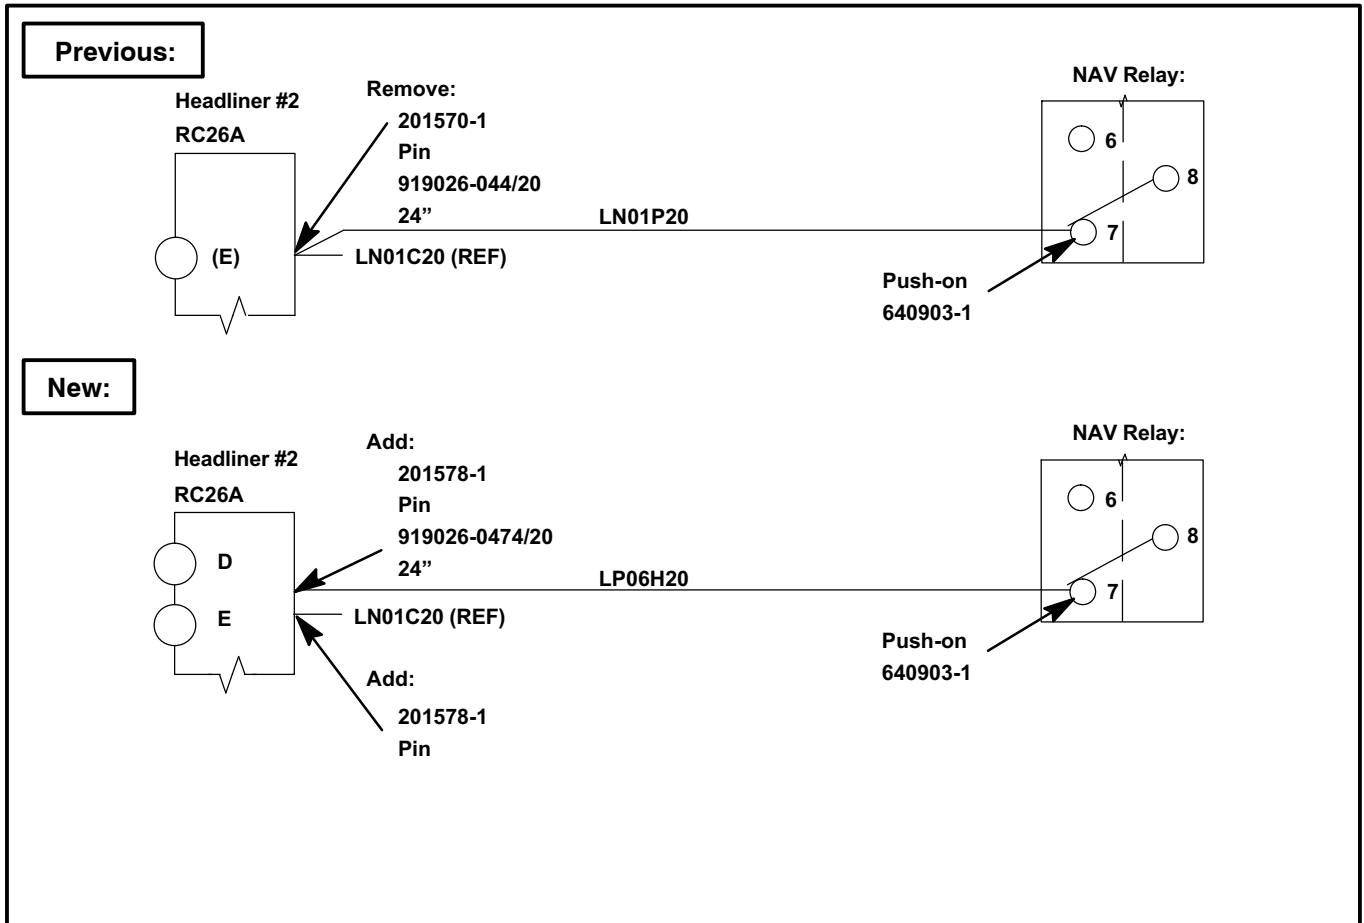
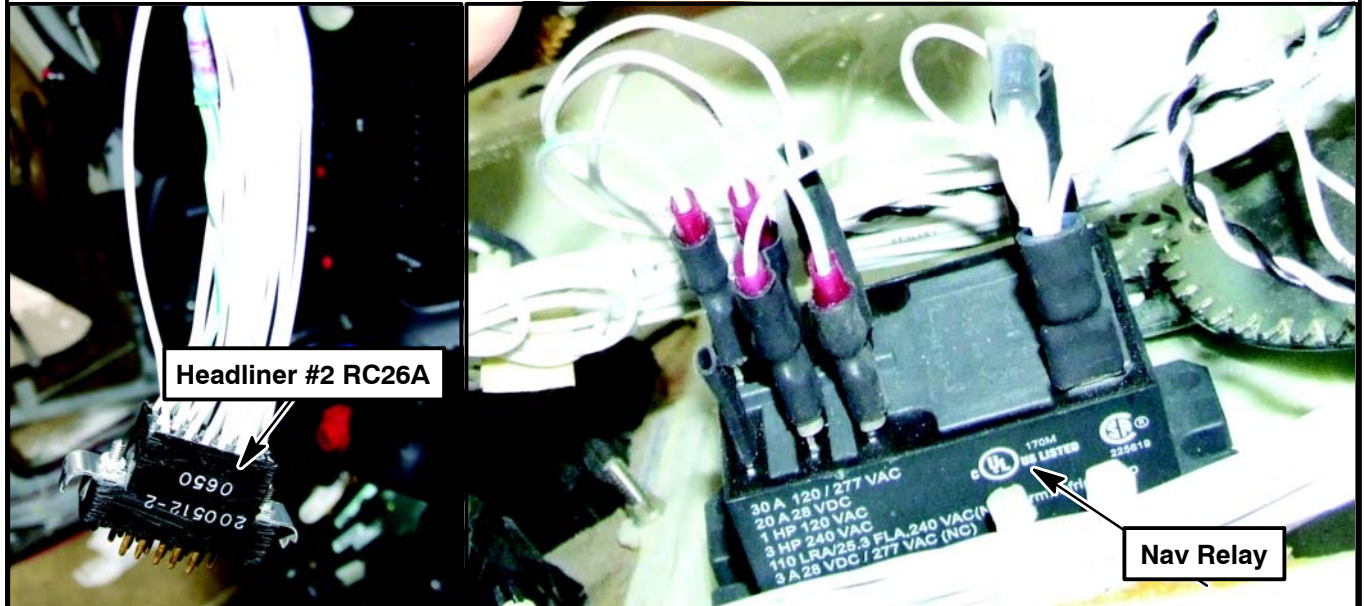
Figure SB M20-330-1 – Rewire Headliner #2

INTRODUCTION: Mooney International Corporation discovered the panel lights failed to power off when the NAV circuit breaker was pulled on M20U and M20V Ultra aircraft. The factory found the issue of a wire connected to the NAV circuit breaker that was feeding power to the panel lights. This service bulletin provides instructions on moving the relay power from the NAV circuit breaker to the panel light circuit breaker. No safety issue is connected with this service bulletin.

- 1.3. Above the PSU panel on the PSU wire harness, locate and disconnect the Headliner #2 PL/RC26A connectors. De-pin the LN01P20 and LN01C20 wires from pin E of the PSU Headliner #2 connector. Disconnect LN01P20 push-on terminal from the NAV Light Relay terminal #7. Remove and discard the 201570-1 pin that was de-pinned from pin E and the LN01P20 wire segment. See Figure SB M20-330-1.

- 1.4. Terminate a new 201578-1 pin onto the existing LN01C20 wire and reinsert the wire back into pin E of the PSU Headliner #2 connector. See Figure SB M20-330-1.

- 1.5. Terminate the 640903-1 push-on terminal onto the new LP06H20 36" 919026-044/20 wire segment and connect the terminal to the NAV Relay terminal #7 where the previous wire segment was removed. Route and secure the wire along the existing PSU harness to the Headliner #2 connector. Trim wire length as required, terminate a new 201578-1 pin onto this wire, and insert wire into pin D of the connector. See Figure SB M20-330-1.
