SUBJECT: Improve Headset Clarity in NXi Installed Aircraft

MODELS/ SN M20U Ovation Ultra - 32-0002
AFFECTED: M20V Acclaim Ultra - 33-0002, 33-0003, 33-0005

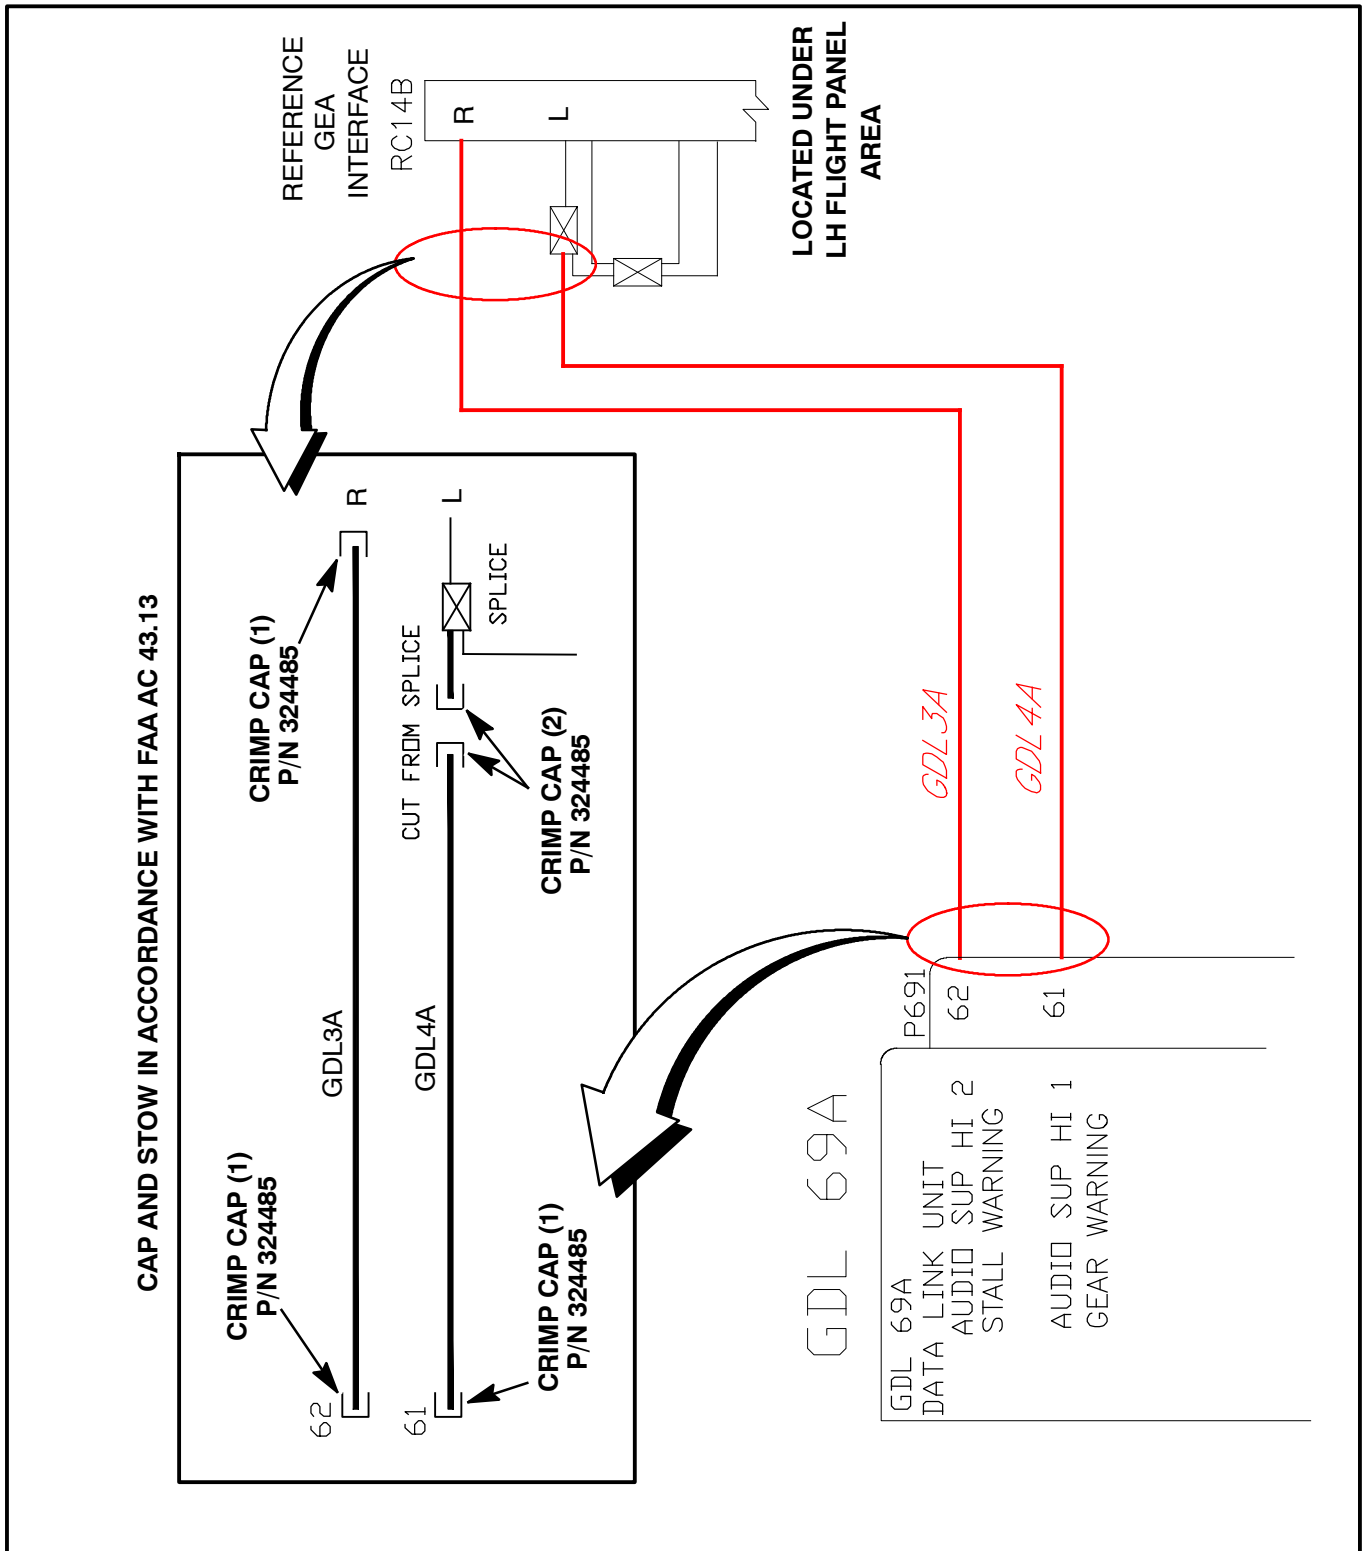
Figure SB M20-331-1 - GDL69A CAP AND STOW WIRE DIAGRAM

INTRODUCTION: It has been discovered in the field (one aircraft), when the stall vane is on the threshold of being activated, popping and crackling can be heard in the headsets on NXi installed Mooney M20U and M20V Ultra aircraft. Mooney Engineering concluded that 2 wires initially added into the configuration, were not required for new components of NXi Aircraft. This service bulletin provides instructions on disconnecting, capping and stowing the 2 extra wires. No safety issue is connected with this service bulletin.

- 1.4. Remove the connector P691 from the GDL back plate.
- 1.5. Locate wire GDL4A pin (#61) and remove from connector, refer to Figure M20-331-1.
- 1.6. Install crimp cap p/n 324485 and stow wire in accordance with FAA AC43.13, refer to Figure M20-331-1.

- 1.7. Locate wire GDL3A pin (#62) and remove from connector, refer to Figure M20-331-1.
- 1.8. Install crimp cap p/n 324485 and stow wire in accordance with FAA AC43.13, refer to Figure M20-331-1.

- 1.11. Locate wire GDL4A pin (#L), follow wire to wire splice, cut GDL4A wire allowing room to install crimp cap p/n 324485 to both cut ends, and stow wire in accordance with FAA AC43.13, refer to Figure M20-331-1.

- 1.12. Find wire GDL3A pin (#R) and remove from connector, refer to Figure M20-331-1.
- 1.13. Cut pin from wire, install crimp cap p/n 324485 and stow wire in accordance with FAA AC43.13, refer to Figure M20-331-1.
