SUBJECT: M20V ALTERNATOR WIRING, MOUNTING AND SECURITY
[Chapter 24 - ELECTRICAL POWER]

MODELS/ SN Mooney M20V - 33-0001 THRU 33-0018
AFFECTED:

SBM20- 340A Page 1 of 5

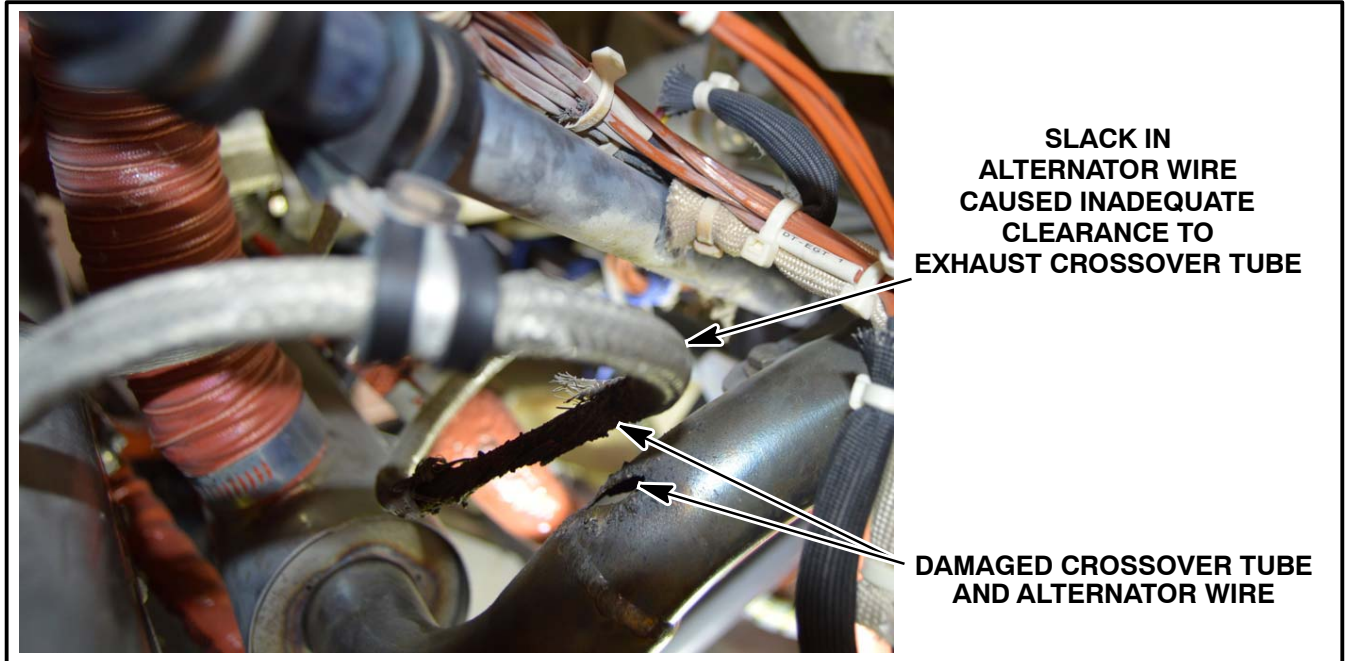
Figure SB M20-340-1 - EXISTING ALTERNATOR WIRE ROUTING

- 1.1. Turn master switch - OFF.
- 1.2. Remove top and bottom cowling, refer to Mooney Service and Maintenance Manual.
- 1.3. Locate upper alternator wire (refer to Figure SBM20-340-1). Inspect wire for any signs of damage; chafing, cracks in shielding, burnt spots, etc., if wire is damaged, contact MOONEY TECHNICAL SUPPORT support@mooney.com for a replacement wire.

- 1.4. Locate RH exhaust crossover tube. Inspect for damage; holes, cracks, etc., if damaged contact MOONEY TECHNICAL SUPPORT support@mooney.com for a replacement crossover tube, refer to Figure SBM20-340-1.

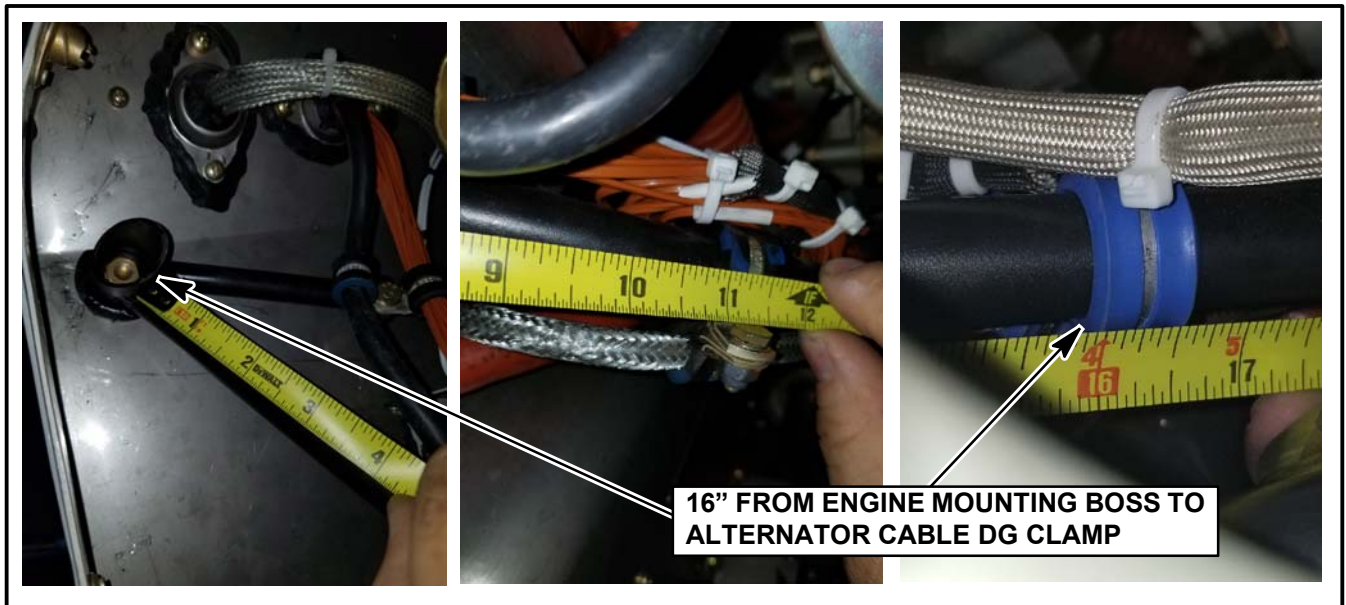
Figure SB M20-340-2 - ALTERNATOR WIRE ROUTING LOCATION (RH ENGINE MOUNT)

- 1.5. From RH engine mount mounting boss, measure along engine mount tube approx 16" to locate DG clamps mounting alternator field sensor wires to engine mount, refer to Figure SBM20-340-2.

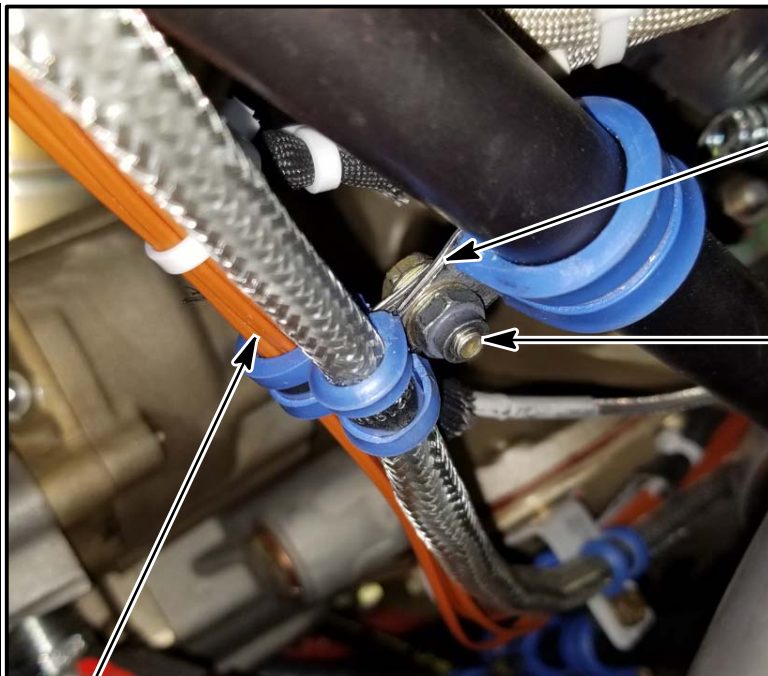
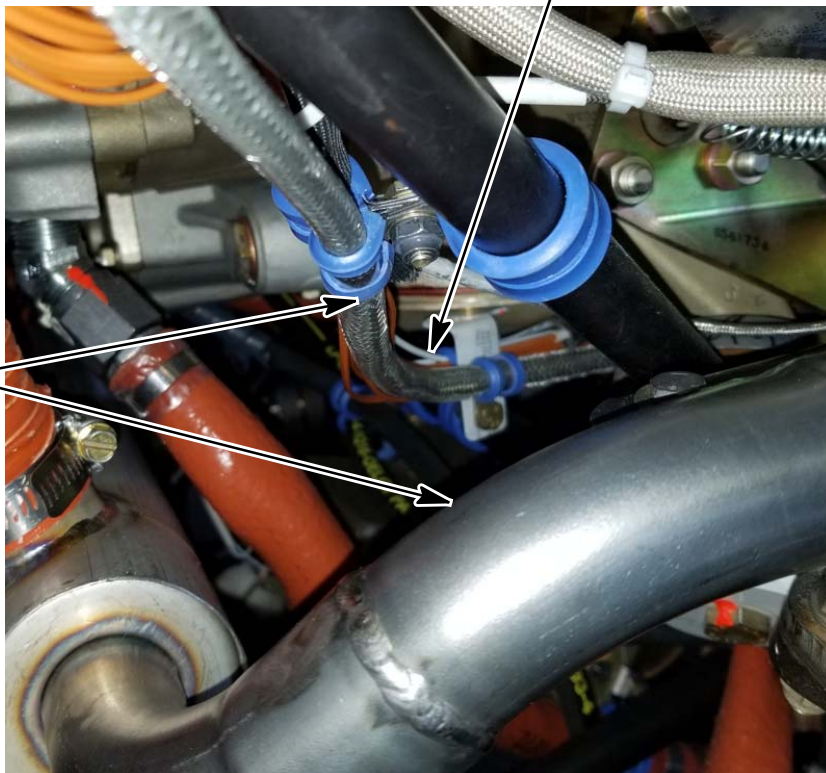
Figure SB M20-340-3 - NEW ALTERNATOR WIRE MOUNTING

REF:
STACK CLAMPS AS SHOWN

AN3-6A BOLT (1 QTY)
NAS1149F0363P WASHER (1 QTY)
MS21912WCJ6 CLAMP (1 QTY)
MS21045L3 NUT (1 QTY)
(TORQUE TO 20-25 In. Lbs)

NOTE:
KEEP ALTERNATOR WIRE TAUT
WHILE CLAMP IS TORQUED.

CAUTION:
ALLOW MINIMUM 2" SPACE
BETWEEN EXHAUST TUBE
AND MS21912WCJ6 CLAMP

- 1.6. Remove (1 qty) mounting bolt AN3-5A, (1 qty) NAS1149F0363P Washer, (1 qty) MS21045L3 Nut, connecting the large and small DG clamps together, refer to Figure SBM20-340-3.

- 1.7. Insert alternator wire into new MS21912WCJ6 Clamp, mount to existing DG clamps with new hardware; (1 qty) AN3-6A Bolt, (1 qty) NAS1149F0363P Washer, (1 qty) MS21045L3 Nut, stack clamps as shown in Figure SBM20-340-3.

- 1.8. Tighten stacked clamp assembly together and torque to 20-25 In. Lbs. Make sure slack in alternator wire stays taut along engine mount and keep minimum clamp height clearance as shown in Figure SBM20-340-3.
