SERVICE BULLETIN M20-282-A

Revised Date: September 22, 2004

SUBJECT: INSPECTION OF AVIONICS PRODUCTS, EATON, MOONEY OR VICKERS LANDING GEAR ACTUATORS [MAC P/N'S – 560254-501, -503, -505, AND –507; AVIONICS PRODUCTS AND EATON (OR VICKERS) P/N'S 102000-1, -2, -3, -4, -5, -7]
Revision A corrected return address for actuators to be reworked.

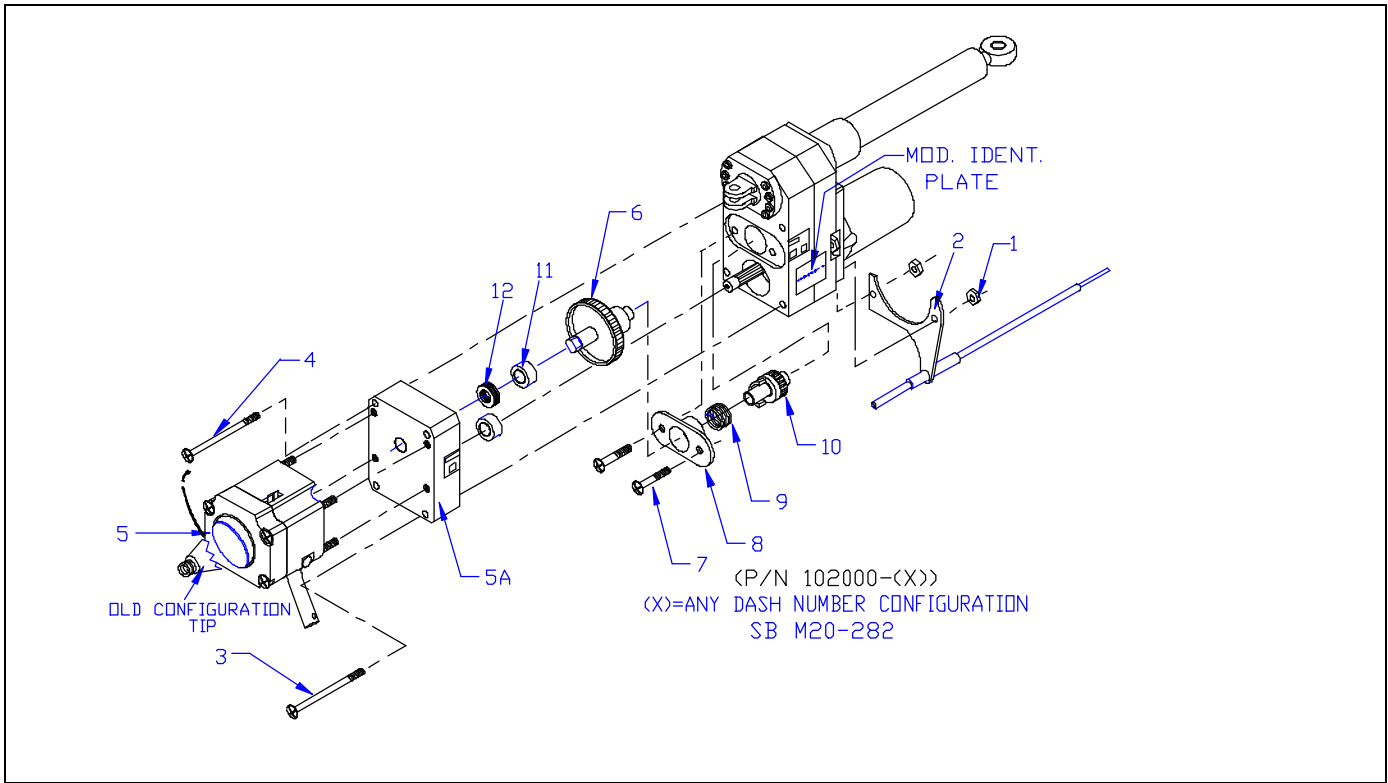
FIGURE SB M20-282-1

DISASSEMBLY OF ACTUATOR: [Reference **Figure SB M20-282-1**]

1. To avoid stripping screw heads, use impact screwdriver to break Loctite thread seals and remove two (2) long screws (Item 3) and two (2) short screws (4).
2. With razor or similar tool, slice through identification plate and remove recoiler assembly (5) and Clutch Housing Mount Assembly (5A).

3. Remove input gear assembly (6) from clutch housing (8) by pulling with slight force.
10. Remove two (2) screws (7) and remove clutch housing (8), "No-Back" Clutch Spring (9), and output gear assembly (10) from actuator body.
4. Remove "No-Back" Clutch Spring (9) from clutch housing using input gear assembly (6) as removal tool. Insert input gear assembly (6) into "No-Back" Clutch Spring from flanged end of housing (8). Remove "No-Back" Clutch Spring by rotating gear CCW and pulling slightly.

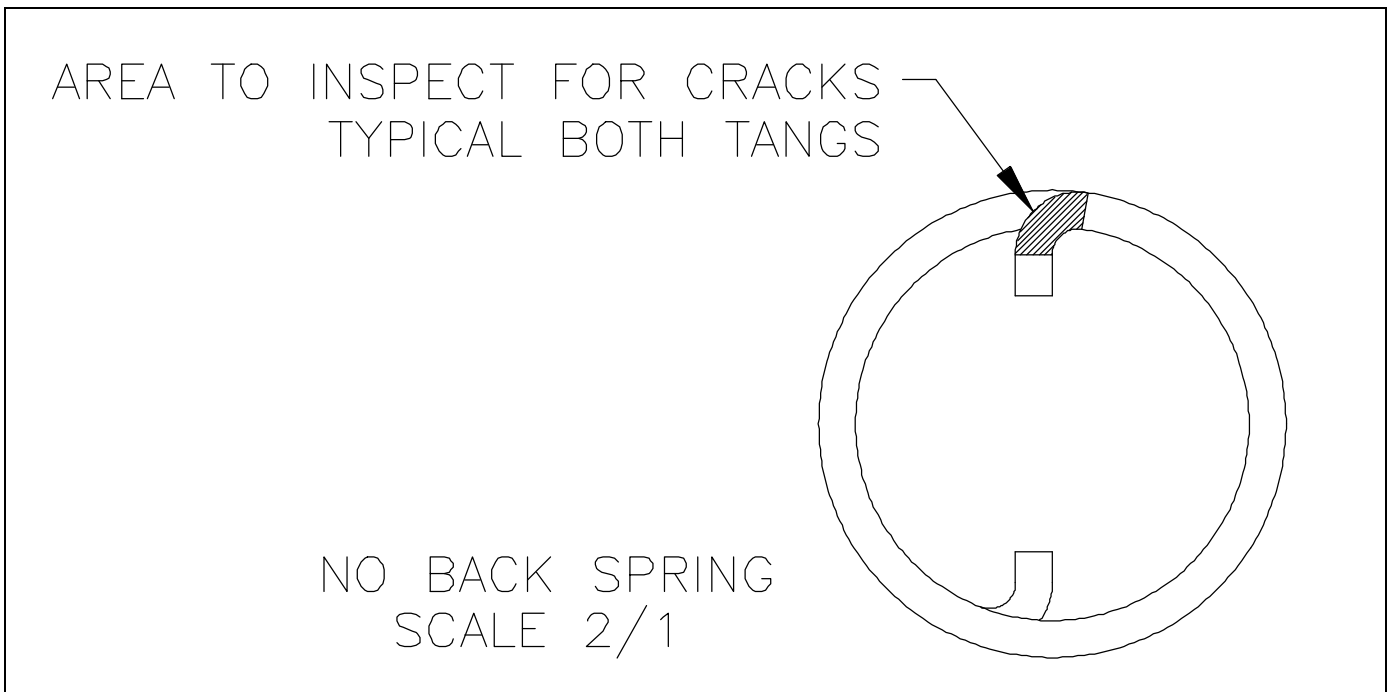
FIGURE SB M20-282-2

1. The inspection will require the use of a magnifying glass in the 16X to 40X power range. This inspection should be conducted in a clean room environment with good lighting.
2. If a maintenance shop has any "No Back" Clutch Springs in inventory, it is recommended that these also be visually inspected by qualified shop QA personnel in accordance with the criteria of Step 3 below and tagged as approved with a NOTE or Date Stamp documented by the maintenance shop QA personnel.
3. All clutch springs, either from the actuator or from shop inventory, must be visually inspected at the bend radius of both "tang ends" for evidence of any type of crack or stress fracture in the outboard, bend radius [reference **Figure SB M20-282-2** for additional inspection criteria]

4. If any evidence of a crack or stress is found, the clutch spring must be discarded.
5. An approved, new clutch spring that has been inspected and documented as inspected and approved either by a maintenance shop's QA personnel per Step 2 above or a clutch spring received from Mooney Airplane Company, Inc., which has been inspected by MAC Quality Inspection Department personnel are eligible for installation into the actuator removed from the aircraft.
