Louis Schreiner Field
Kerrville, Texas 78028

SERVICE BULLETIN M20-285

- SUBJECT:** STABILIZER TRIM TORQUE TUBE SCORING
- MODELS/ S/N** MOONEY M20K, S/N 25-0002 thru 25-2032
- AFFECTED:** MOONEY M20L, S/N 26-0001 thru 26-0041
MOONEY M20M, S/N 27-0002 thru 27-0328
MOONEY M20R, S/N 29-0001 thru 29-0332, 29-0334 and 29-0338
MOONEY M20S, S/N 30-0001 30-0065

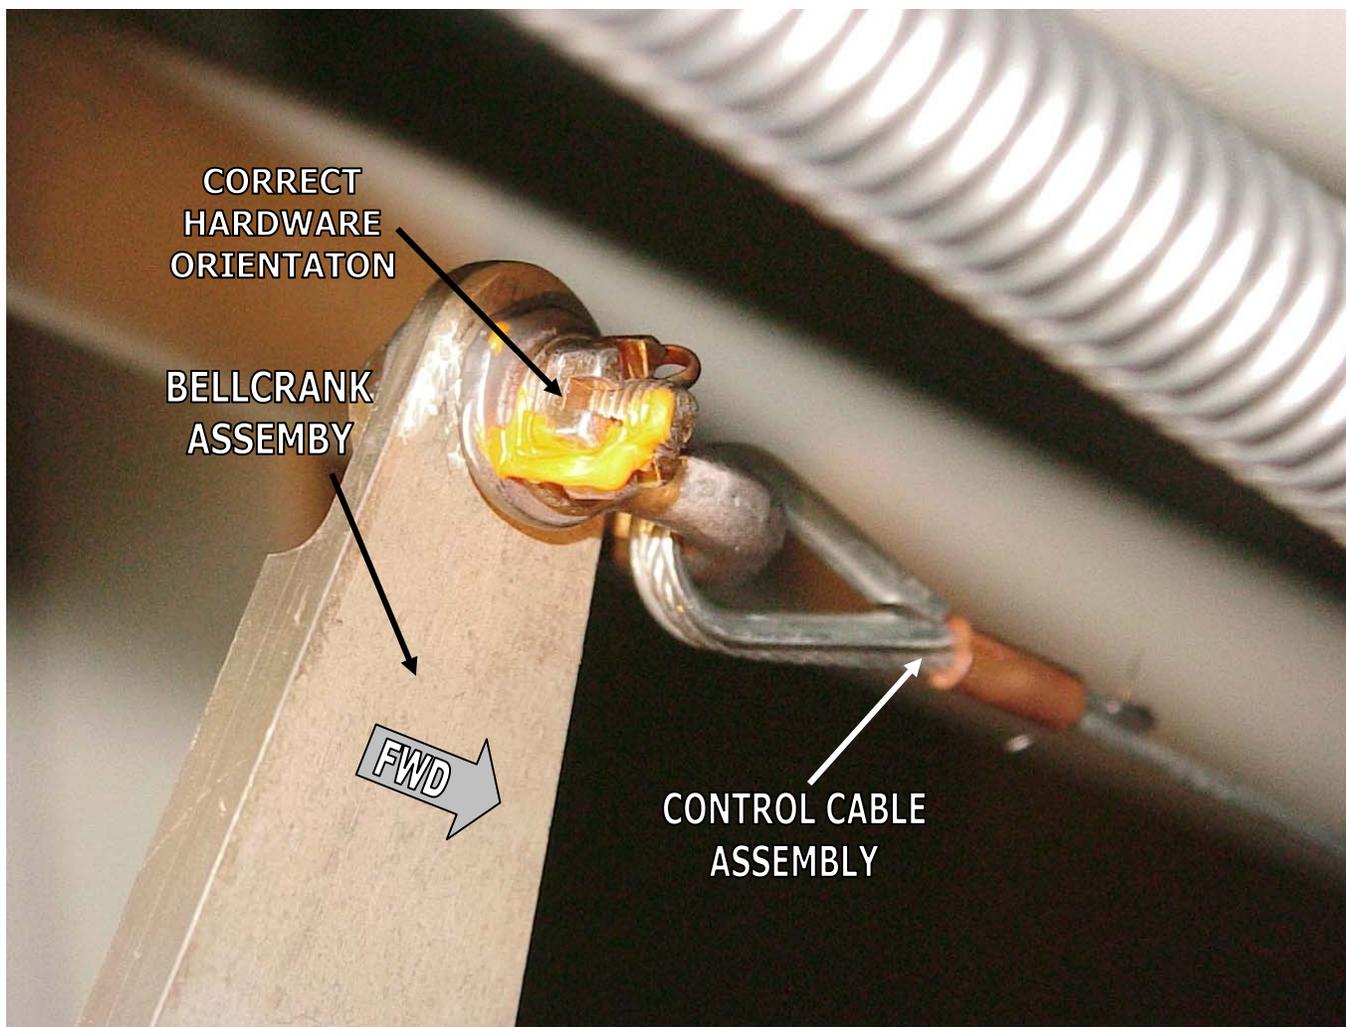
Figure SB M20-285-1

- INTRODUCTION:** There has been a report that the attaching hardware (bolt, washers (4), nut and cotter pin), attaching the Down Spring Control Cable Assembly (710081-501) to the Bellcrank Assembly (710076-501) in the aft tailcone, may have been installed in reverse direction of engineering design.
The threaded end of the bolt should be inserted from aircraft left side to aircraft right side; threaded end pointing in the outboard direction away from the Stabilizer Trim Torque Tube (aircraft centerline).
An incorrect hardware installation orientation may cause scoring of the Stabilizer Trim Torque Tube as a result of the bolt thread contacting the Stabilizer Trim Torque Tube surface during Horizontal Stabilizer trimming movement. Scoring of the Stabilizer Trim Torque Tube could result if attaching hardware is installed incorrectly by maintenance personnel.

2. Locate Bellcrank and verify orientation of mounting hardware at Down Spring Control Cable Assembly attaching point (ref. Figure SB M20-285-1).
 3. If hardware is installed in the proper orientation, reinstall removed Inspection Cover.

6. Temporarily secure Control Cable Assembly to prevent it from falling into Tailcone cavity. Remove existing cotter pin, nut, washers and bolt and discard. Reattach Control Cable Assembly with new hardware (Kit M20-285-1) in correct orientation. Insert bolt with washer from inboard to outboard side of the aircraft. Install washer, castellated nut and cotter. Remove temporary material used to secure Control Cable during procedure. Apply Torque Seal to attaching hardware.

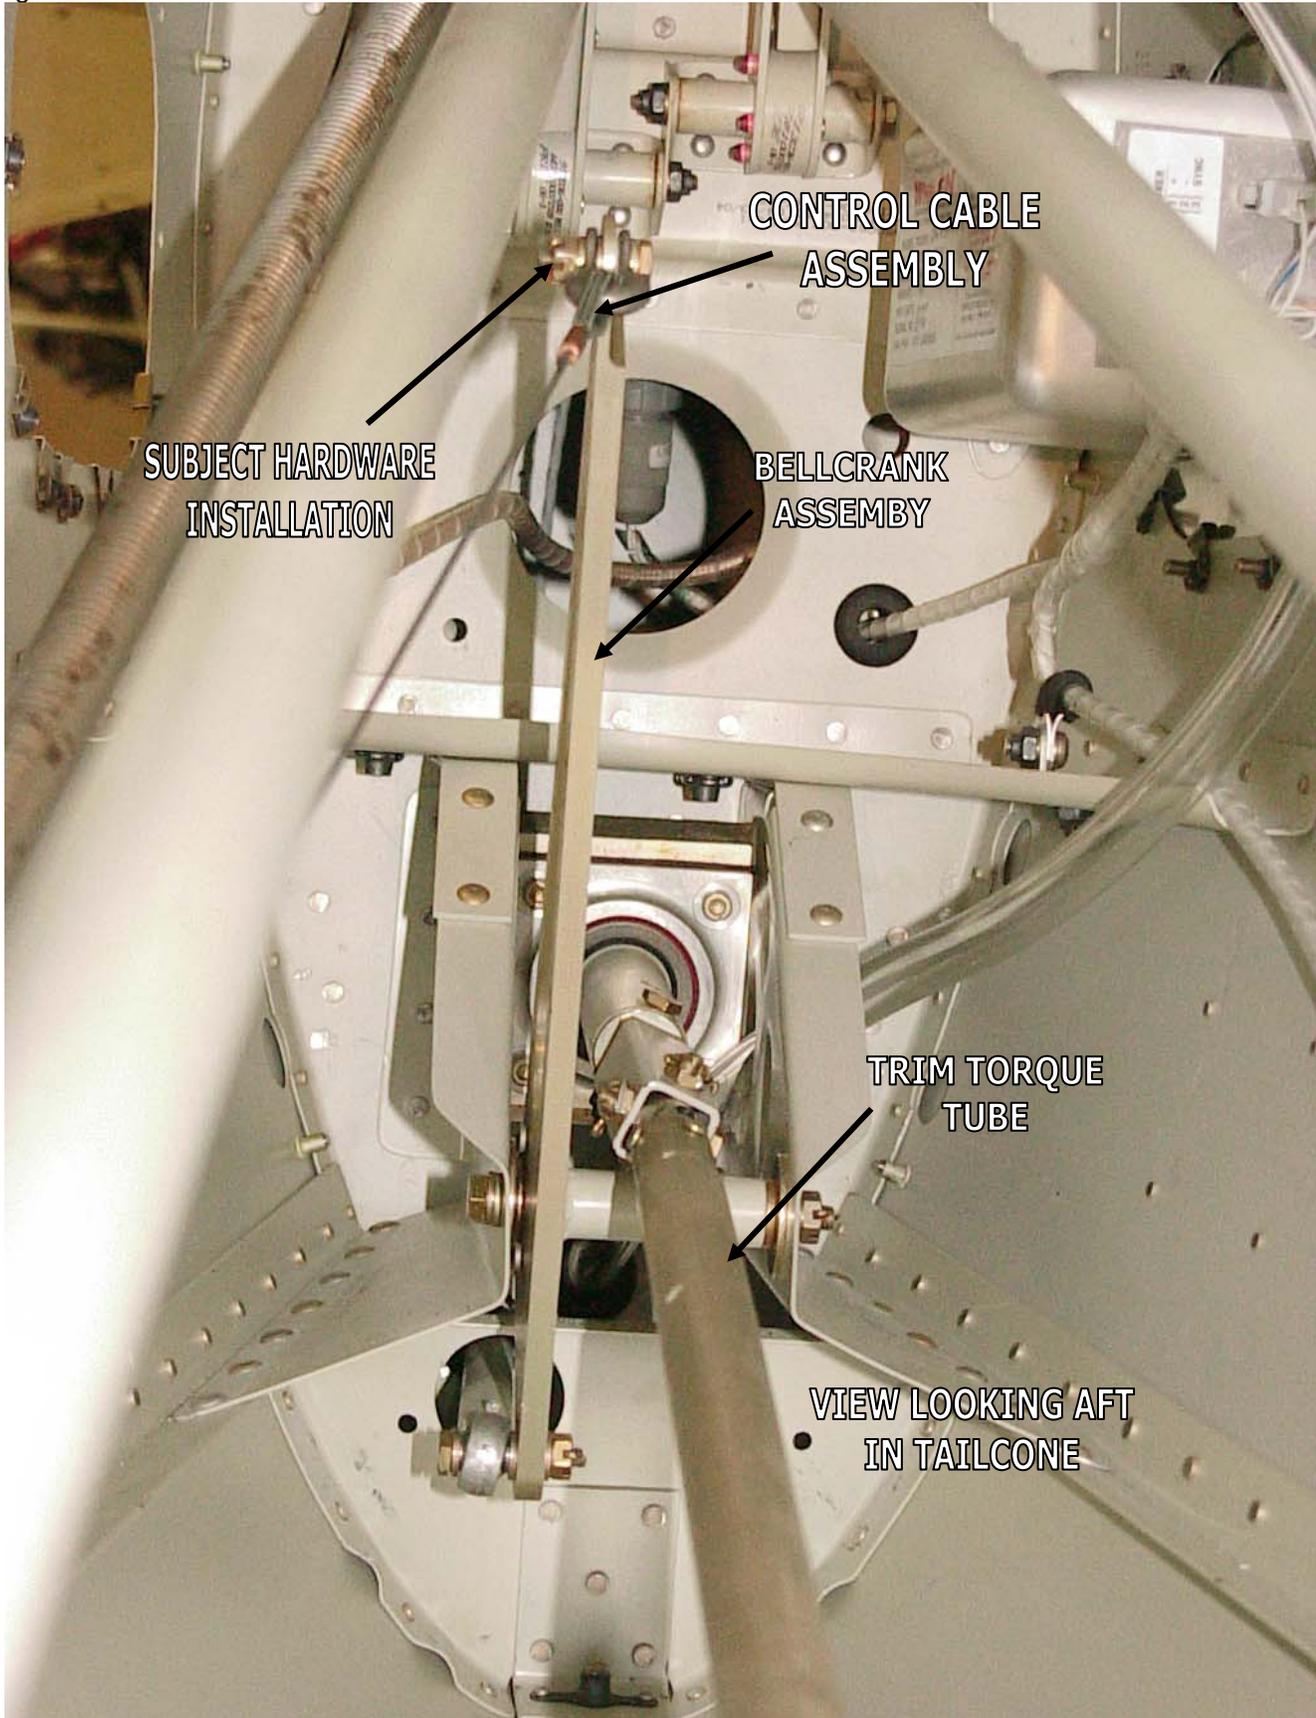
Figure SB M20-285-2

8. Locate and inspect existing Stabilizer Trim Torque Tube for scoring damage created by interference with the Down Spring Bellcrank/Cable attach bolt's threaded end. If scoring has occurred, the Stabilizer Trim Torque Tube (ref. Figure SB M20-285-2) will require replacement.
