MOONEY AIRCRAFT INC.
KERRVILLE, TEXAS

SERVICE LETTER 20-4
SERVICE BULLETIN M 20-4

SUBJECT: Carburetor Float Height

MODELS AFFECTED: M-20 Serial Nos. 1002 thru 1008, 1010 thru 1026

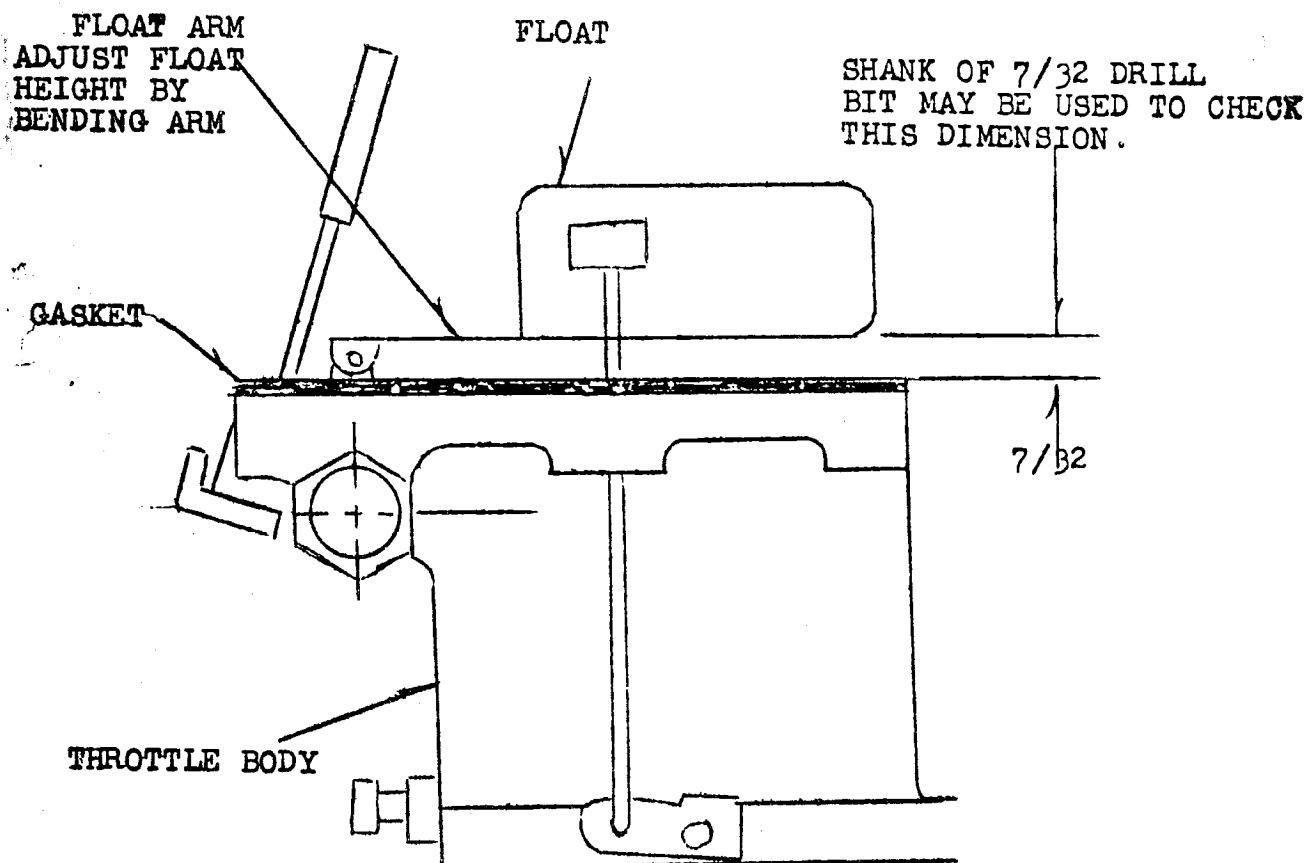
Figure 1.

Upon examination of a number of carburetors it was found that the float height was incorrect. This situation causes engine roughness. All carburetors are now being inspected by Mooney Aircraft for proper float height before installation.

1. Having removed the carburetor from the engine detach the throttle body from the bowl assembly.
2. Inspect and set the float height if necessary as shown in figure 1.
