Service Letter

NUMBER: 20-103

SUBJECT: Modification of Instrument Panel & Manifold Pressure System

MODELS AFFECTED: M20C, Serial Numbers 1852, 1940 through 2575
M20D, Serial Numbers 1, 101 through 190

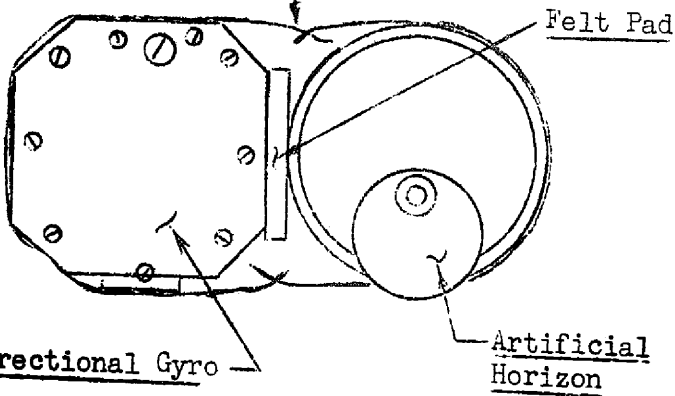
TY-27 Nylon Straps (2)
Joints Between Instruments as Shown

View Shown Looking at Back of Instrument Cases

6. Included in the service letter kit are two nylon straps and one felt pad. Install the pad between the directional gyro and the artificial horizon instrument cases and secure the two instruments together as shown in Detail D on Page 2 (located on Page 2 top).
