This Service Letter reidentified as  
Service Bulletin M 20-125  
per Service Instruction M20-15.

**SUBJECT:** Fuel Line from Electric Boost Pump to Fuel Fitting Box

**MODELS AFFECTED:** M20C, 2742, 2807 - 2924; M20D, 252; M20E, 400, 470 - 591

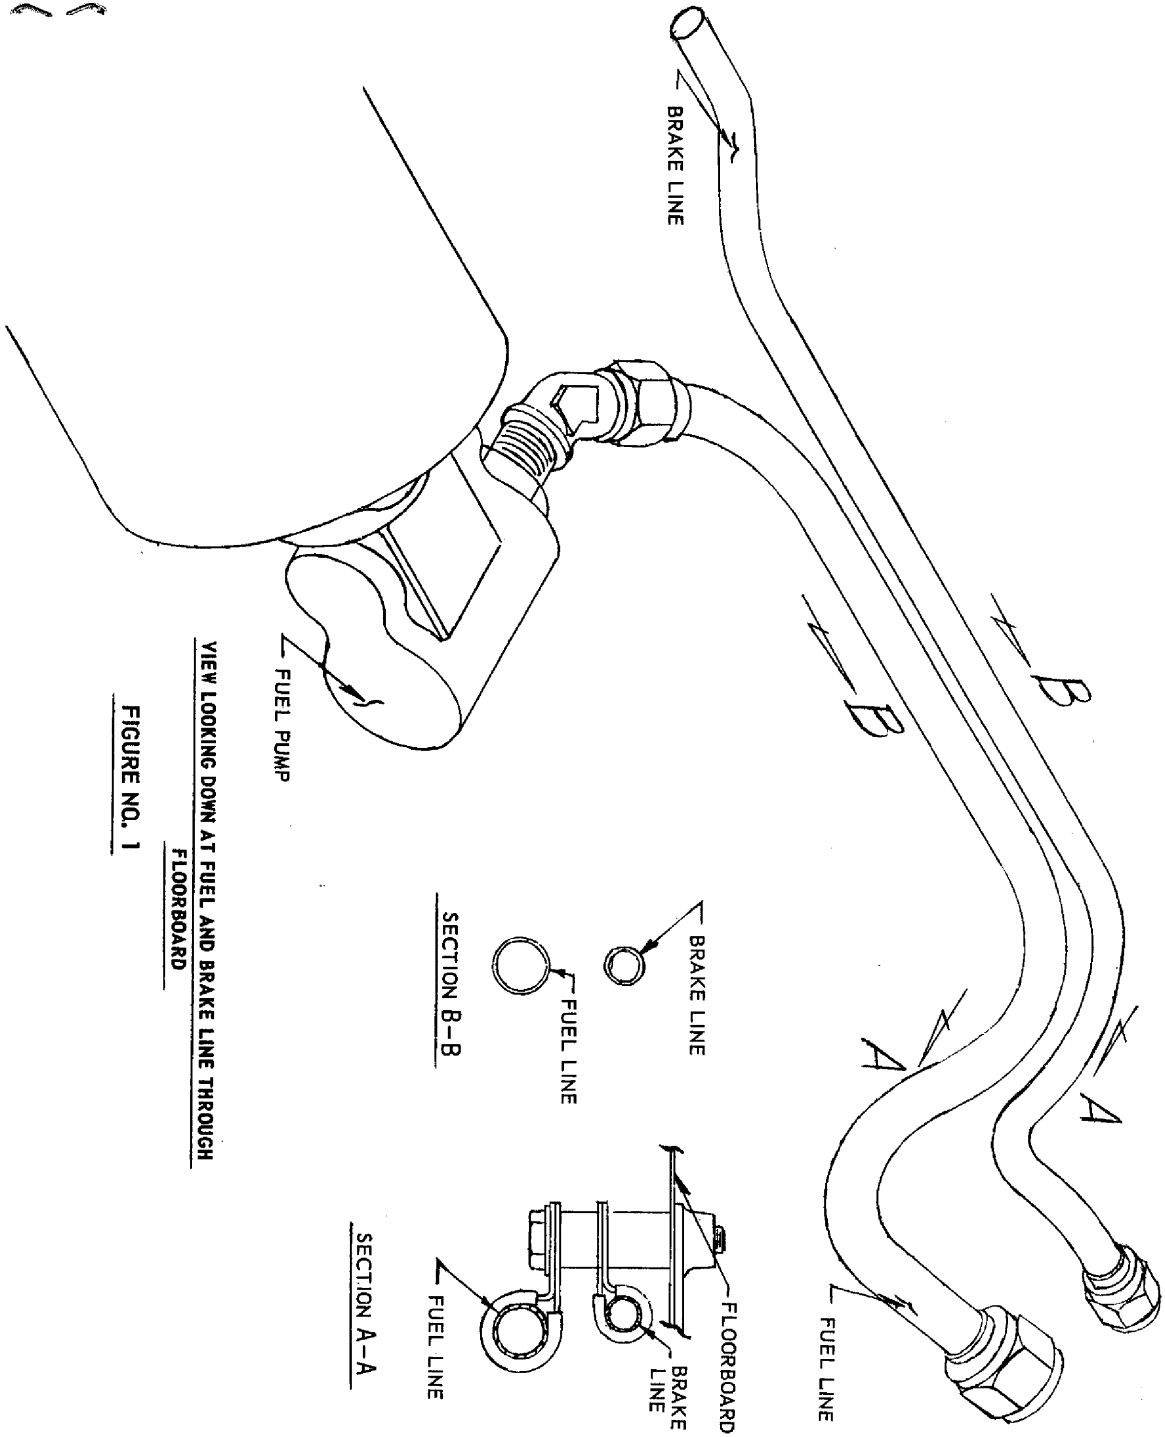
FIGURE NO. 1

**INTRODUCTION:** It will be necessary for the owners of the above mentioned aircraft to reroute the fuel line from the electric boost pump to the firewall fitting box.

VIEW LOOKING DOWN AT FUEL AND BRAKE LINE THROUGH FLOORBOARD

1. Remove the left hand augmentor cavity.
2. Remove fuel line from electric fuel pump to firewall fitting box.
3. Remove brake line from outboard left hand master cylinder to tee on firewall structure.
4. Reinstall brake and fuel lines, routing the fuel line under the brake line taking care to have no low spots in the fuel line (see Figure 1).
5. Bleed brakes; pressure check fuel and brake lines.
6. Reinstall left hand augmentor cavity.
