**SUBJECT:** Magnetic Compass Interference

**MODELS AFFECTED:** M20B 1701 thru 1851, 1853 thru 1939  
M20C 1852, 1940 thru 3286  
M20D 1, 101 thru 259  
M20E 101 thru 950

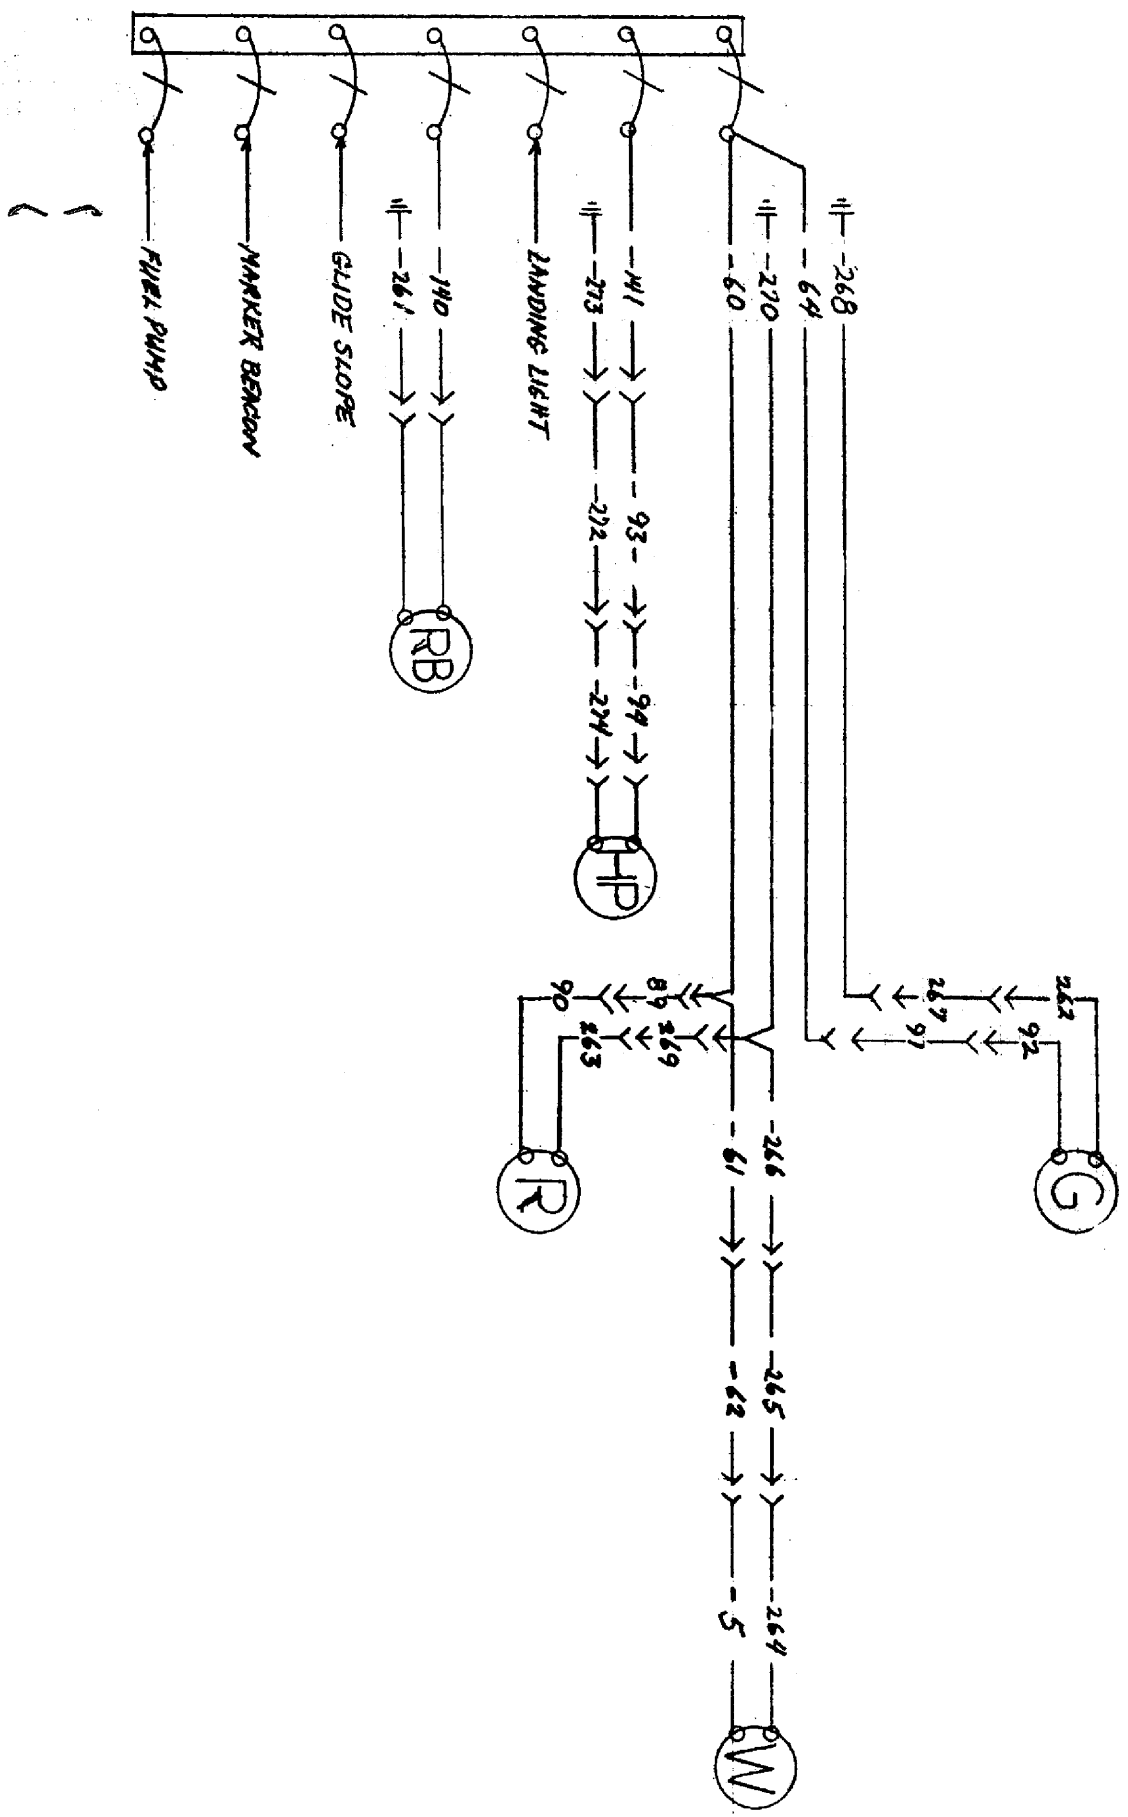
WIRING SCHEMATIC FOR SERVICE LETTER NO. 20-134

**INTRODUCTION:** The compass error induced by using the airframe as a ground return path for the navigation lights, rotating beacon, and heated pitot may be reduced by the addition of a ground wire twisted together with the supply wire in each circuit.

**INSTRUCTIONS:** Remove necessary upholstery, inspection plates, access panels and fairings to provide access to the navigation light wires. Remove all navigation light wires from switch to lights. Using the attached schematic, install SLKit 20-134-1 wiring taking care not to displace grommets from wing ribs and fuselage bulkheads when pulling in new wires. Attach wires number 60 and 64 to switch and ground wires number 268 and 270 to the nearest instrument panel mounting bolt below switch. Solder wires number 90, 92 and 5 to the center contact of their respective navigation lights and solder wires number 262, 263, and 264 to the outside shell of lights. Check operation of lights.

On aircraft having rotating beacons installed, remove wiring from switch to light and remove ground wire from beacon if installed. Install SL Kit 20-134-2 wiring. Connect wire number 140 to switch and positive terminal on beacon. Ground wire number 261 to instrument panel mounting bolt nearest switch and connect to beacon negative terminal. Check operation.

On aircraft having heated pitot installed, remove wiring from switch to pitot head. Cut off terminal from pitot ground and install knife disconnect on wire. Install Service Letter Kit 20-134-3 wires using attached schematic. Connect wire number 141 to switch and ground wire number 273 on nearest instrument panel mounting bolt. Polarity at pitot head is not critical. Check operation.
