MOONEY AIRCRAFT INC.
KERRVILLE, TEXAS

SERVICE LETTER 20-14

SUBJECT: Landing Gear Inspection

MODELS AFFECTED: M-20 Serial Numbers 1009, 1016, 1026 thru 1044

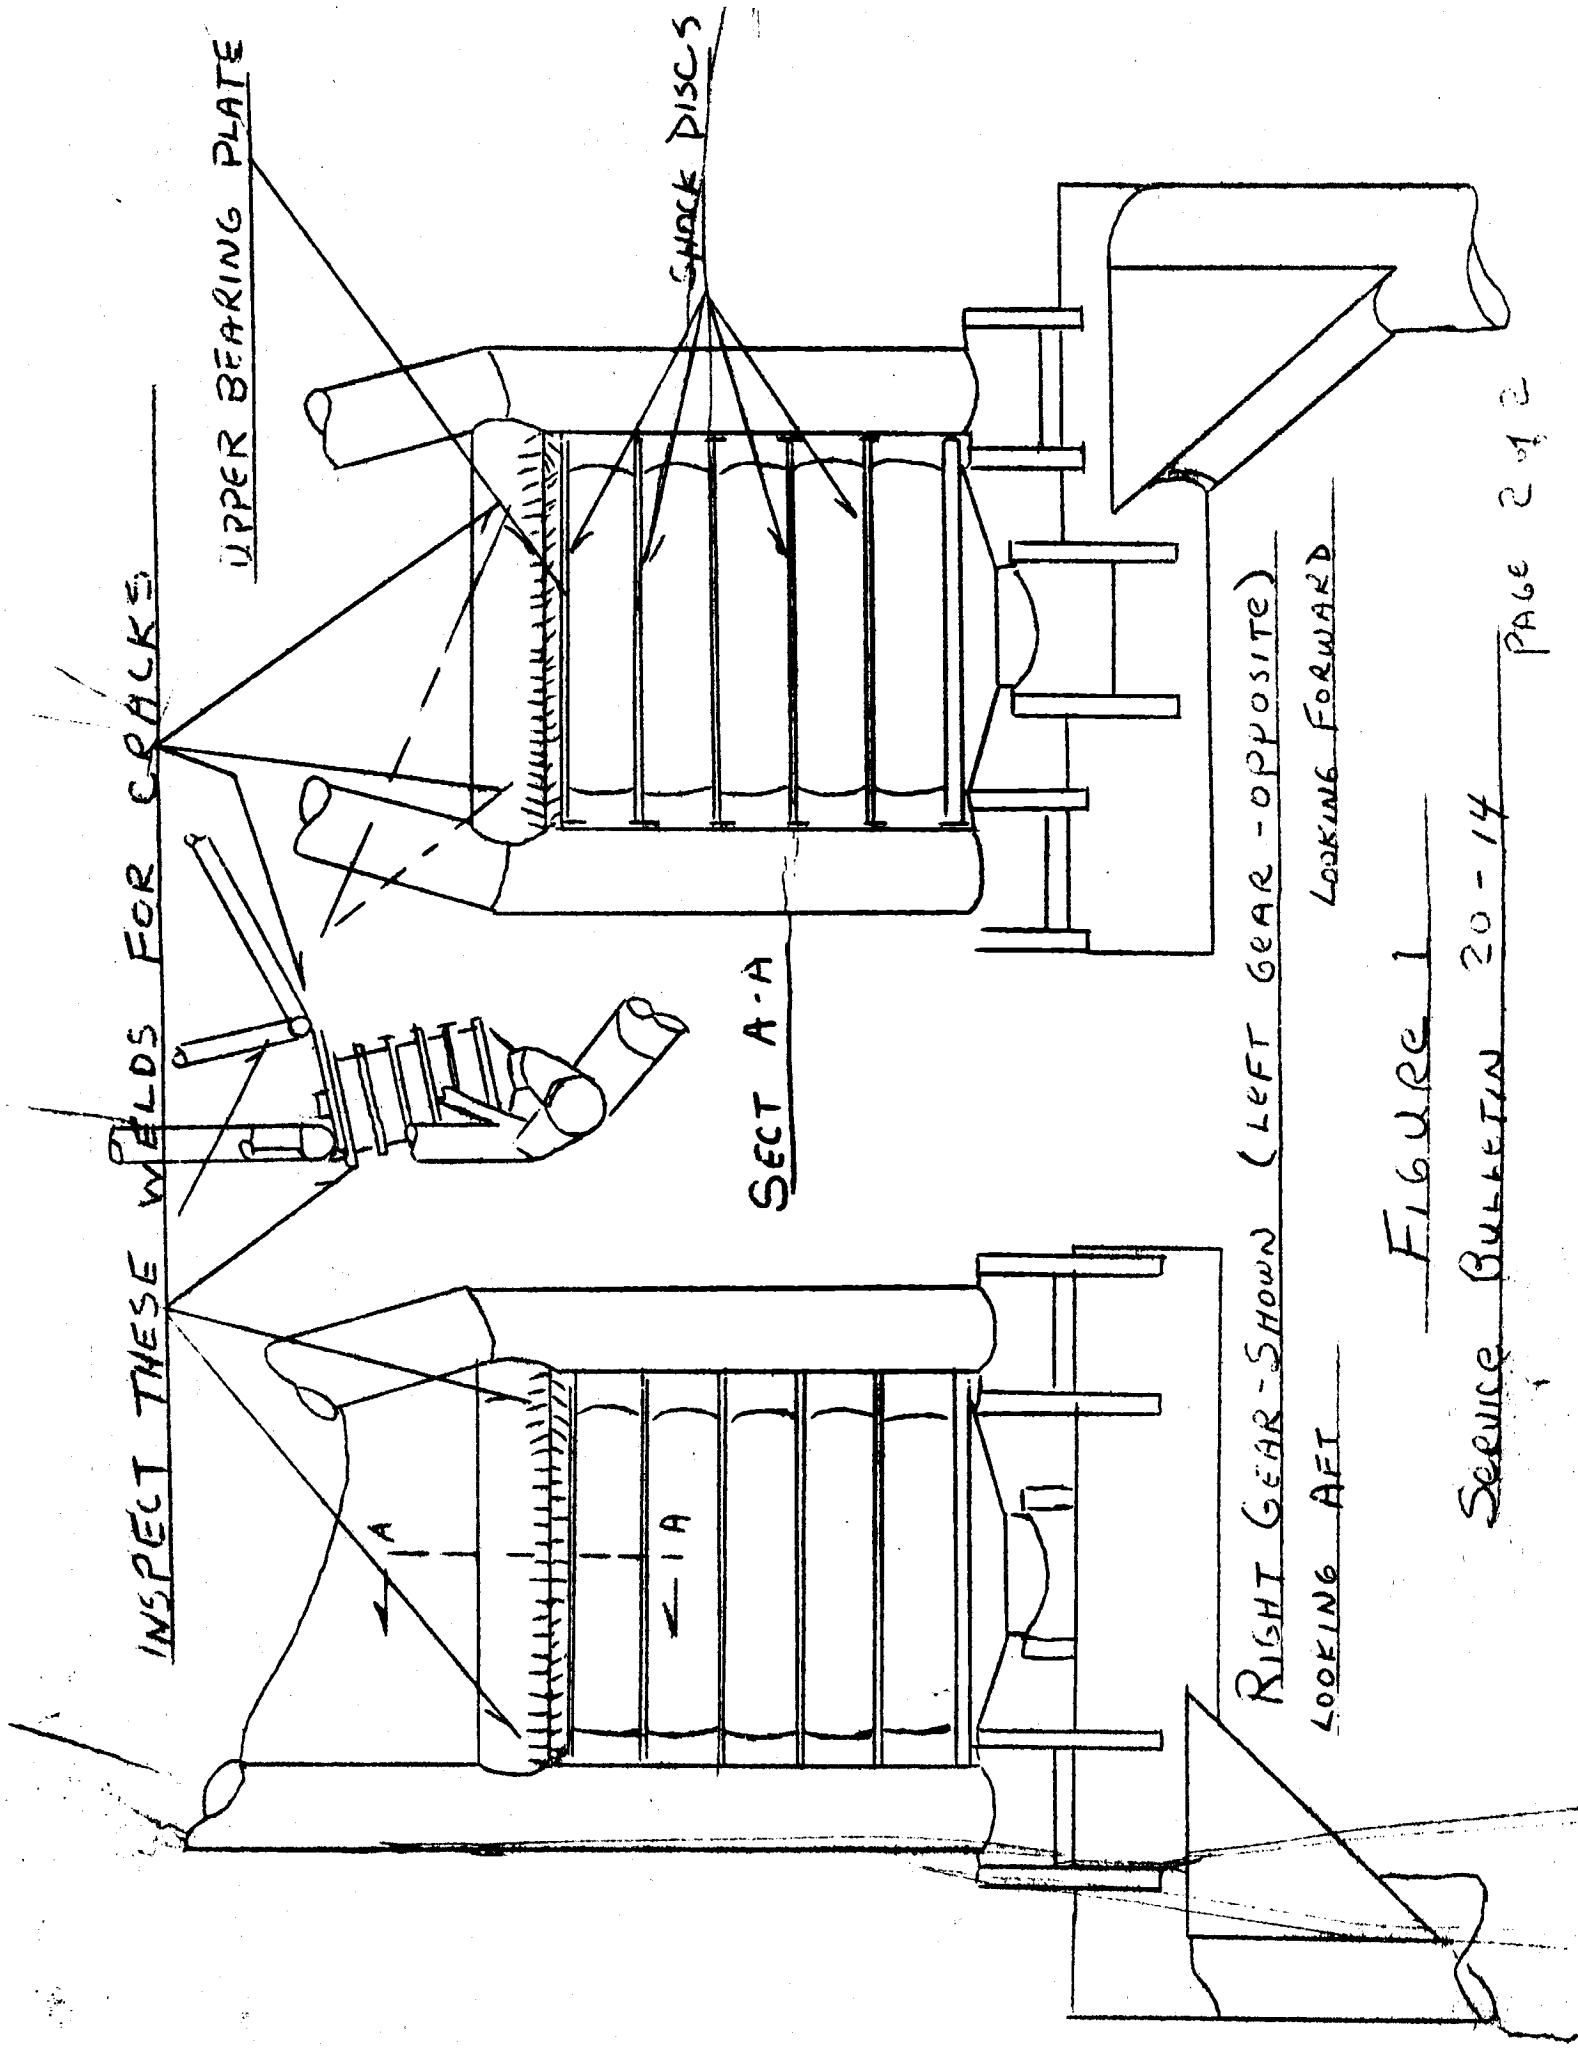
FIGURE 1

There have been several occurrences of failure of the weld joining the upper shock disc bearing plate (see Fig. 1) to the main landing gear structure on the airplanes prior to serial No. 1026. This joint has been strengthened with additional weld and the airplanes listed in the heading have this later type gear. So far there have been no failures in this group. However a failure of this point will allow the wheel and spindle to rotate freely making it difficult or impossible to retract and extend the gear and leaving it subject to malfunction under landing loads. In view of the above it will be necessary to inspect these welded joints (as shown in Fig. 1) at ten hour intervals and oftener if gear is subject to rough use. If cracks are found the airplane should be grounded and the factory notified immediately.

INSPECT THESE WELDS FOR CRACKS
