(This Service Bulletin is FAA D.O. Authorization SW-1 Approved)

SUBJECT: Replacement of Seat Release Tube Attachment Bolt

MODELS AFFECTED: M20F S/N 670001 thru 670175

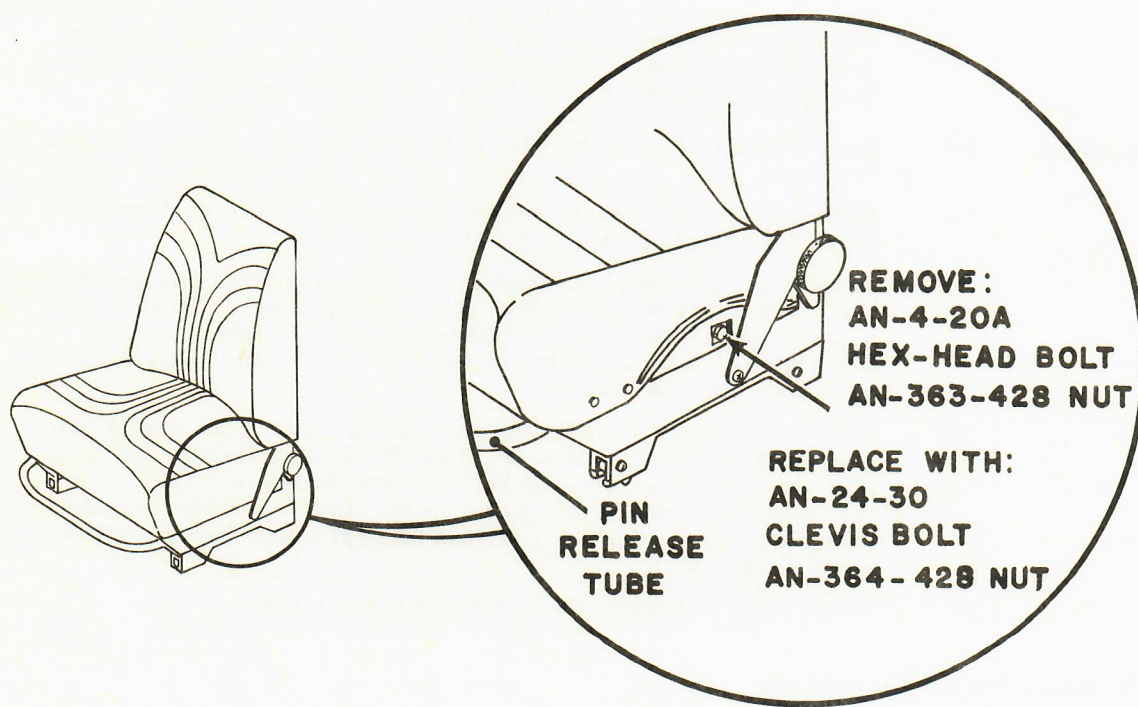
FIGURE 1

INTRODUCTION: On the aircraft above, the front seat pin release tube is attached on both sides with an AN-4-20A hexagon head bolt. The head of this bolt can sometimes cause the seat bottom upholstery cover to protrude enough that the cover can be cut or worn by the seat back support plates when the seat back is rotated forward. If this problem occurs, the AN-4 bolts can be replaced with AN-24 clevis bolts as described below.

- INSTRUCTIONS:
- (1) Remove both front seats from the airplane. Remove the seat belts from the seats.
 - (2) Remove the bottom cover upholstery clips on both sides as shown in figure 1 to provide access to the AN-4 bolts.

- (3) Remove the AN-4-20A bolts (both sides) and AN 363-428 nuts and replace with AN-24-30 clevis bolts and AN-364-428 nuts. Cut away any canvas material from under the bolt head, and do not use a washer under the bolt head so that the installed bolt will bear directly on the metal web retention strap.

- (4) Replace upholstery using the original plastic clips. If the original upholstery cover has been damaged, it can be replaced from Mooney Spare Parts stock. Replace the seat belts, routing the belt webs outside of the seat back support plates except for the pilots inboard belt which is routed between the support plates and the seat bottom for trim control wheel clearance.
