SERVICE BULLETIN

SUBJECT: AUTOPILOT CONTROL WHEEL DISENGAGE SWITCH

**MODELS
AFFECTED:** M20J S/N 24-0063, 24-0068, 24-0077, 24-0080,
24-0084, 24-0088, 24-0091 and 24-0093

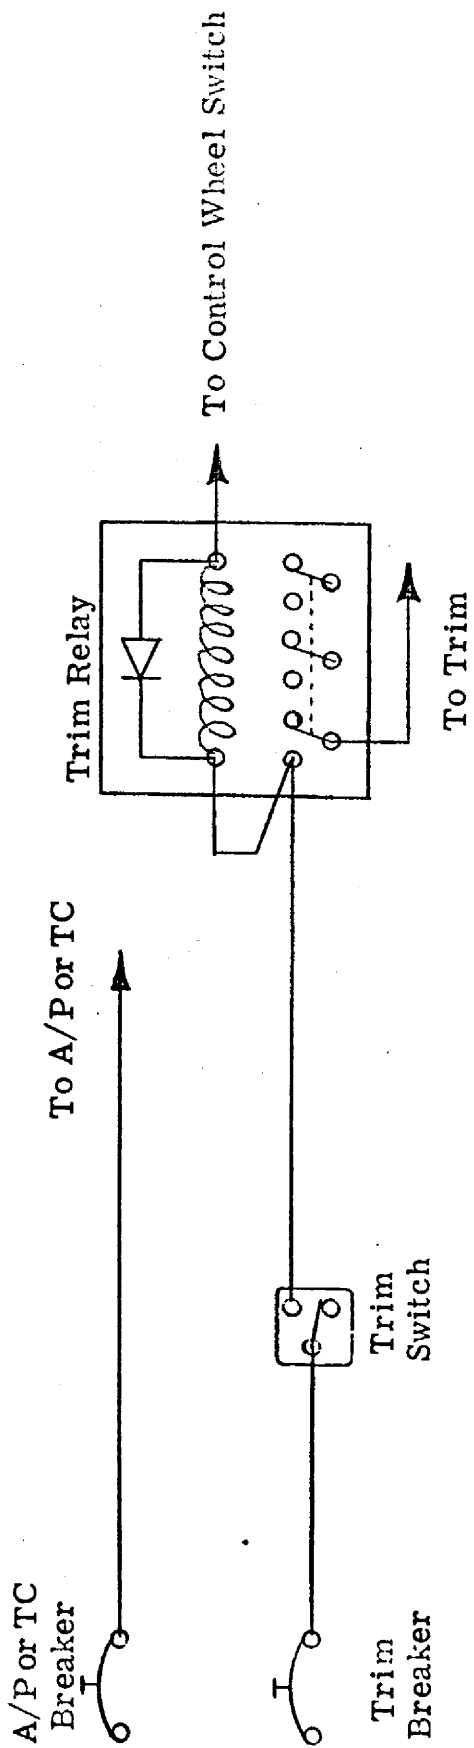
FIGURE 1

INTRODUCTION: In some instances, when an electrical elevator trim system has been installed, the control wheel disengage switch becomes inoperative if the "TRIM" circuit breaker is tripped. This can be corrected by a minor wiring change.

1. Disconnect the power lead from the disengage relay coil (located forward of right side of instrument panel on electrical junction plate). (See Figure 1 schematic).
2. Install diode assembly per Figure 2 schematic using window splices supplied.
3. Check operation of control wheel switch alternately pulling "Autopilot" (or Turn Coordinator if Brittain PC is installed) and "TRIM" circuit breakers. Control wheel switch should interrupt trim function when autopilot breaker is pulled and interrupt autopilot function when trim breaker is pulled.
4. Fill out enclosed compliance card and return.
