MOONEY AIRCRAFT INC.

SERVICE LETTER 20-20

SUBJECT: Proper use and adjustment of vernier throttle and propeller governor control (Shakespeare 3A1529)

MODELS AFFECTED: M20 & M20A Serial Numbers 1002-1589

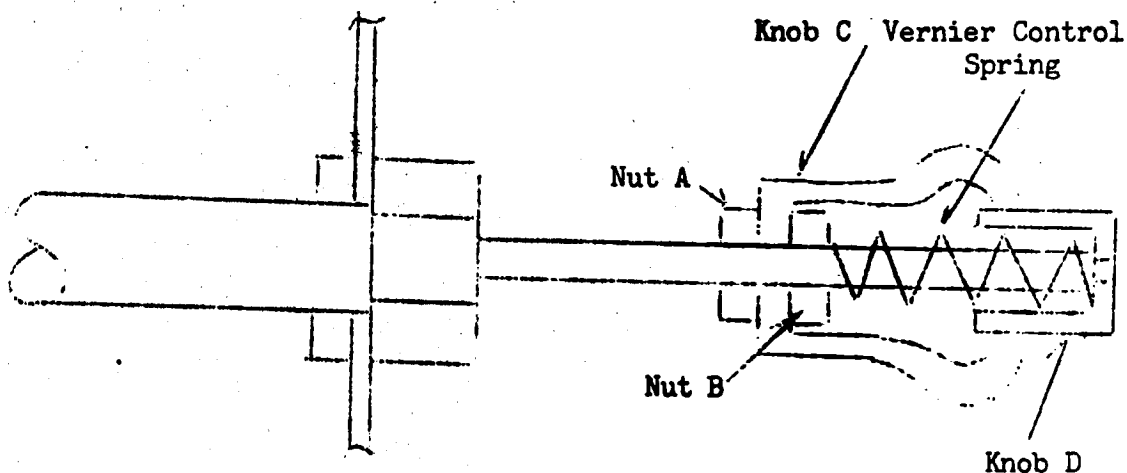
When the control is at either fore or aft limit, the vernier adjustment should not be turned past the point where resistance is felt. When the end of the vernier adjustment travel is reached, knob C should be turned back in the opposite direction approximately at $\frac{1}{4}$ turn. This will eliminate the possibility of knob D becoming jammed.

In turning the vernier control it is possible (if nut B is loose) to move knob C far enough aft to hold knob D in the locked position. This condition may be corrected as follows:

1. Remove knob D and spring.
2. Tighten nut A all the way forward on the control shaft.
3. Tighten nut B with socket wrench.
4. Replace spring and knob D.
