MOONEY AIRCRAFT INC.
KERRVILLE, TEXAS

SERVICE LETTER 20-21

DATE: 2-21-57
SUBJECT: Inspection of P/N 5035 for cracks.
MODELS AFFECTED: All Airplanes
TIME OF COMPLIANCE: Immediately and at subsequent periodic 25 hour inspections.

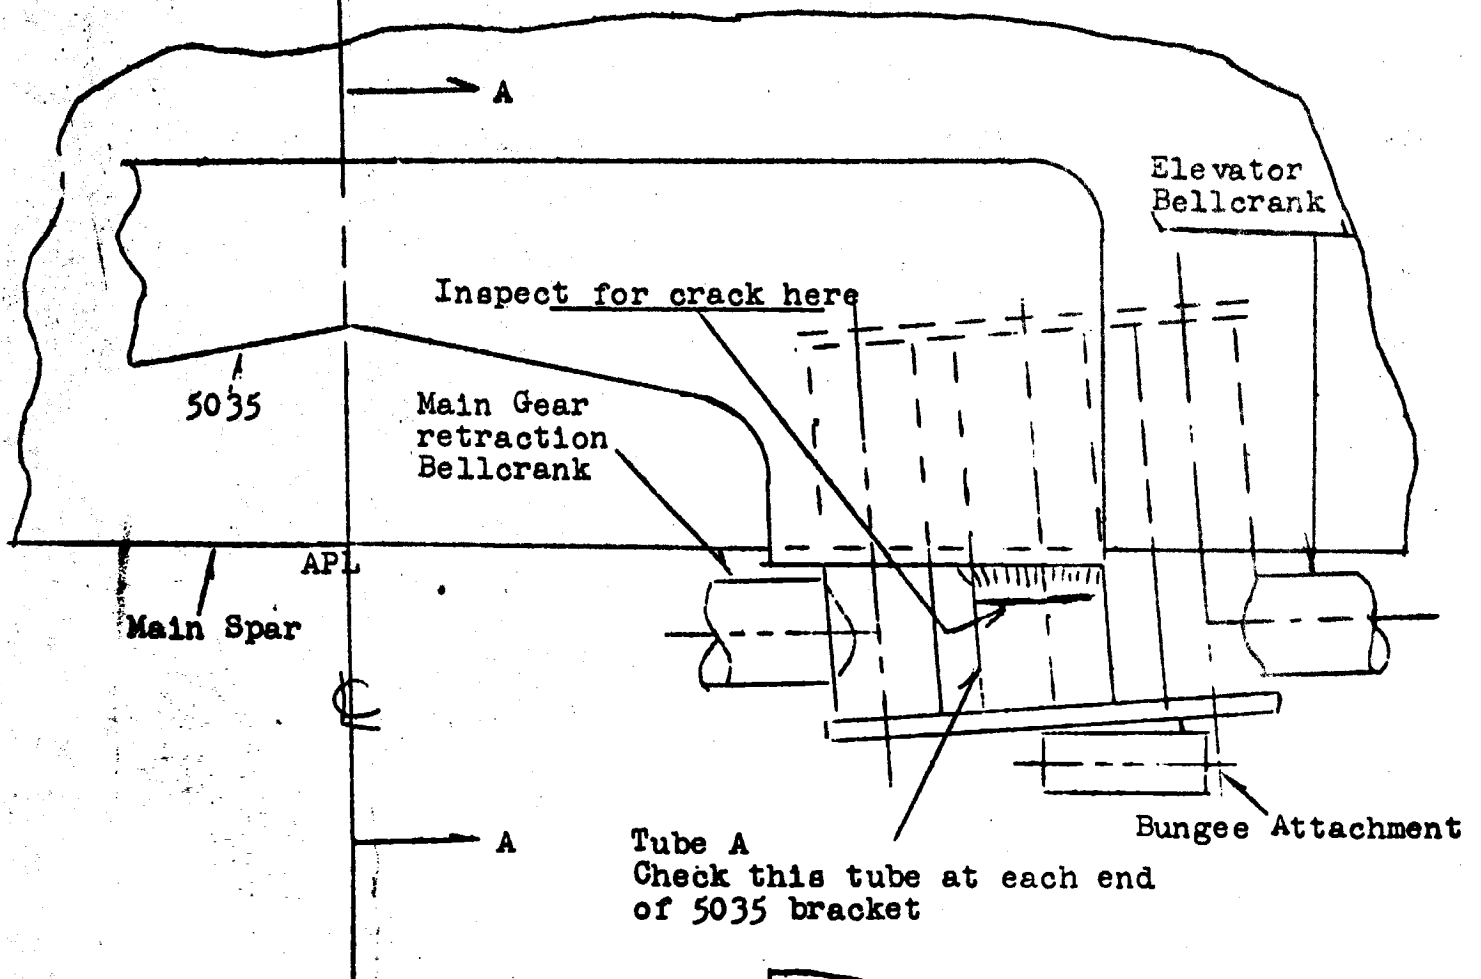
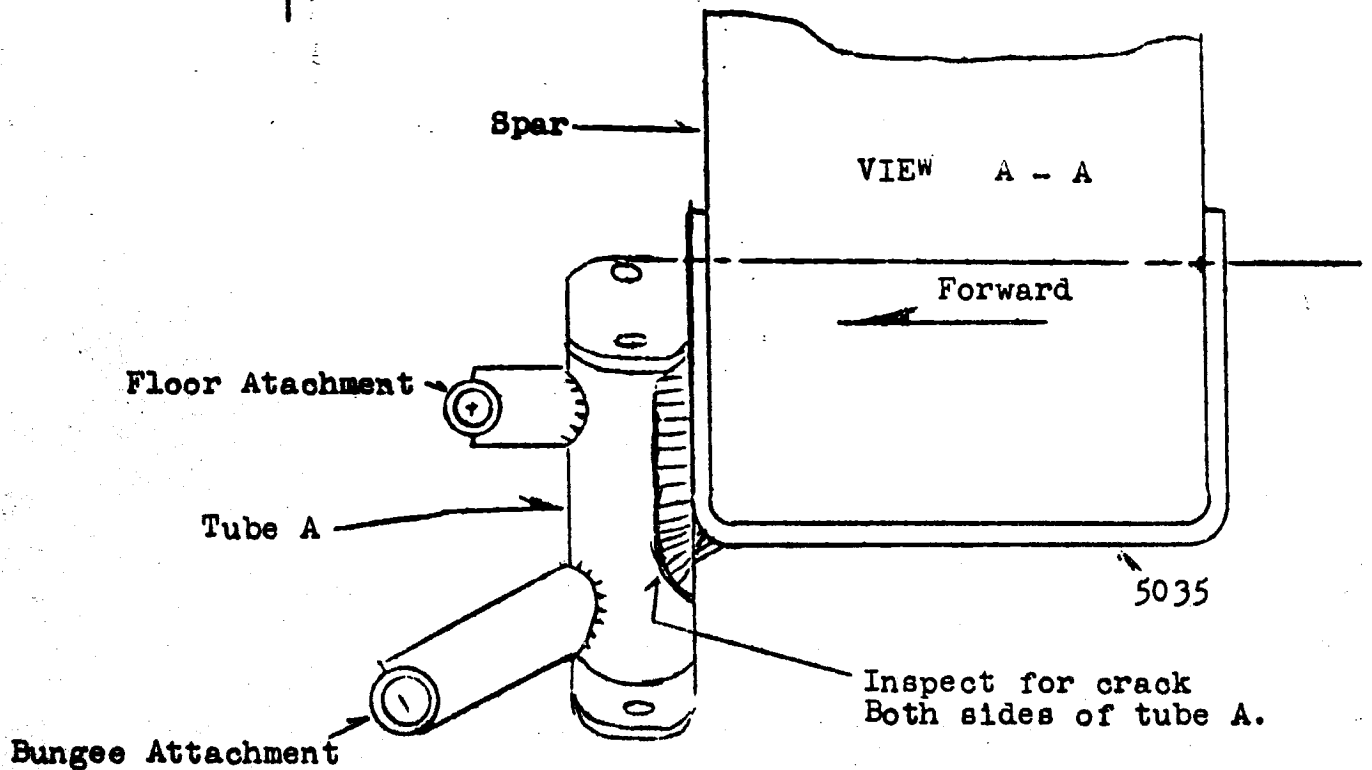
FIGURE ONE VIEW LOOKING FORWARD AT MAIN SPAR

There has been an occurrence of cracking in tube (A) as shown in Fig. 1. A failure at this point could cause a malfunction of the elevator or rudder control system or gear retraction system. It is therefore necessary to accomplish the following inspection immediately and at subsequent periodic 25 hour inspections. Please fill out and return the enclosed card when the first inspection has been completed.

1. Raise airplane off the ground in the prescribed manner and retract the gear. This is necessary in order to get a clear view of the area to be inspected.
2. Remove the two access panels directly below the main spar.
3. Clean and carefully inspect area as shown in fig. 1 for cracks.
4. If cracks are discovered notify the factory and ground the airplane until a new part is installed.
