# SERVICE BULLETIN

NUMBER: M20-219-1

**SUBJECT:** PROPELLER SPINNER BULKHEAD INSPECTION  
AND MODIFICATION

**MODELS  
AFFECTED:** M20J S/N's 24-0001 thru 24-0786

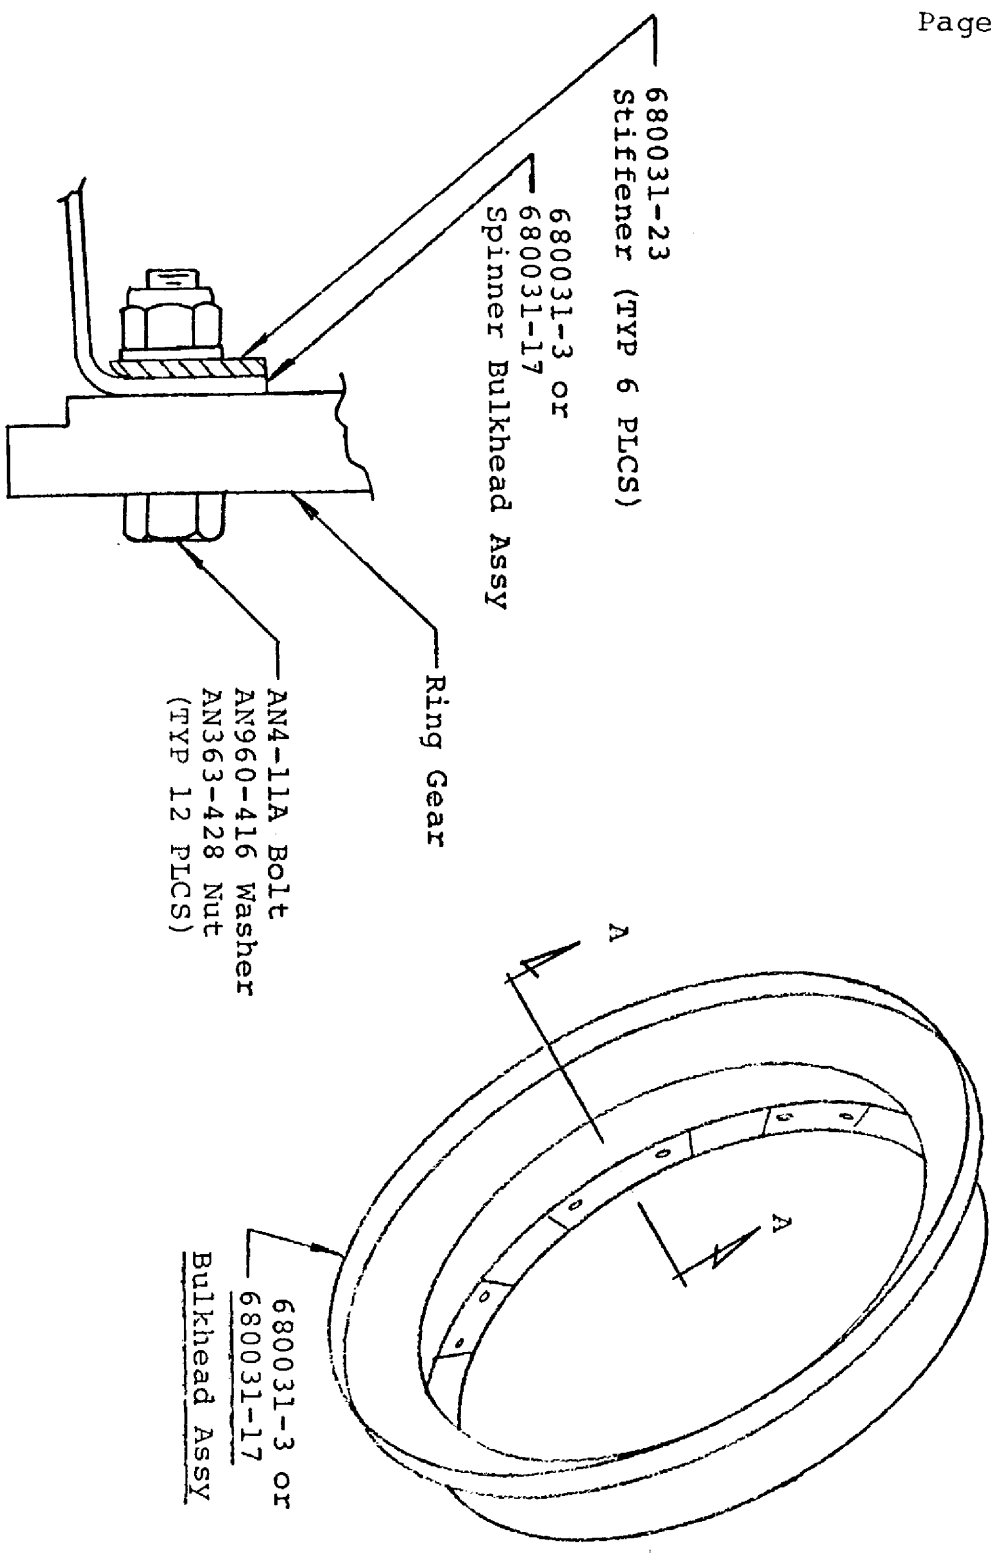
Figure 1

**INTRODUCTION:** In order to prevent the possibility of cracking  
of the 680031-3 or -17 spinner aft bulkhead  
assembly around the attachment bolts, the  
following inspection and modification should  
be implemented.

1. Remove the 680031-7 or -19 propeller spinner.
2. Remove the propeller assembly.
3. Remove (12) AN4-10A bolts attaching  
680031-3 or 680031-17 bulkhead assy to  
the engine ring gear.
4. Inspect 680031-3 or 680031-17 bulkhead  
assy for cracks; if cracked, replace bulkhead.  
If no cracks are found, proceed with instal-  
lation of Service Bulletin stiffeners  
680031-23 (6 each as shown in Figure 1).
5. Reinstall propeller and spinner removed per  
Steps 1 and 2 with existing hardware. (Torque  
all bolts to specified torque. AN4-11A 50 to  
70 in-lbs., prop attach bolts 55 to 65 ft-lbs.,  
and spinner screws 30 in-lbs. +5 in-lbs.).

**CAUTION:** The forward spinner bulkhead should have a  
snug fit on the propeller dome. Install  
6.5 MIL x .50 wide "Scotch Brand" No.  
549 pressure sensitive tape, mfg. by 3M  
Co., St. Paul, Minnesota, on propeller  
dome as required to provide a snug hand  
press fit.
