SUBJECT: MOONEY M20M ENGINE MOUNT HEAT SHIELD

MODEL/S/N
AFFECTED: 27-0001 THRU 27-0129

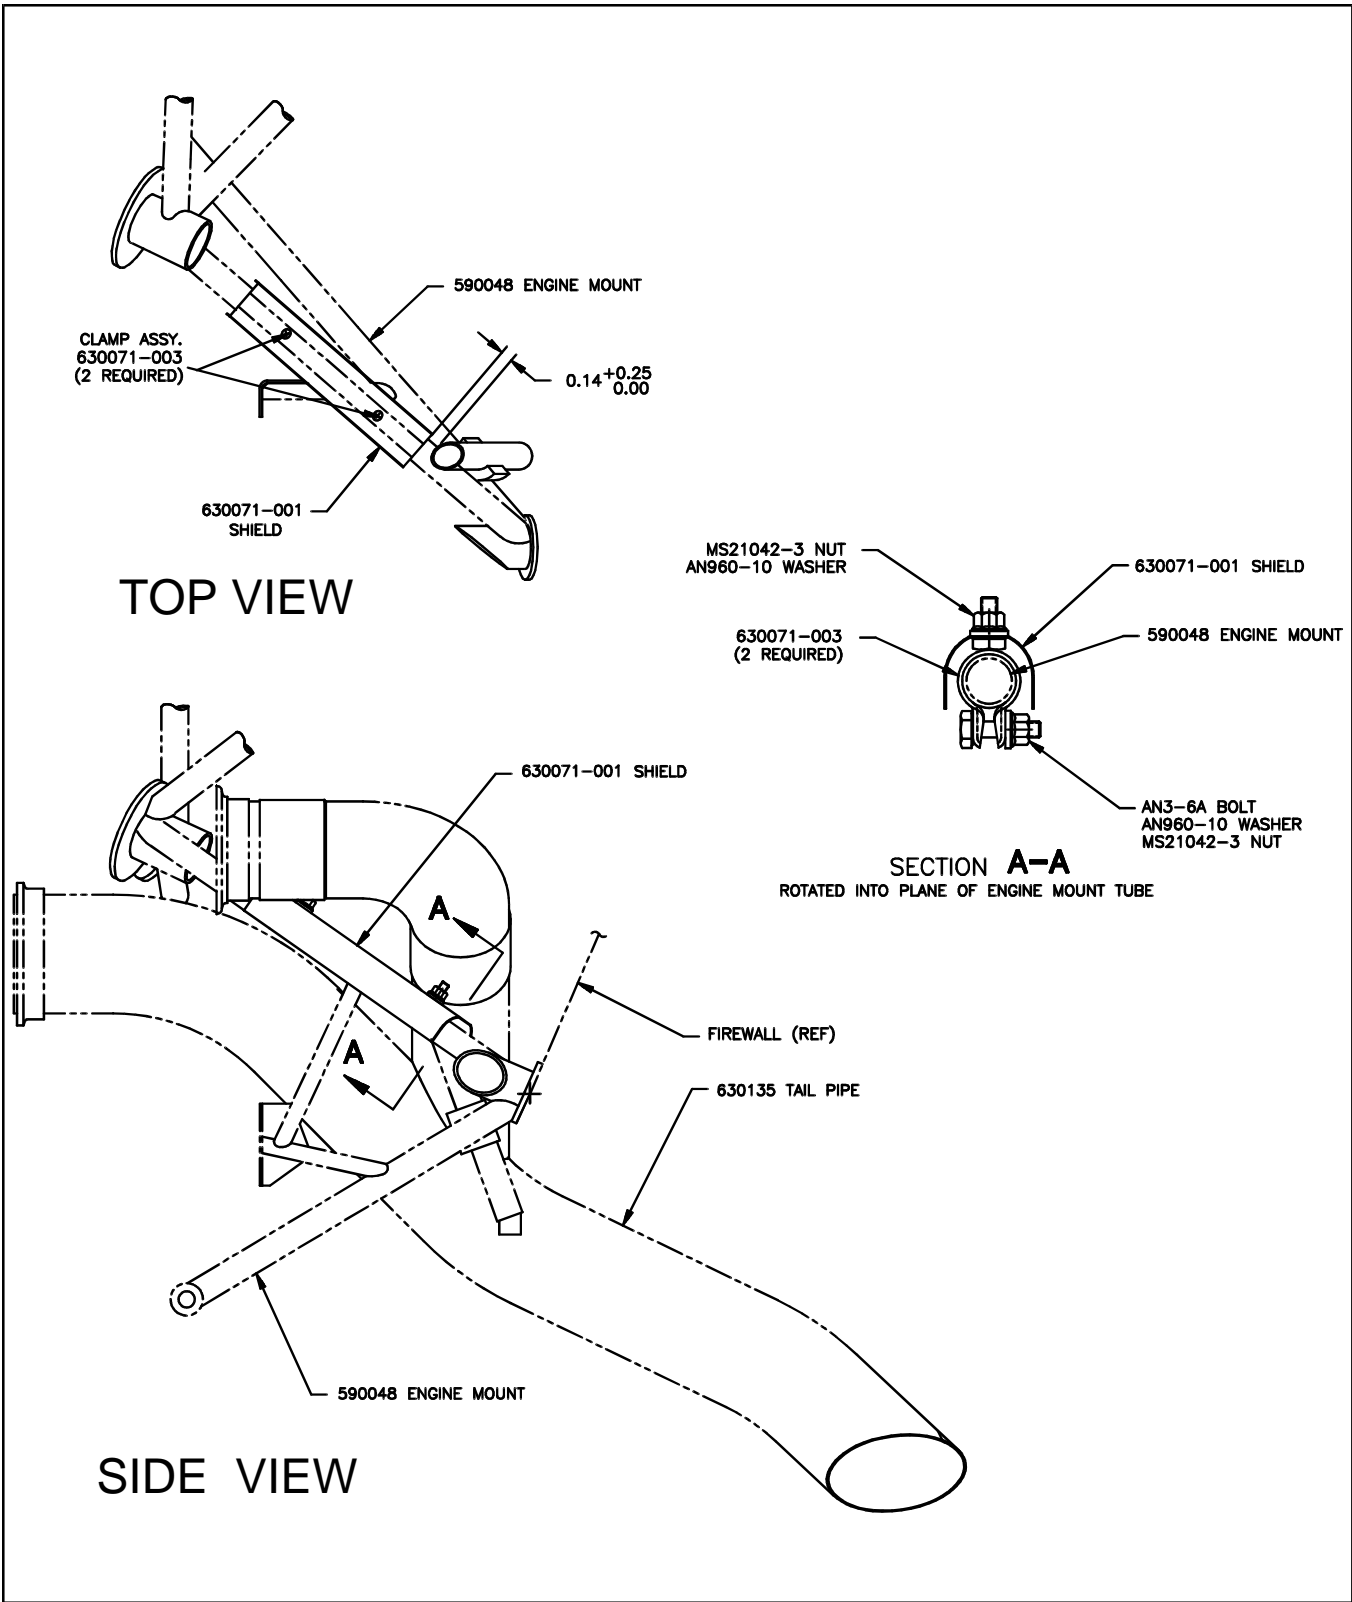
FIGURE SB M20-251-1

INTRODUCTION: There have been occasions that the engine mount, in the vicinity of the turbocharger, has had paint scorched or missing due to exhaust temperatures. The steel tubing may show evidence of heat and in need of maintenance action. The heat shield and associated components on this kit will reduce this temperature related action.

1. Remove upper and lower cowling per M20M S & M, Section 71-10-00.
2. Locate the area of the engine mount as shown. (See Figure SB M20-251-1 for location)
3. Inspect all engine mount tubes in close proximity to the exhaust/turbocharger for evidence of heat related damage. Repair any damage per appropriate AC43-13 procedures or M20M S & M manual, Chapter 51.
4. Lightly sand, and repaint with high temperature paint, any tubes showing evidence of heat.
5. Install 630071-001 shield using two each 630071-003 clamp assemblies and appropriate attaching hardware. (Reference Figure SB M20-251-1 for proper location and orientation on the engine mount tube.
6. Re-install lower and upper cowling per M20M S & M, Section 71-11-00.
7. Enter compliance statement in Airframe log book and return aircraft to service.
