MOONEY AIRCRAFT INC.
KERRVILLE, TEXAS

SERVICE LETTER 20-26

DATE: 5-20-57
SUBJECT: Inspection of ~~P/N 5062 nose Gear Retraction Truss~~
MODELS AFFECTED: M-20 Serial Number 1002 to 1126
TIME OF COMPLIANCE: At or prior to next 25 Hour Inspection.

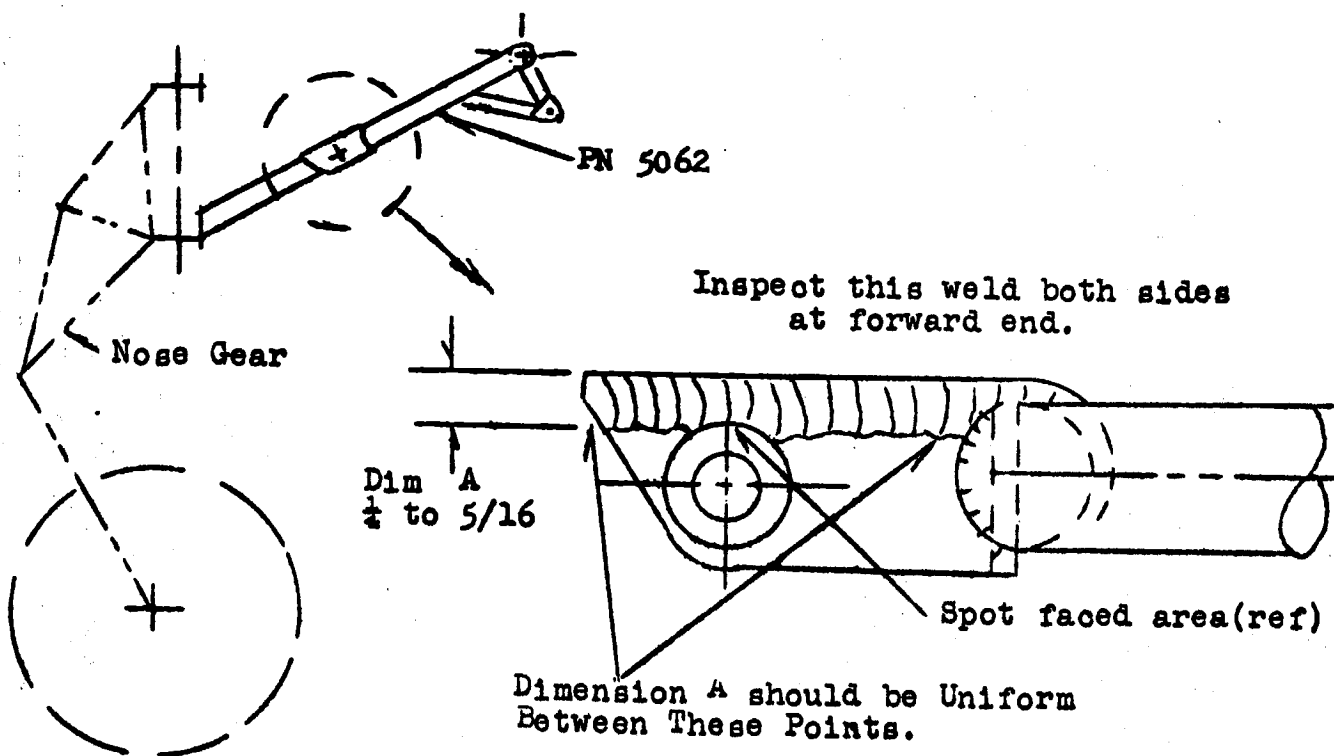
Figure 1

There has been one case of failure of P/N 5062 Nose Gear Retraction Truss in which the plate that rests against the cadmium plated retraction link peeled back allowing the nose gear to collapse on landing. The failure was evidently due to an inadequate weld, since static tests have shown that the part has high strength when the weld is adequate. A more rigid inspection has instituted at the factory and it is necessary that such an inspection be made on those airplanes listed above, in the field. Inspect the weld for possible cracks and for extent of weld coverage as shown in figure 1. If the weld is found to be unsatisfactory a replacement part will be furnished on request, on an exchange basis at no cost to the aircraft owner.
