MOONEY

SERVICE BULLETIN M20-276

Date: December 18, 2000

SUBJECT: OVERHEAD TUBULAR STRUCTURE MODIFICATION

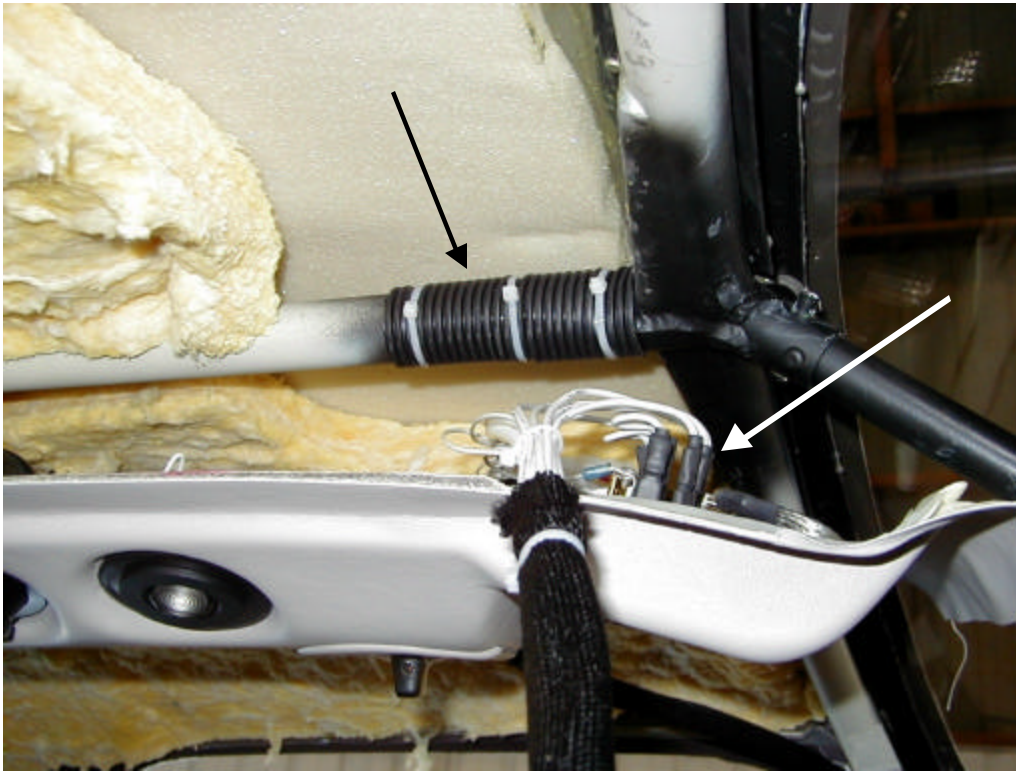
Figure M20-276-1

INTRODUCTION: It has been determined that the possibility of arcing between the headliner assembly bus bar (associated with the overhead light switches) and the overhead tubular structure exists in the affected aircraft. This service bulletin provides for inspection of the overhead area and installation of split loom tubing over part of the overhead tubular structure to prevent inadvertent arcing from either of the headliner assembly bus bars.
