SERVICE BULLETIN M20-279 REVISION C

SUBJECT: Mooney Aircraft Corporation, Inspection of EATON and AVIONIC PRODUCTS Landing Gear Actuators, MAC P/N 560254-501, -503, -505, And -507, (EATON and AVIONIC PRODUCTS P/N 102000-1, -2, -3, -4, -5, and -7 Landing Gear Actuators).

102000 Landing Gear Actuator

Document No.	SI102000-1-901 Rev. 2
Subject:	Landing Gear Actuator No-Back Inspection
Date:	April 3, 2003

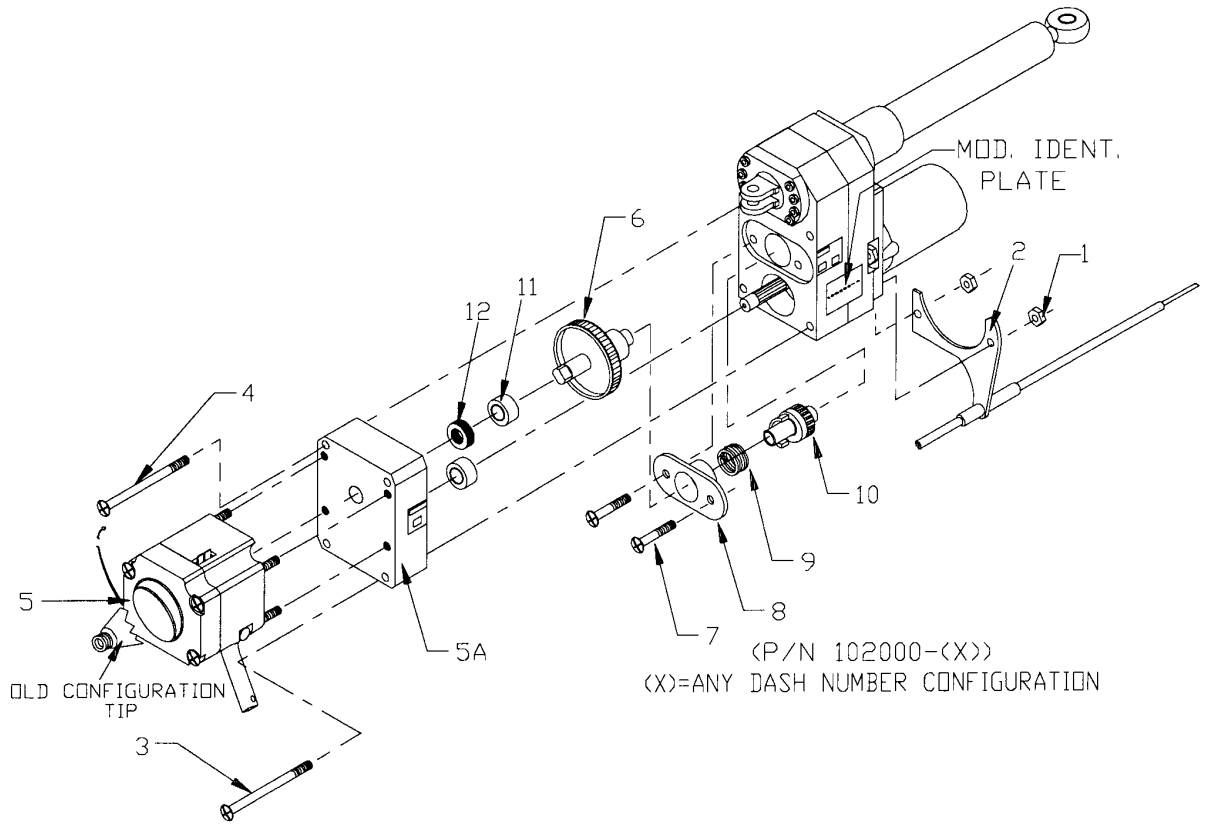
Figure 1.

1. Remove the two long screws(item 3) and two short screws (item 4) securing the recoiler assembly to the actuator.
2. With the four screws removed, separate the recoiler assembly (item 5) and the no-back clutch housing mount (item 5A).

3. Remove input gear assembly (item 6) by pulling with slight force.
4. Remove two screws (item 7) securing the clutch housing(item 8), remove the clutch housing and no-back spring (item 9). Remove the output gear assembly (item 10).

12. Install the output gear assembly (item 10) into the no-back housing (item 8) and rotate the gear to position the notches in the hub to index with the offset tangs on the spring (item 9).

14. Reinstall the two screws (item 7) securing the clutch housing (item 8) into the actuator body, use loctite on screw threads and tighten securely.
15. Insert the input gear and hub assembly (item 6) into the clutch housing and rotate to engage hub notches into clutch spring tangs. Verify that rotation of input gear both clockwise and counter clockwise results in movement of the jackscrew.

17. Install the housing mount assembly (item 5A) and tighten the housing screws. Check the rotational torque of the no-back clutch drive with a modified socket and torque wrench, rotational torque should be no greater than 4 inch pounds in both directions. The objective is to remove endplay without applying a preload on the bearings.

18. If rotational torque is greater than 4 inch pounds, remove housing mount(item 5A) and remove the least amount of shims (item 12) necessary to obtain proper rotational torque. Shims are installed under the bearing (item 11) within the housing mount assembly (item 5A). Three different thickness of shims are available, and any combination of these three are allowed to achieve proper rotational torque of the input gearshaft with the housing mount installed and torqued.

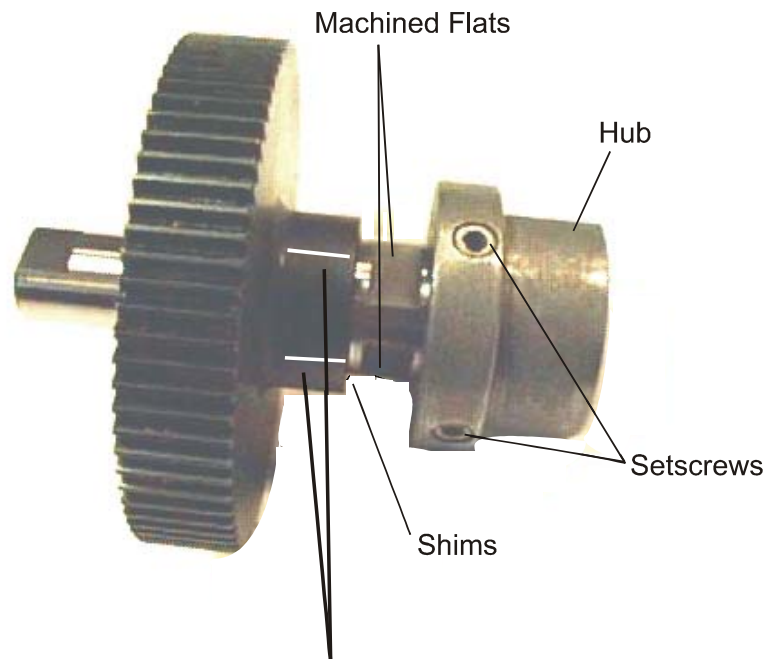
Figure 2.

Scribe Alignment Marks To Indicate Position of Both Machined Flats of Input & Output Gears in relation to Setscrews

5. Remove input hub from input gear shaft by loosening the two set screws. Note the location and quantity of shims and reinstall upon reassembly.
6. Clean and inspect the parts, Replace any parts with damage.
7. Index mark the location of the two machined flats of the gear shaft onto the shaft shoulder next to the gear by applying a small dot of paint, refer to figure 2.

8. Wash all no-back clutch parts in acetone prior to reassembly. An oil free surface must exist for the proper adhesion of the loctite product.
9. Reinstall shims (as removed) onto input gear shaft and apply a liberal coating of loctite 609 to the gear shaft area of hub contact. Reinstall hub aligning the set screw holes with the index marks. Ensure the hub is seated firmly against the shims and gear shaft shoulder. Apply loctite 609 to set screws and reinstall, tighten set screws ensuring that they are fully seated on the gear shaft flats. Torque Set screws to 5 to 8 inch pounds.
10. Repeat steps 8 through 9 for the no back clutch output gear.
