**THIS BULLETIN IS FAA APPROVED FOR ENGINEERING DESIGN**SERVICE BULLETIN M20-286
Date: May 09, 2005

SUBJECT: LANDING/TAXI LIGHT SYSTEM MODIFICATON
MODELS/ S/N MOONEY M20J, S/N 24-3411 thru 24-3431
AFFECTED: MOONEY M20K, S/N 25-2000 thru 25-2032
MOONEY M20M, S/N 27-0244 thru 27-0338
MOONEY M20R, S/N 29-0131 thru 29-0367
MOONEY M20S, S/N 30-0001 and ON
TIME OF COMPLIANCE: AIRCRAFT WITH WING MOUNTED LANDING AND TAXI LIGHTS
AT NEXT SCHEDULED ANNUAL INSPECTION, BUT WITHIN NEXT 100 FLIGHT HOURS.

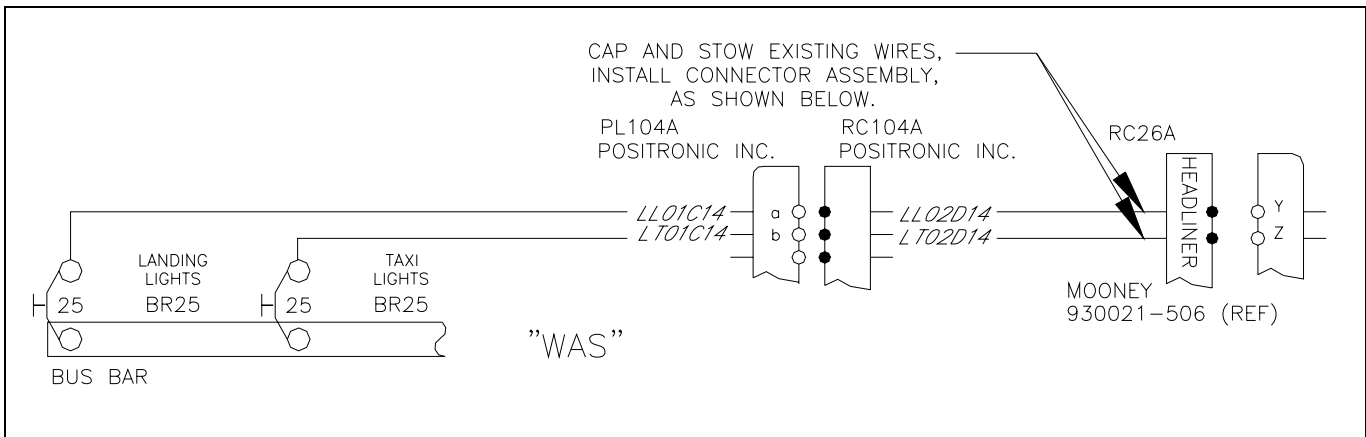
Figure SB M20-286-1

INTRODUCTION: There has been a report that specific connecting pins and sockets in the Positronic, Inc. connector, PL104A/RC104A, of the 28 volt landing lights and taxi lights wiring located behind instrument panel circuit breaker panel may be of insufficient size for the applied load when landing light and taxi light circuits are energized. This may result in overheating of these pin connections. The specific wire segments involved are (ref. Figure SB M20-286-1):
- LL01C14 and LL02D14 connecting 25 AMP LANDING LIGHTS circuit breaker through PINS a on connector PL104A/RC104A to connector RC26A PIN Y, and
- LT01C14 and LT02D14 connecting 25 AMP TAXI LIGHTS circuit breaker through PIN b on connector PL104A/RC104A to connector RC26A PIN Z.
These wires will be capped and stowed per the instructions provided in this bulletin and a new connector harness assembly installed.

3. Locate and remove wires LL01C14 and LT01C14 from pin locations from "a" and "b" on circuit breaker panel connector, PL104A, (ref. Figure SB M20-286-1). See Figure SB M20-286-2 for pin locations.

4. Remove existing sockets, strip wire and add AMP 32448 knife connectors, (ref. Figure SB-M20-286-3).
5. Remove, cap and stow wires LL02D14 and LT02D14 from "Headliner" connector RC26A pins "Y" and "Z" (ref. figure SB M20-286-1).
