SERVICE BULLETIN M20-291A

SUBJECT: S-TEC Autopilot/Full Flap Condition

MODELS/ SN  
AFFECTED:M20M - All aircraft equipped with Garmin G1000 Integrated Avionics and S-TEC Autopilot  
M20R - Aircraft equipped with Garmin G1000 Integrated Avionics and S-TEC Autopilot, S/N  
29-0455 and prior

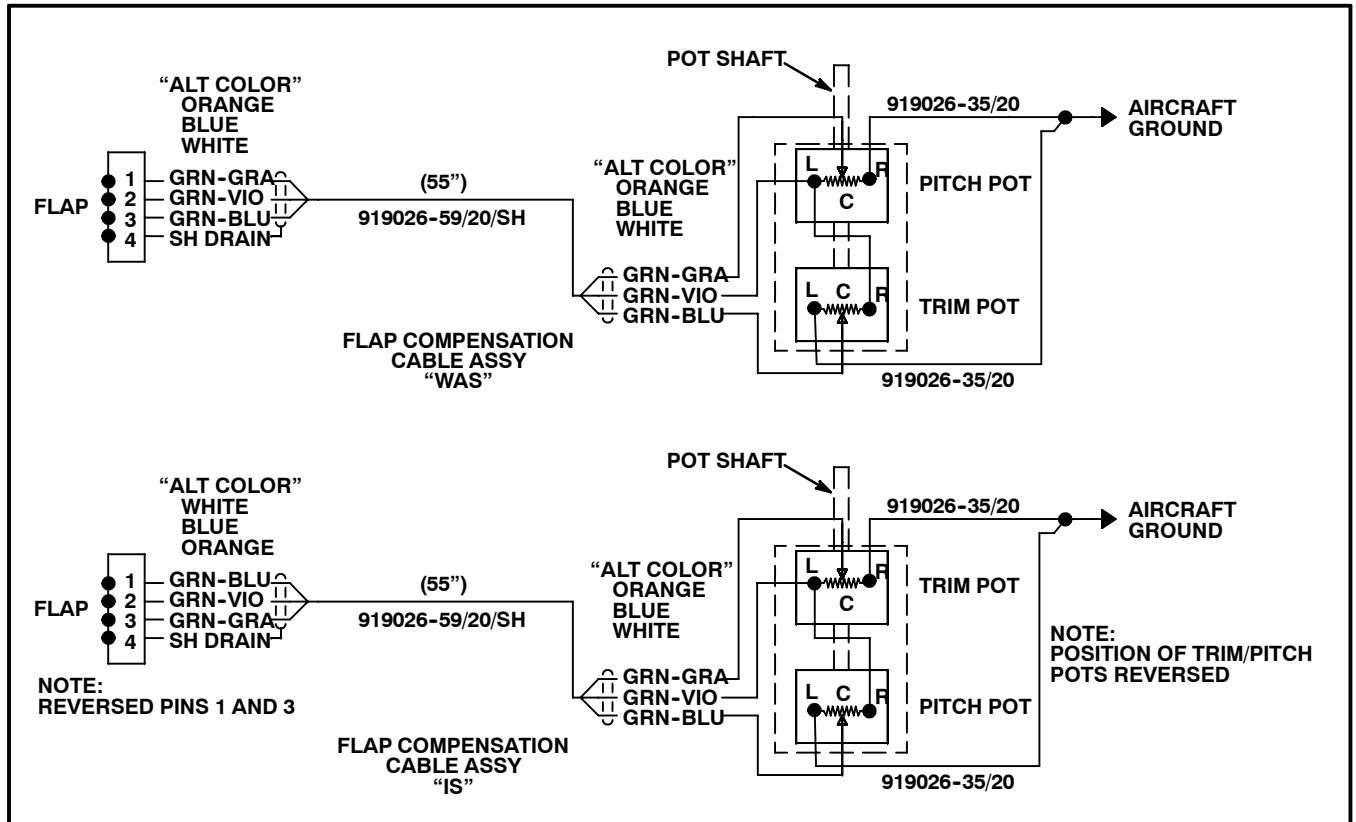
Figure SB M20-291-2

INTRODUCTION: Aircraft equipped with Garmin G1000 and S-TEC autopilot will experience a hard nose down pitch condition with the flaps in full down position and the autopilot engaged. This condition is corrected by reversing position of two wires in the Flap Compensation Cable Assembly supplying the Pitch Pot and Trim Pot. By reversing the wires, the Trim Pot and Pitch Pot functions are reversed.

3. Disconnect the connector.
4. On the male side of the connector, locate pins 1 and 3 (Ref. Figure M20-291-002). Depress the tabs on the pins to allow their removal from the connector housing. Relocate pin 1 (GRN-GRA) into pin 3 location. Relocate pin 3 (GRN-BLU) into pin 1 location.
