MOONEY AIRCRAFT, INC.

Service Letter 20-30

DATE: : 3-13-58
SUBJECT: Inspection - Tail Truss
MODELS AFFECTED: M20 & M20A Serial No. 1002 - 1210
TIME OF COMPLIANCE: Immediately

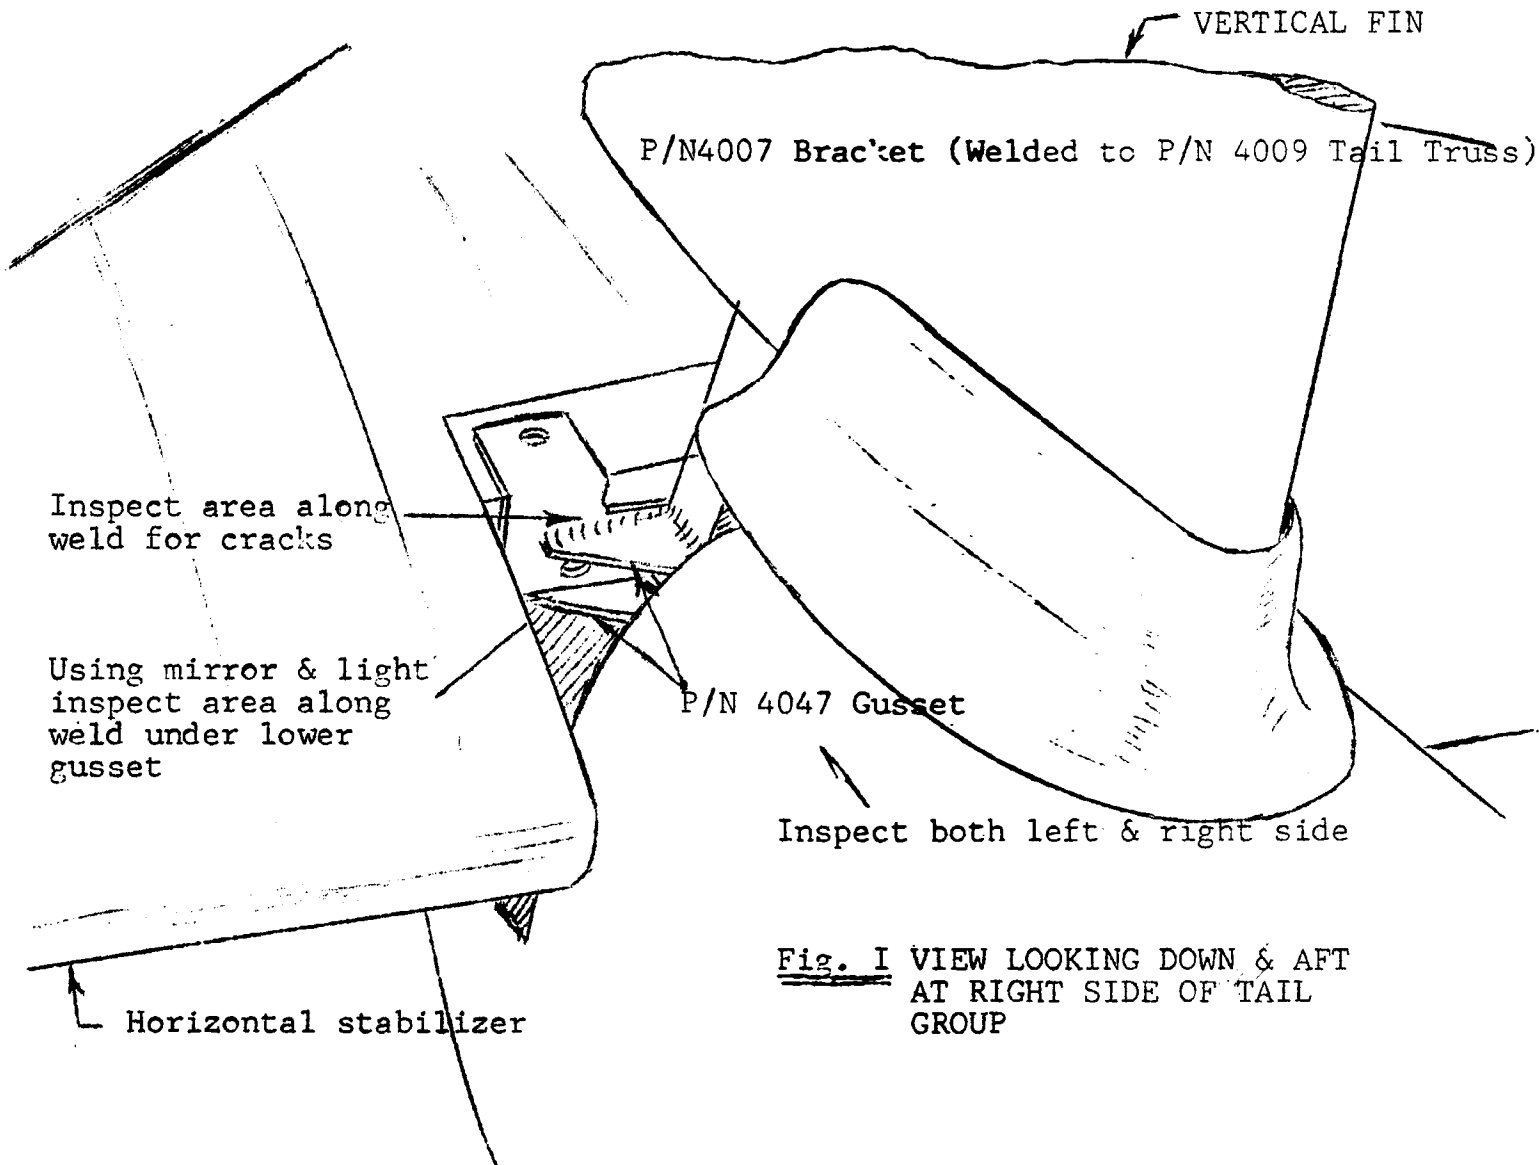
Fig. 1 VIEW LOOKING DOWN & AFT
AT RIGHT SIDE OF TAIL
GROUP

Due to the possibility of cracks at the welded joint between P/N 4007 bracket and P/N 4047 Gusset (4 Places on P/N 4009 Tail Truss) the following inspection is necessary. (See Fig. 1)

- (1) Remove the fairing between Horizontal Stabilizer and Fuselage.
- (2) Remove Paint at Welded Joints.
- (3) Carefully inspect for cracks on both right and left sides of Tail Truss areas shown in Fig. 1.
- (4) Complete and return enclosed compliance card.

If cracks exist replace P/N 4009 Tail Truss.
