SUBJECT: M20M, M20R and M20TN Lower Spar Cap Doubler Inspection

**MODELS/ SN
AFFECTED:** Mooney Aircraft M20M Bravo Serial Number 27-0222
Mooney Aircraft M20R Ovation Serial Numbers 29-0523 thru 29-0525
Mooney Aircraft M20TN Acclaim Serial Numbers 31-0140 and 31-0141

**TIME OF
COMPLIANCE:** **ONE-TIME INSPECTION WITHIN NEXT 200 FLIGHT HOURS**

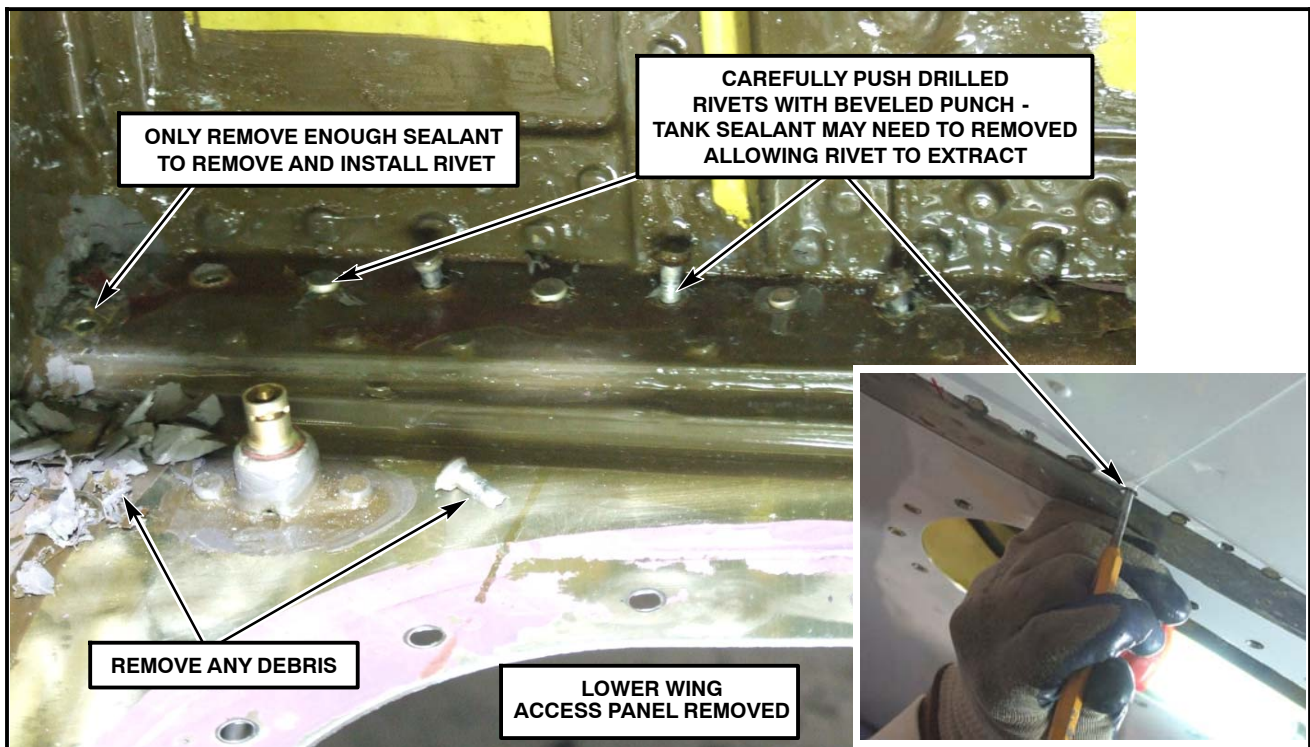
Figure SB M20-324-4 - LOWER SPAR CAP RIVET LINE - INSIDE WING TANK AREA

- 2.15. Inspect for any chipping or damage around hole as shown in Figure SB M20-324-4.
- 2.16. After 2nd sequence Inspection of holes is completed (in wing area), verify fit of larger rivets are a #5 MS20426AD5 and the smaller rivet is a #4 MS20426AD4 as shown on Mooney Drawing #220000 and in Figure SB M20-324-5. If rivet size is larger than specified - Please contact Mooney Customer Support at support@mooney.com for further action.

- 2.5. The next steps will be completed in 2 sequence steps, to keep components stationary and prevent misalignment of the assembled parts.
- 2.6. **Sequence #1** - mark every other rivet with a visible marker. Remove rivets, and any tank seal-er from around and undercut rivet heads by drilling. Use a drill of the same size as the diameter of the rivet. Drilling must be exactly centered and to the base of the head only. After drilling, break off the head with a beveled pin punch and carefully drive out the shank, to Wing Station 59.25 (both sides), as shown in Figures SB M20-324-3, SB M20-324-4 and M20-324-5.

- 2.14. **Sequence #2** - mark every other rivet with a visible marker. Remove rivets, undercut rivet heads by drilling. Use a drill of the same size as the diameter of the rivet. Drilling must be exactly centered and to the base of the head only. After drilling, break off the head with a beveled pin punch and carefully drive out the shank, as in 1st sequence out to Wing Station 59.25 (both sides), as shown in Figures SB M20-324-3, SB M20-324-4 and M20-324-5.

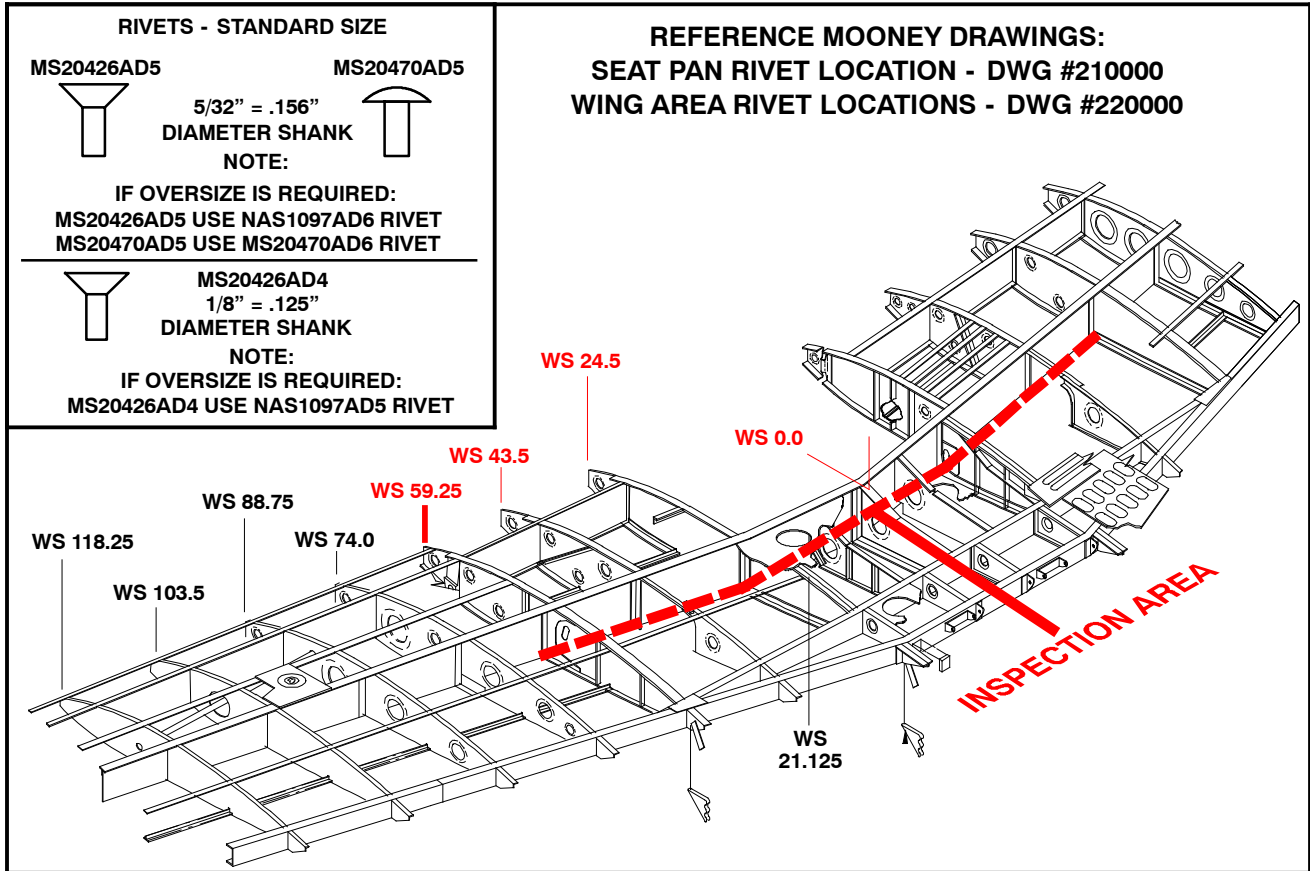
Figure SB M20-324-5 - LOWER SPAR CAP RIVET LINE AND RIVET IDENTIFICATION

- 2.7. Inspect for any chipping or damage around hole(s) as shown in Figure SB M20-324-7.
- 2.8. After 1st sequence Inspection of holes (Wing area) is completed, verify fit of larger rivets are a #5 MS20426AD5 and the smaller rivet is a #4 MS20426AD4 as shown on Mooney Drawing 220000 and in Figure SB M20-324-5. If rivet size is larger than specified - Please contact Mooney Customer Support at support@mooney.com for further action.

- 2.9. After 1st sequence Inspection of holes is completed (in seat pan area), verify fit of rivets are #5 MS20470AD5 as shown on Mooney Drawing 210000 and in Figure SB M20-324-5. If rivet size is larger than specified - Please contact Mooney Customer Support for further action.

- 2.17. After 2nd sequence Inspection of holes (Seat Pan area) is completed, verify fit of rivets are #5 MS20470AD5 as shown on Mooney Drawing 210000 and in Figure SB M20-324-5. If rivet size is larger than specified - Please contact Mooney Customer Support at support@mooney.com for further action.

- 2.10. If damage is found around the hole, it is acceptable to use 1 size up alternate rivet and appropriate drill bit and/or countersink bit to clean-up hole as shown in Figure SB M20-324-5 and M20-324-7. If 1 size larger hole or countersink will not clean-up damaged area, Please contact Mooney Customer Support at support@mooney.com for further action.

- 2.18. If damage is found around the hole, it is acceptable to use 1 size up alternate rivet and appropriate drill bit and/or countersink bit to clean-up hole as shown in Figure SB M20-324-5 and M20-324-7. If 1 size larger hole or countersink will not clean-up damaged area, Please contact Mooney Customer Support for further action.
