MOONEY AIRCRAFT INC.
SERVICE LETTER 20-37 (CAA APPROVED)

DATE: 7-28-58
SUBJECT: Rework of carburetor air box installation.
MODELS AFFECTED: M20A Serial Number 1201 thru 1275.
TIME OF COMPLIANCE: Immediately
INTRODUCTION:

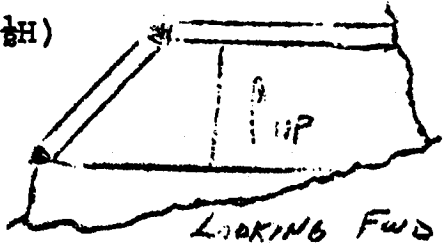
There have been several cases (on M20A aircraft only) in which the cross vanes in the neck of the carburetor air box (PN 6235) have cracked and broken off. This failure can cause a power loss if the vanes are drawn into the carburetor opening. In these cases it is also reported that the top of the carburetor air box cracked around the neck. In view of these failures, it is necessary to accomplish the rework outlined below.

- 1) Remove carburetor air box and inspect for cracks on outside. Repair as necessary by welding.
- 2) Add $1\frac{1}{2}$ x $1\frac{3}{8}$ x .125 (2) weldable (2 or 3S $\frac{1}{2}$ H) aluminum brace to each side at fore and aft center line of neck as shown to stiffen box (accomp. at factory Ser. 1258 & on)
- 3) Remove cross vanes (2) in neck by cutting off at inside surface of tube
- 4) Shorten $\frac{3}{8}$ O.D. Alum. fuel overflow drain tube on bottom of air box $\frac{1}{2}$ inch to remove bind at cowl (accomp. at factory Ser. 1258 and On)
- 5) Enlarge fuel overflow drain tube hole to $1\frac{1}{4}$ Diam. and grommet (in cowl) To remove bind (accomp. at factory Ser. 1261 and on).
