MOONEY AIRCRAFT INC. KERRVILLE, TEXAS

SERVICE LETTER 20-39

Inspection - Aileron Counterweight

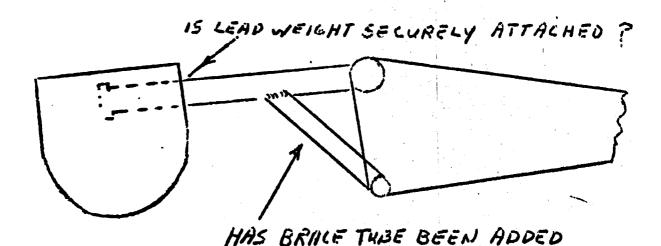
Some aircraft remain which have not been modified in accordance with Mooney Service Letter 20-7 kev. A, issued on 10-28-57. It is Necessary that the above listed aircraft be inspected to determine if the brace has been added to the aileron counterweight arm (see sketch). Check also to determine that the lead weight is securely in place on the tubular arm.

Please complete and return the enclosed compliance card so that Service Letter 20-7 (Kit-Aileron Counterweight Balance Arm Reinforcement) can be issued as necessary and our records brought up to date.
