MOONEY AIRCRAFT INC.
SERVICE LETTER 20-46

Subject: Inspection of Empennage Components

Models Affected: As noted below

Time of Compliance: To be accomplished immediately in conjunction with FAA telegraphic airworthiness directive, issued 4-22-59, concerning P/N 3009 (See Item 1 Below for Contents of A. D. Note)

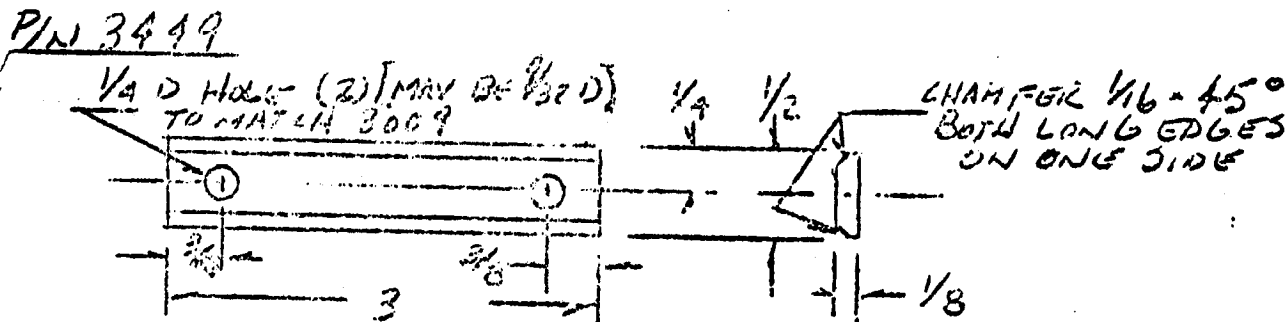
See drawing of P/N 3449 below.

1. On M20 & M20A all Serial numbers remove and inspect immediately the empennage to fuselage upper attach bracket Part No. 3009 for cracks in bend radii near bolts. Remove paint and use dye penetrant and a ten power glass. Replace all cracked brackets and all brackets damaged by bolt head bearing in radius area of brackets with identical new brackets using 1/8 inch longer bolt, AN4-16A, and 1/8 inch by 1/2 inch by 3 inch -- 1010 cold rolled steel bearing plates Part No. 3449, under the heads of bolts attaching brackets Part No. 3009 to fuselage bulkheads. Bearing plates Part No. 3449 may be made using Part No. 3009 bracket to locate over-size 9/32 inch holes for attach bolts and by filing 1/16 inch by 45 degree chamfer along edges to provide clearance at radii of brackets. Drill and deburr bearing plates. All brackets found satisfactory may be reinstalled provided they are installed with AN4-16A bolts and the above bearing plates, Part No. 3449. Washers on airplanes Serial Numbers 1359 and up shall be replaced with bearing plates.
