MOONEY AIRCRAFT, INC.

SERVICE LETTER 20-53

DATE: NOVEMBER 16, 1959  
SUBJECT: INSPECTION OF BATTERY CABLES AND MODIFICATION OF BATTERY BOX  
MODELS AFFECTED: M-20 - M-20A Serial Nos. 1002-1453  
TIME OF COMPLIANCE: NEXT TIME SIDE COWL IS REMOVED

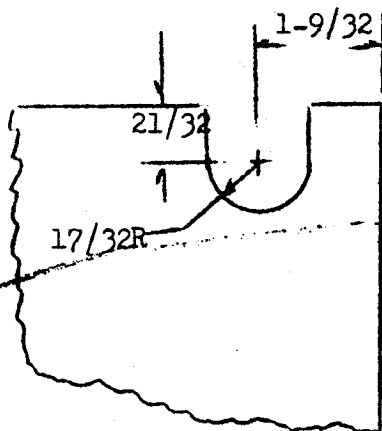
Figure No. 1

Due to variation in the height of the batteries used in the aircraft noted above, some battery cables may be worn at the points where the cables enter the battery box, and it is therefore necessary that the following inspection be accomplished.

INSTALL VINYL TUBING  
AND GROMMET AS SHOWN
