MOONEY AIRCRAFT INC.
KERRVILLE, TEXAS

SERVICE LETTER 20-55
(This service letter is FAA Approved)

DATE: August 19, 1959.
SUBJECT: INSPECTION OF NOSE GEAR STEERING HORN.
MODELS AFFECTED: M-20 AND M-20A - ALL SERIAL NUMBERS.
TIME OF COMPLIANCE: AS NOTED.

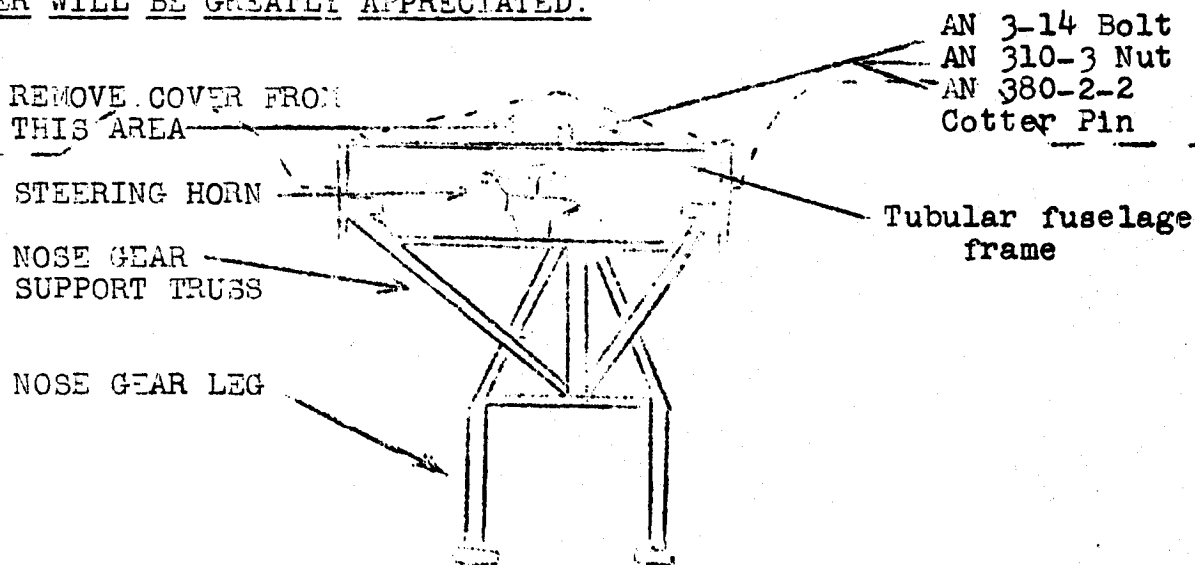
Several reports have been sent to us concerning loosening of the nut on the bolt attaching the nose gear steering horn assembly to the tubular fuselage structure. If this bolt should come loose from the assembly, ground control may be lost. It is therefore necessary that this assembly be inspected as outlined in the instructions.

1. Turn the bolt head at the top of the steering horn illustrated in the sketch. If the bolt is tight this inspection should be repeated at subsequent 25-hour inspections and the following should be done at the next 100-hour inspection.
2. Remove the right or left side cowling.
3. Remove the gear box cover illustrated.
4. Remove nut and bolt and replace with AN 3-14 drilled bolt, AN 310-3 castellated nut, and AN 380-2-2 Cotter pin. Use washers in the same manner as with original bolt and nut.
5. Replace gear box cover and cowling.
6. Please complete and return the enclosed compliance card.
