MOONEY AIRCRAFT, INC.

SERVICE LETTER 20-56

DATE: August 18, 1959  
SUBJECT: INSPECTION OF EMPENNAGE ATTACH BRACKETS  
MODELS AFFECTED: M 20 and M 20A ALL SERIAL NUMBERS  
TIME OF COMPLIANCE: NOTED BELOW

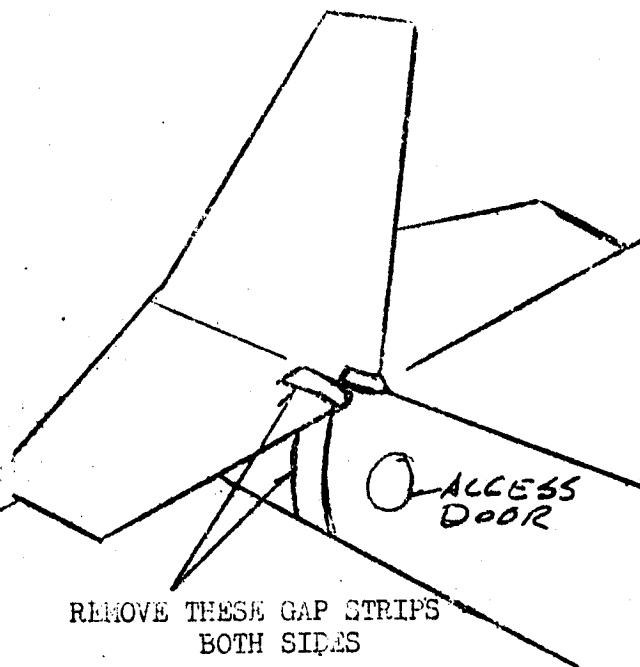
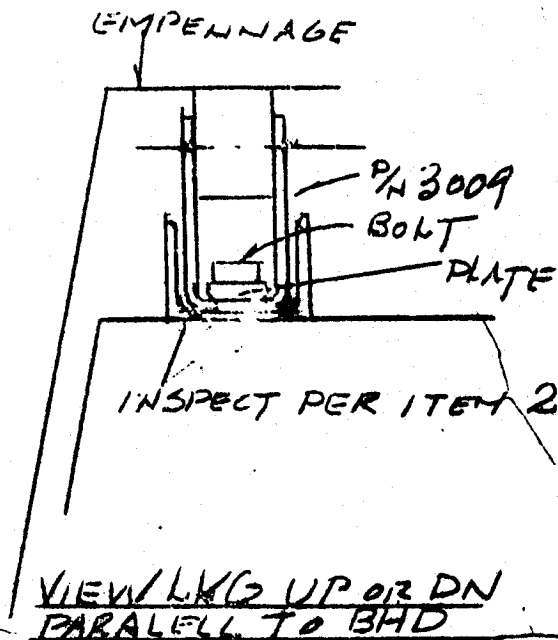
INSPECTION: (SEE SKETCH BELOW)

In order to determine the adequacy in service of P/N 3009 empennage attach brackets with the 1/8" x 1/2" x 3" steel plate under the bolt heads, it is necessary that the following simple inspection be accomplished prior to the next 25 hours of flight and at subsequent 100-hour intervals except that this inspection need not be made sooner than 100 hours after compliance with FAA Airworthiness Directive 59-9-1 concerning this subject. A bracket of improved design and interchangeable with P/N 3009 has been developed and will be available in the near future.

- 1) Remove gap strips between empennage and fuselage. Nuts on lower gap strips are reached through round access doors on either side of fuselage at rear bulkhead.
- 2) Using a light and a ten power glass, inspect the top and bottom ends of P/N 3009 brackets (2) for cracks in the radius and near the edge of the bearing plate.
- 3) Please complete and return the enclosed compliance card.
