MOONEY AIRCRAFT, INC.

SERVICE LETTER 20-57
(This Service Letter is FAA Approved)

DATE: October 6, 1959
 SUBJECT: Modification of Lower Cowl Rails
 MODELS AFFECTED: M-20A Serial Nos. 1201 through 1446 plus Serial Nos. 1448, 1450, 1451, 1453, 1455, 1456, 1457, and 1459

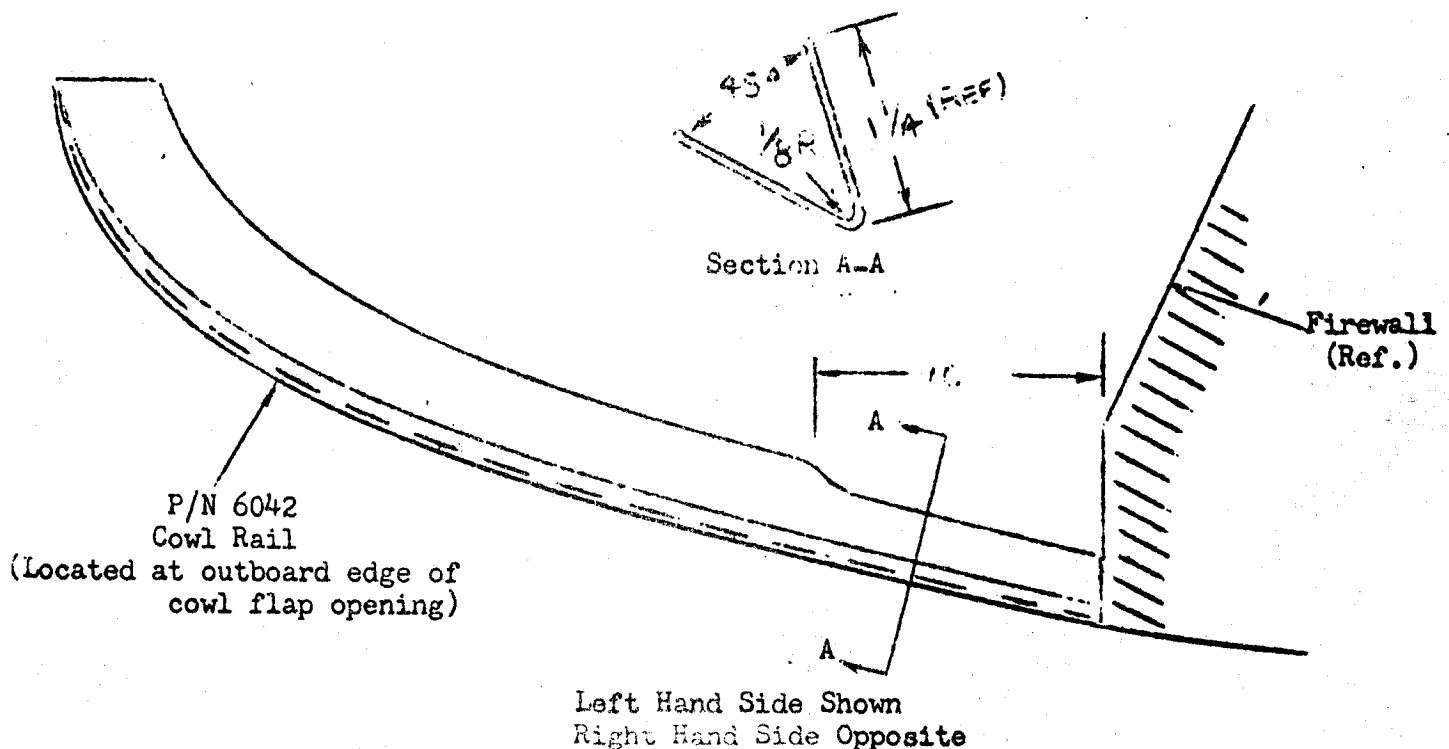
Several cases have been reported to us of cracks appearing in several areas of the M-20A exhaust system. We feel that these cracks may be due, in part, to the exhaust mufflers striking the lower cowling stiffener rails. This is due to the engine movement on the dynafocal mounts during starting and stopping operations. The appearance of ample clearance while the engine is not running does not constitute ample clearance when the engine is running, and we therefore recommend the following modification be accomplished as soon as practical.

1. Remove both the left and right side cowling.
 2. Remove left and right exhaust muffs after marking with a grease pencil in order to reposition tail pipe correctly.
 3. Bend vertical flange of P/N 6042, Cowl Rail, out (from the firewall forward for a distance of about 10 inches) until they form an angle of about 45° as shown in the sketch. This can be done with a soft, non-metallic mallet. A metal hammer is not recommended. Hammer the side of the rail out with the mallet using a sand bag for a back up on the outside of the cowling. A wooden block may also be used if it is padded with rags or rubber.
- . Replace muffs and cowling in the same manner as removed.
