MOONEY AIRCRAFT, INC.

SERVICE LETTER 20-59

DATE: 10-23-59
SUBJECT: CLEARANCE - MAIN GEAR WHEEL IN WHEEL WELL
MODELS AFFECTED: M-20 AND M-20A, ALL SERIAL NUMBERS

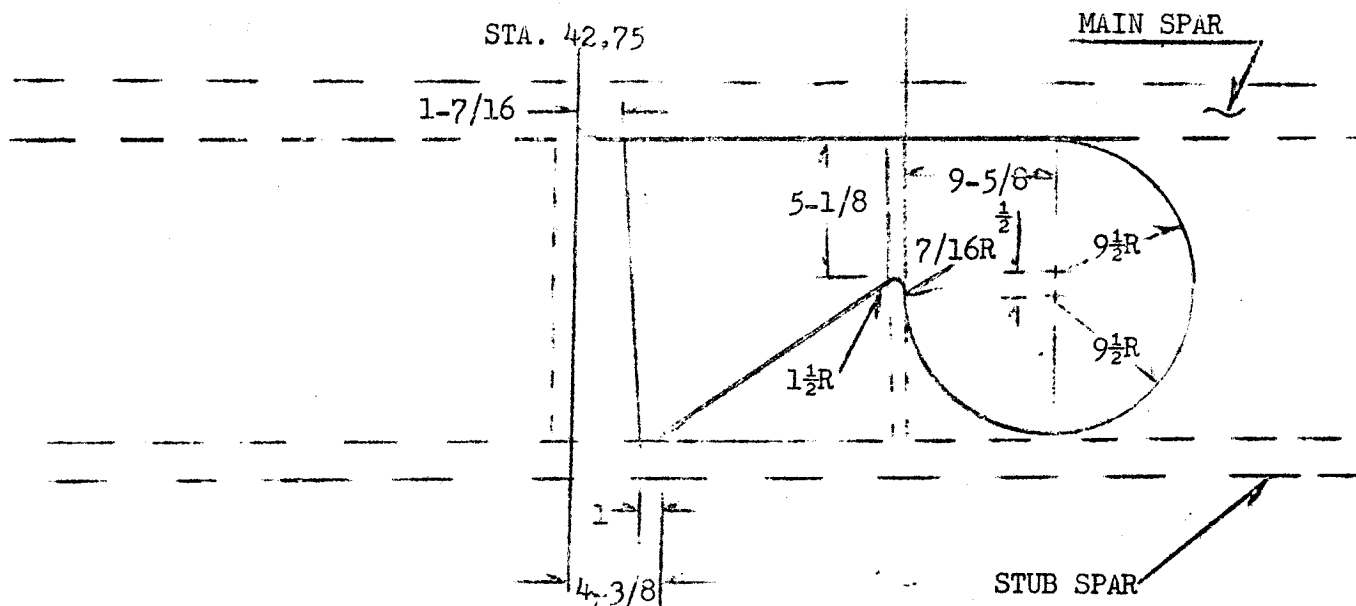
Several cases of landing gear failures have occurred on M-20 and M-20A aircraft due to improper diameter of the tires. If the tire is slightly oversize, it possibly may jam in the wing wheel well, which could cause the retraction tubes to be damaged when the gear is lowered. The gear was designed for a 6:00 x 6 - 6 ply Goodyear tire which is the proper size. Some other makes of 6:00 x 6 - 6 ply tires are slightly larger in diameter, and we therefore recommend only Goodyear tires be used as replacements.

If any doubt exists as to the adequacy of tire clearance in the wing wheel well, it is recommended that a ground retraction check be made. The minimum clearance between the tire and wood with the tire inflated to 30 psi should be approximately 1/2 inch on new tires and approximately 1/4 inch on used tires. The size of the wheel well cutout was increased slightly on airplane Serial Nos. 1350 and subsequent numbers. The cutout on earlier serial numbers may be enlarged to the dimensions shown in the sketch, if necessary, for better tire clearance. The cutout area must be recovered with fabric tape, doped with butyrate dope, and repainted with suitable dope color.
