MOONEY AIRCRAFT, INC.

SERVICE LETTER 20-67

SUBJECT: WHEEL WELL AREA INSPECTION AND/OR REPAIR

MODELS AFFECTED: M-20 & M-20A SERIAL NUMBERS ~~1002-1578~~

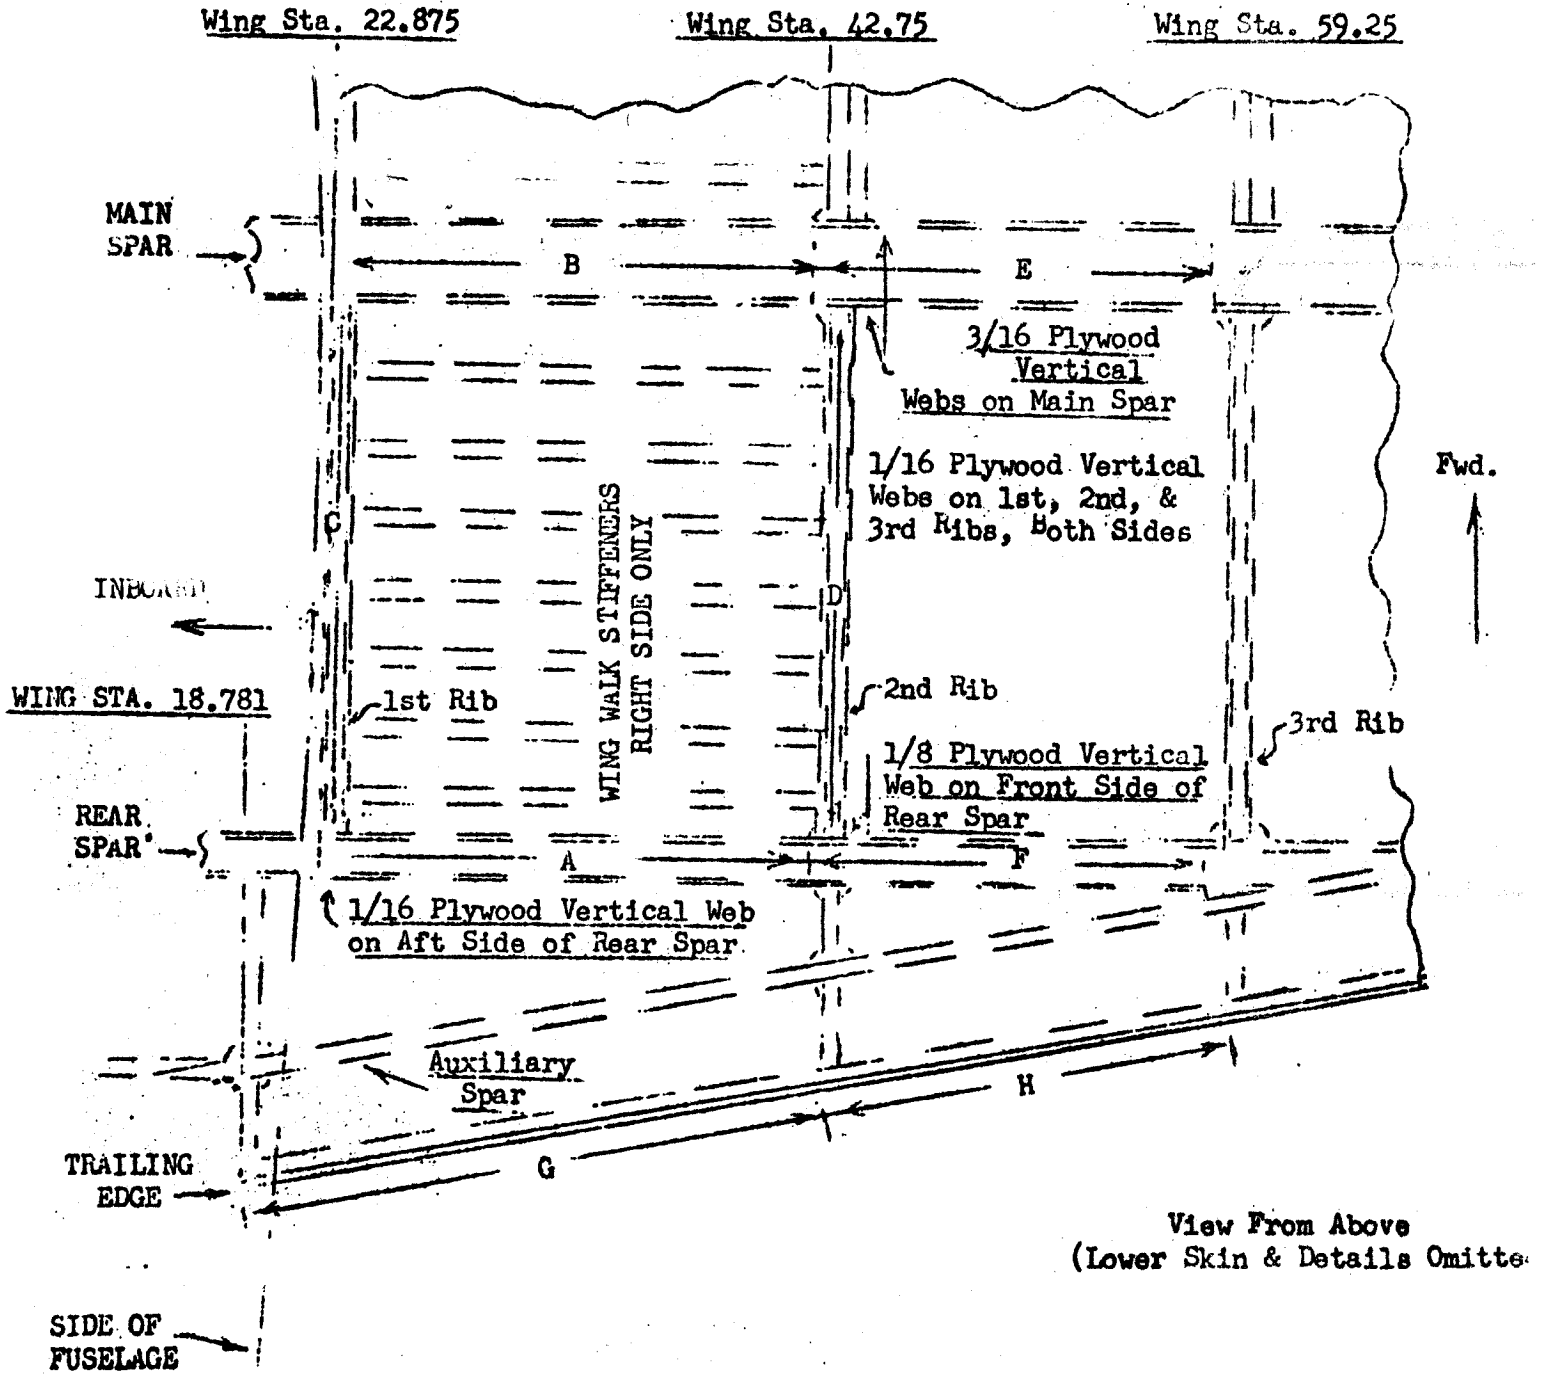
FIGURE 1

Some reports have been received concerning separation of skin from ribs and spars in the wheel well areas. This separation is probably due on the right hand side to overloading of the wing walk area and on the left hand side to people climbing on the wing to fill the rear tank or clean the windows.

If a joint shows a crack, exert a slight upward pressure on the skin and check depth of crack with a feeler gage. Ribs and spars are made with a spruce core and yellow poplar plywood webs. The joints between the wing skin and vertical webs are not structural and separation to this depth is allowable. See Fig. 1 for thickness of plywood vertical webs on ribs and spars. Web thickness may be measured at drain and vent holes. Fig. 1 also shows possible areas of separation. Inspection of trailing edge will be facilitated by removal of the inboard flap gap strip and examining joints by pressing or tapping. If separations are found, repairs may be made in accordance with the following instructions.

POSSIBLE GLUE SEPARATION AREAS

Present Structure. Right Wing Shown
 Left Wing Similar

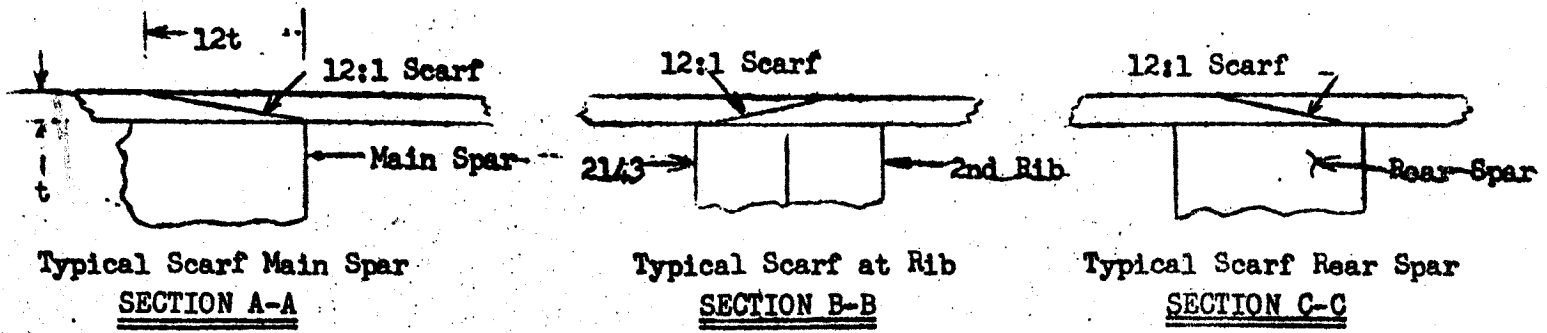
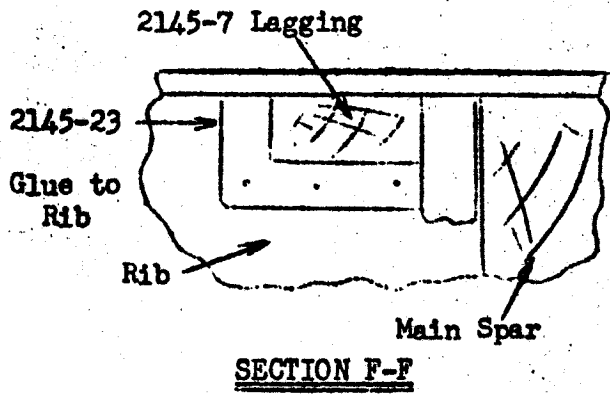
Typical 2 Places for
2145-7 & 2145-9 Lagging

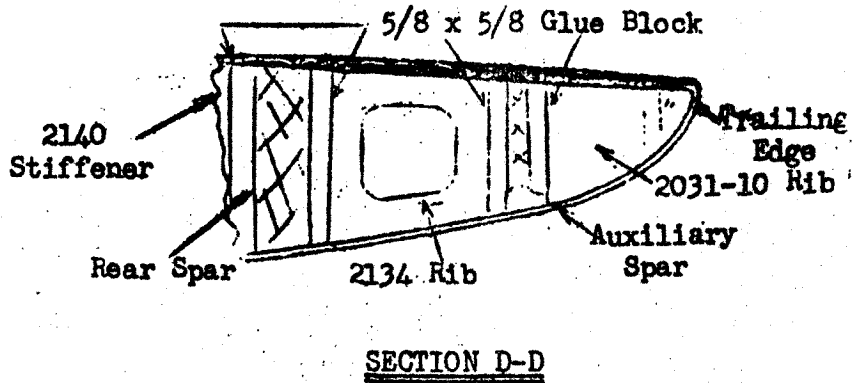
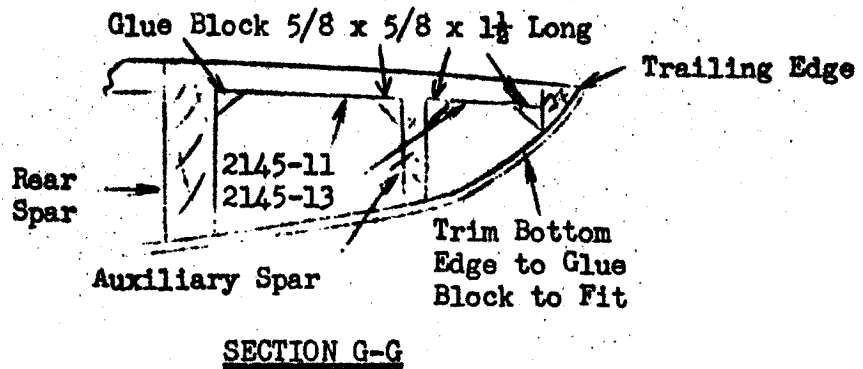
Figure 2 (continued)

Typical for Installation
of 2145-11 & 2145-13 Lagging
