MOONEY AIRCRAFT, INC.

SERVICE LETTER 20-71

SERVICE BULLETIN M20-71

DATE: July 26, 1960

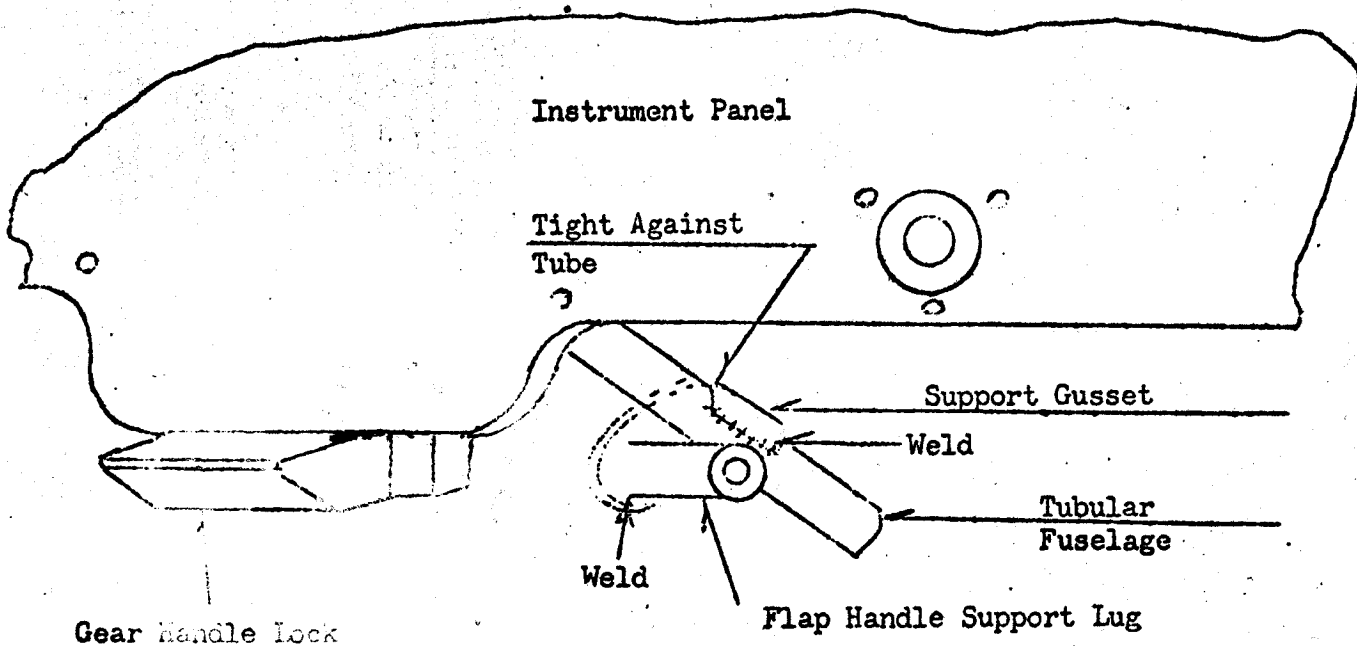
Effective on Mooney aircraft Serial Nos. 1002-1571. A method of improving the flap handle support bushing locally is contained in the following repair instructions for use by your A&E mechanic. Failure of the attachment could result in loss of flap control. It is therefore recommended that the security of this attachment be checked and that it be reworked in accordance with the following instructions:

FIGURE 1
View looking fwd. and inboard from right

1. Remove flap control handle and attached control tube.
2. Protect items near the area to be welded. Remove or loosen instrument panel attachments (including nuts on vernier controls) in area above flap handle, pull panel back and insert wet asbestos behind panel. Place wet asbestos around throttle control housing. Loosen clamps on wiring loom, push it away from area to be welded and wrap it with wet asbestos.
3. Weld up any cracks on front outboard side and back of flap handle attach lug. Add weld along outboard side if this area is not presently welded.
4. For added strength, it is recommended that a support gusset be made and installed as shown in figure.
5. Clean, Prime and paint weld area.
6. Install parts removed.

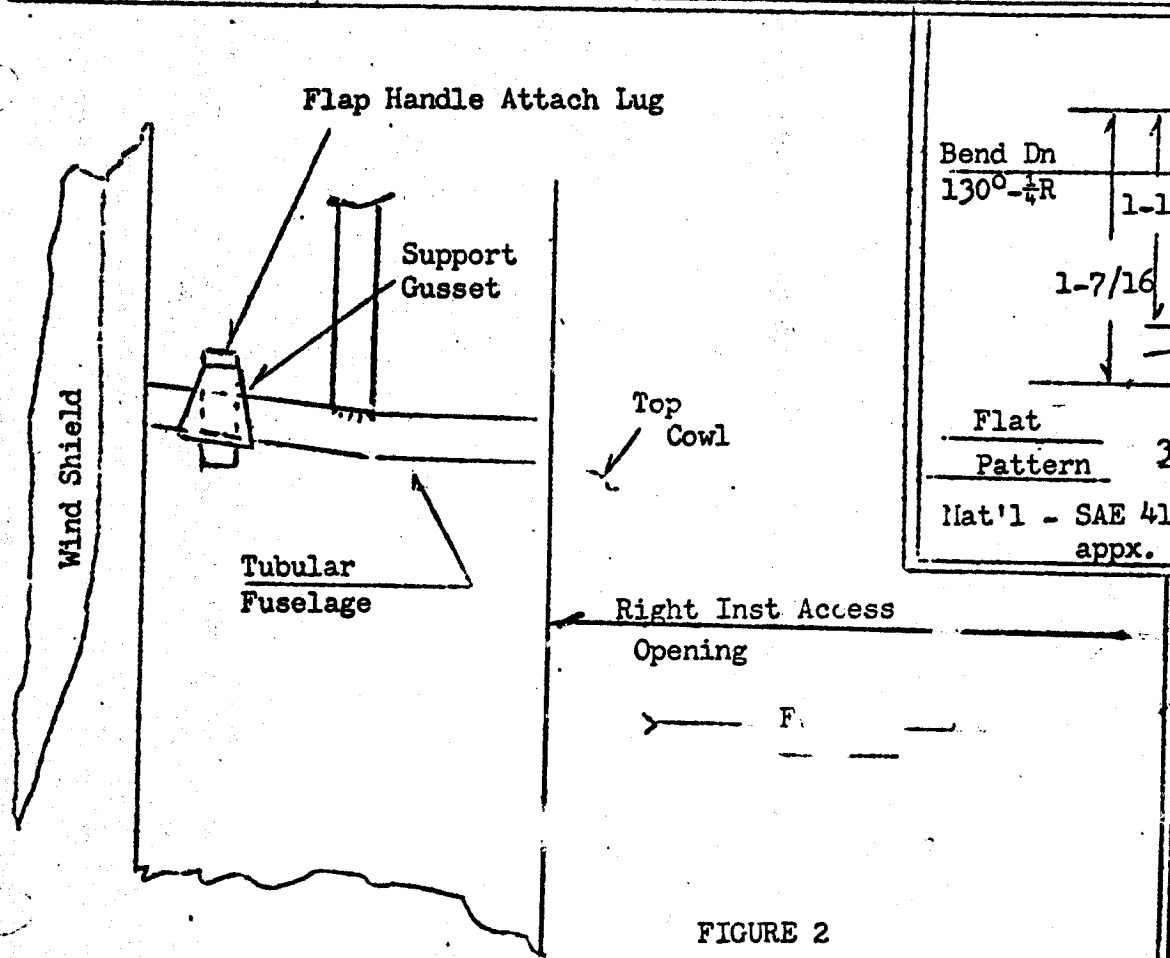
View looking down thru R.H. instrument access opening

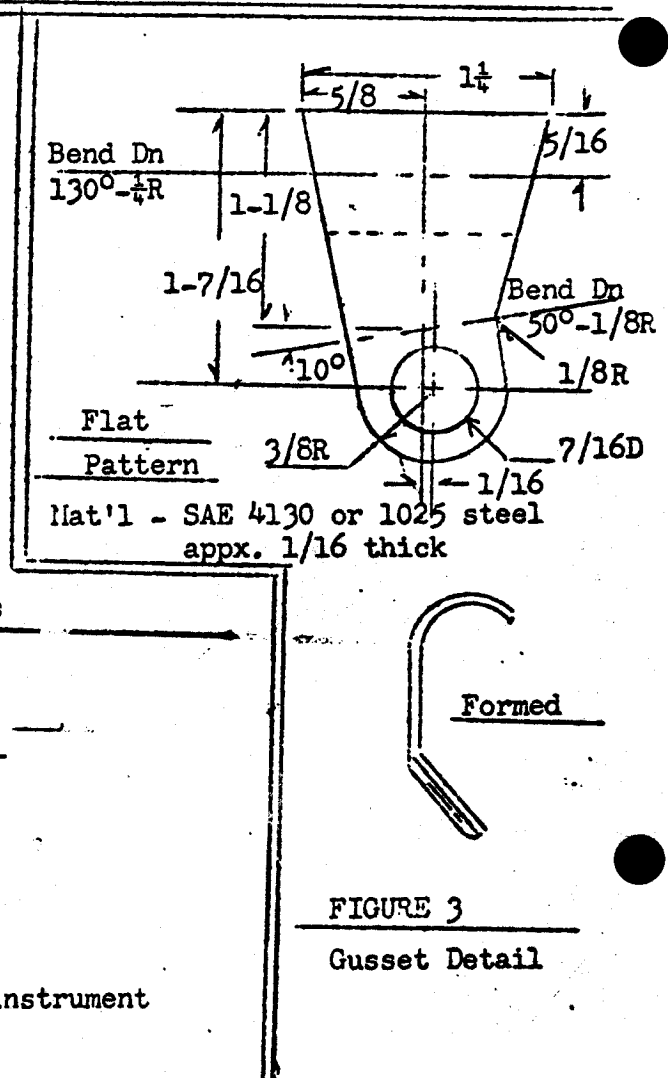
FIGURE 3
Gusset Detail
